AFFIDAVIT

Response to PG&E Report 411-77.55

Subject: Failure Analysis of Cracked Field Weld No. 212, Diablo Canyon Unit 1, Steam Generator 1-2, Nozzle-To-Pipe Weld.

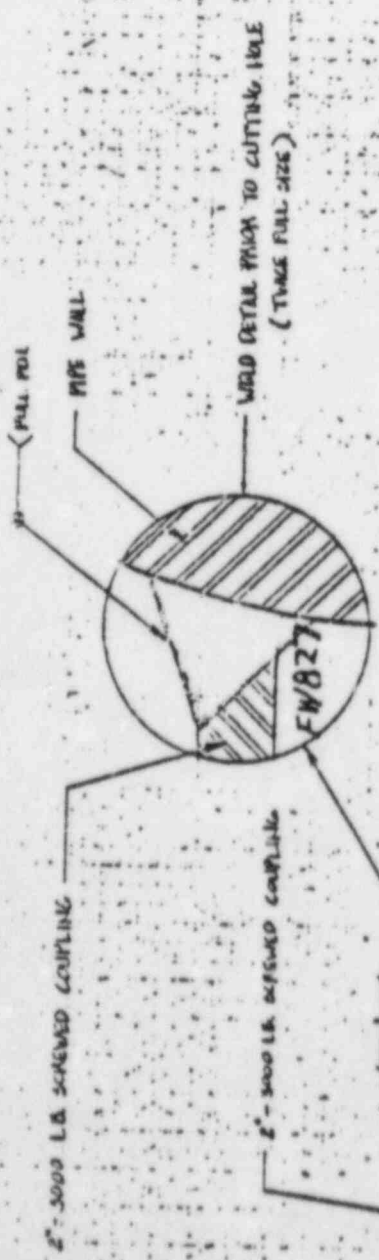
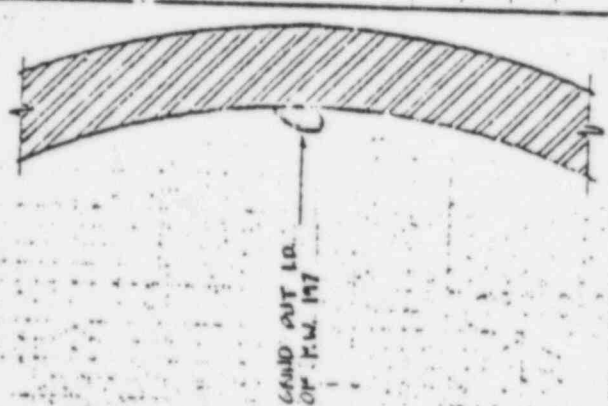
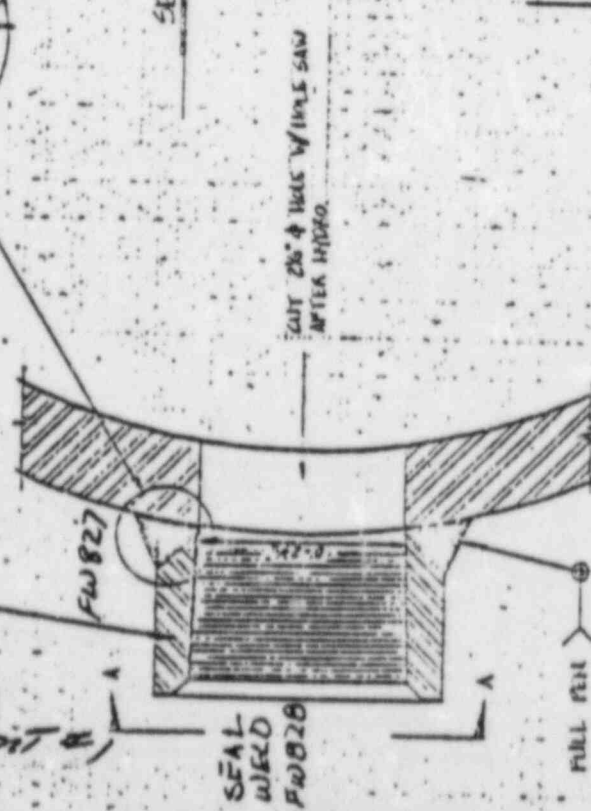
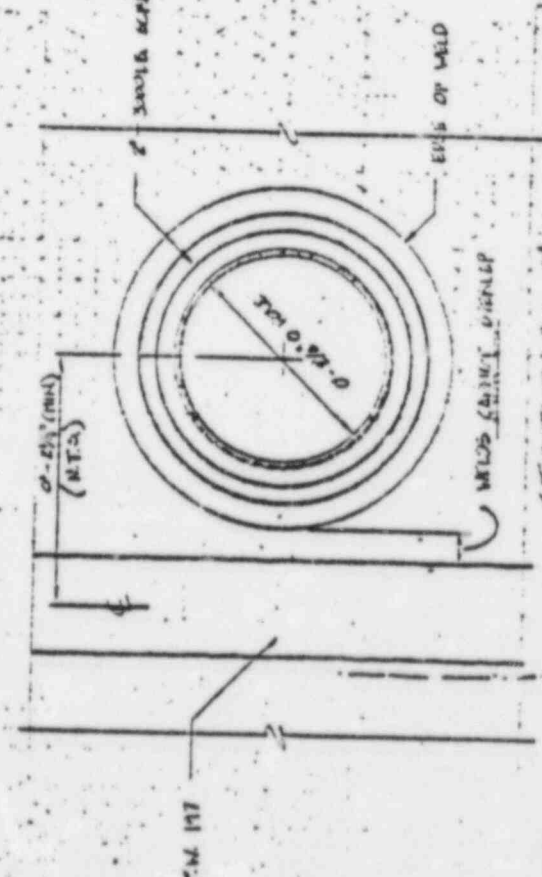
SECTION THRU PIPE NEAR F.W. 197

The review revealed a questionable indication in F.W. #197 on the feedwater lead to Steam Generator 1-1. The indication appears to be a burn through which contains linearly oriented voids. The accompanying radiographic report accepted the weld but did not indicate the presence of the burn through. Further investigation revealed that a second set of radiographs, shot at a later date, exist. This set also shows the burn through which was recorded on the radiographic report as acceptable (see copies attached).

To determine the severity of the indications in the burn through, we have made additional radiographs of the burn through area. These radiographs indicate that the voids are probably contained within the burn through and do not extend into the weld. There is no indication of propagation of the indications.

To eliminate the possibility of a potential problem at a later date, it is recommended that the burn through be removed.

1. Weld a 2" threaded coupling to the pipe as shown on the attached sketch using weld procedure 88/89 or 92/93. (FW # 827)
2. M.T. per ESD-209.
3. Post weld heat treat the weld - ESD-218.
4. Perform a hydrotest on the weld prior to drilling into the pipe.
5. Following satisfactory completion of the hydrotest, cut the hole through the pipe wall with a hole saw (Ref. ESD-230) NOTE: Additional reinforcement of 2" opening is not required per P.G. & E. calculations
6. Using an extended shaft grinder with a cone shaped rock, grind the burn through flush with the pipe surface.
7. Radiograph the area to assure complete removal of unacceptable indications.
8. Install threaded plug and seal weld (F.W. #828).

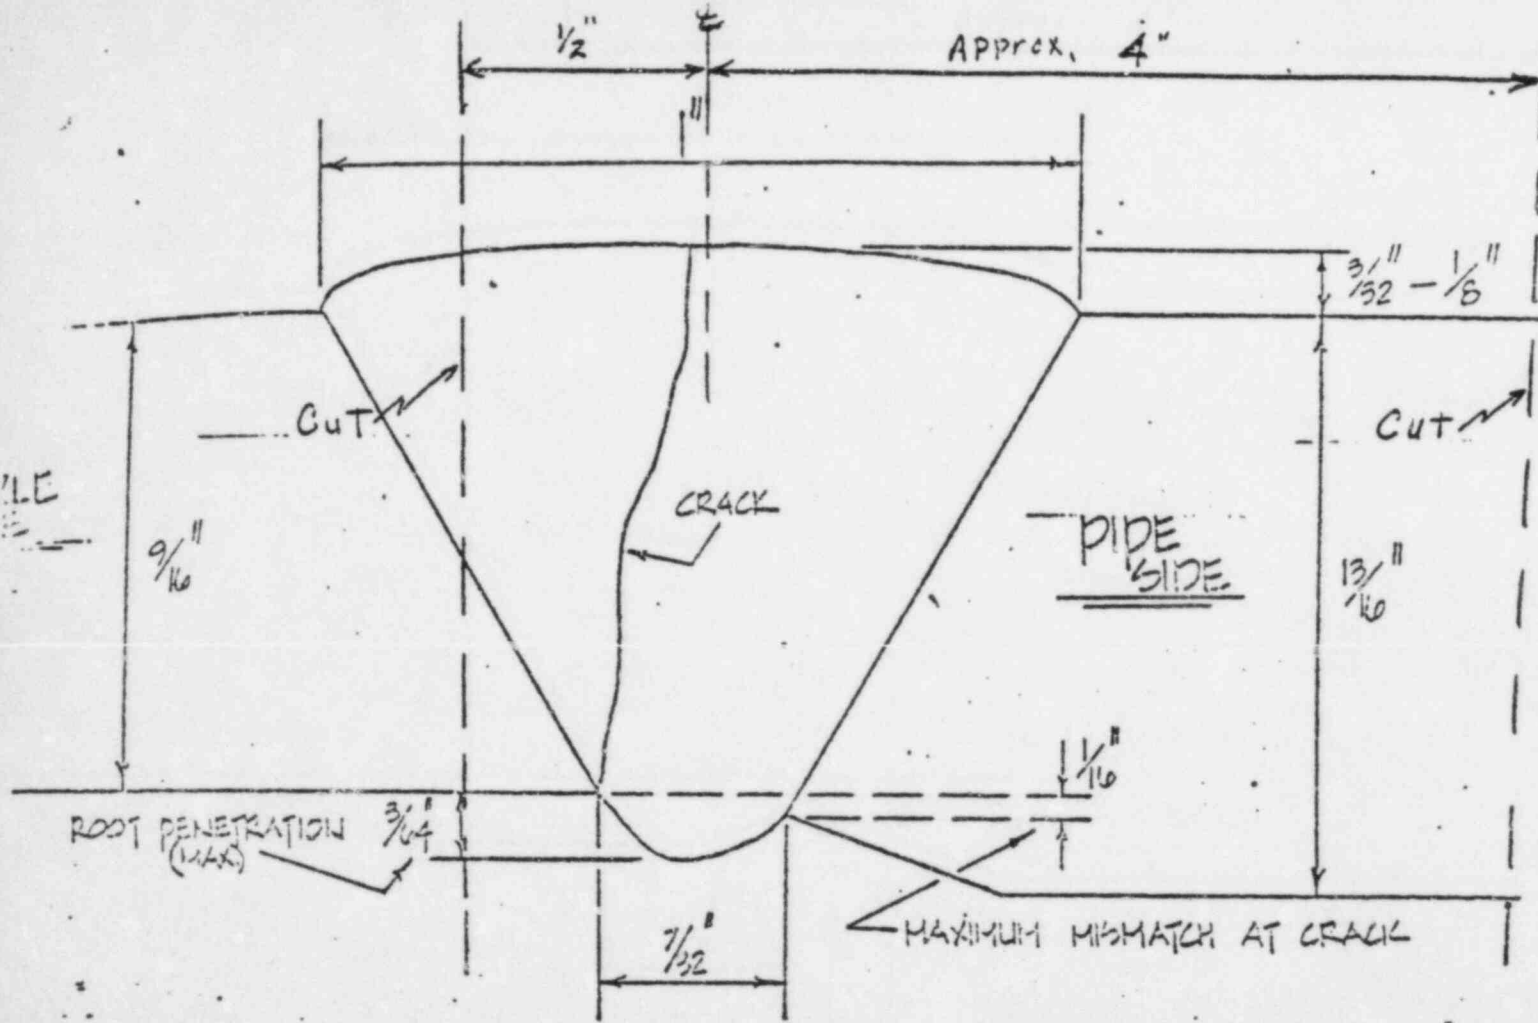
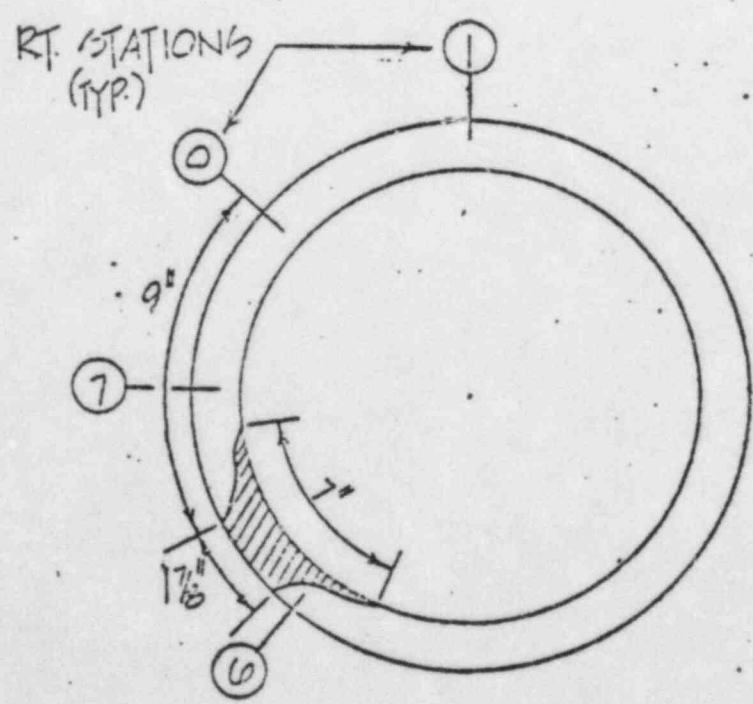
1. WALL THICKNESS MEASR. ARE APPROXIMATE
2. REF. TO DR. 3366 REV. A
3. STEAM GENERATOR 1-2  
F.W. #212  
V.D. 500146  
LINE # K10-555-10 IV

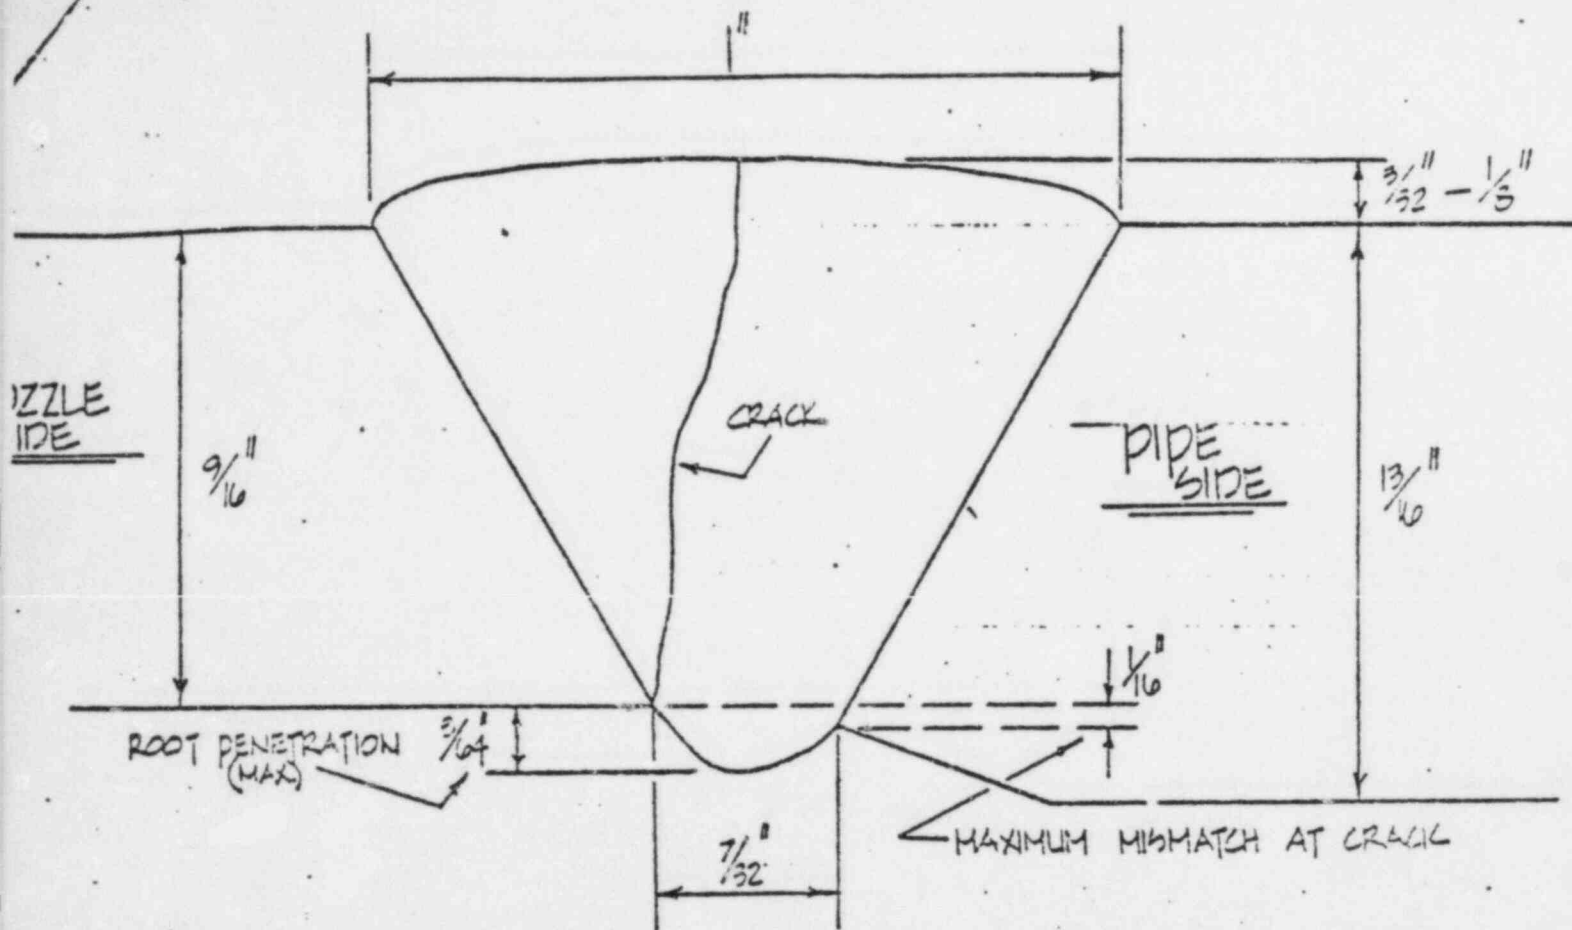
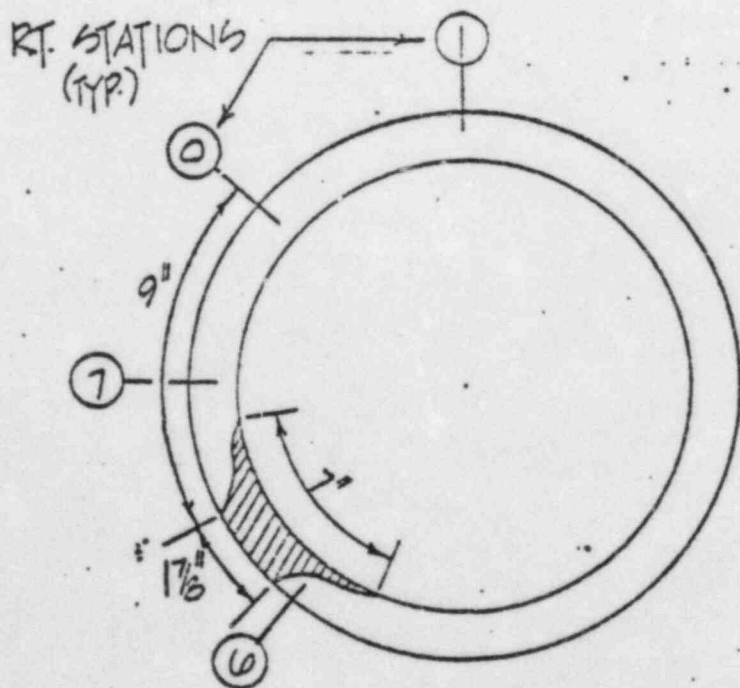
1. WALL THICKNESS MEASR. ARE APPROXIMATE
2. REF. TO DR. 3366 REV. A
3. STEAM GENERATOR 1-2  
F.W. #212  
NO. 500141  
-LINE # K10-553-10 IV

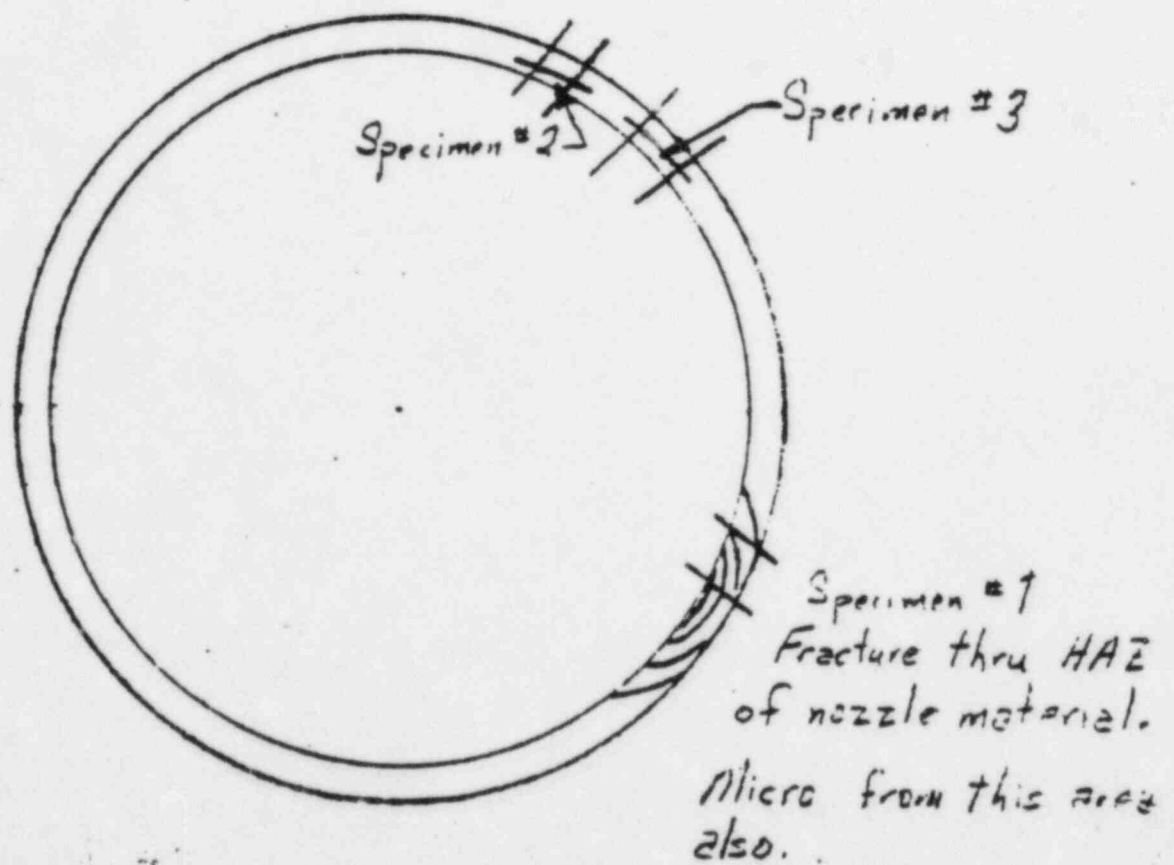
Figure 1. Schematic diagram of failed nozzle illustrating the locations from which samples were removed.

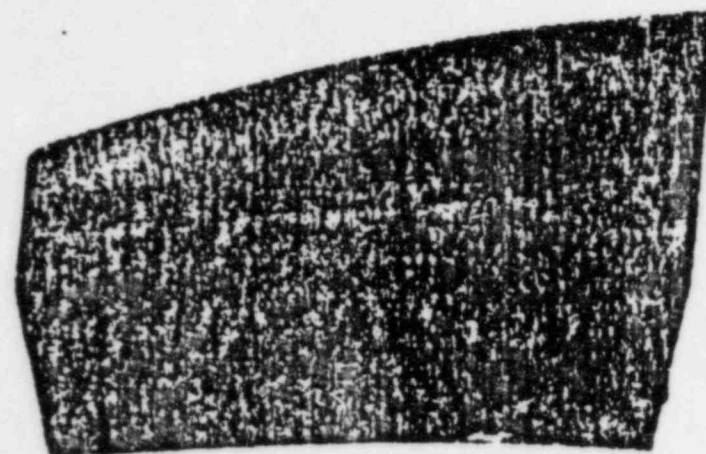
Figure 3 Specimen #1, showing fracture surface with parallel markings originating along one side of weld bead; 3X.

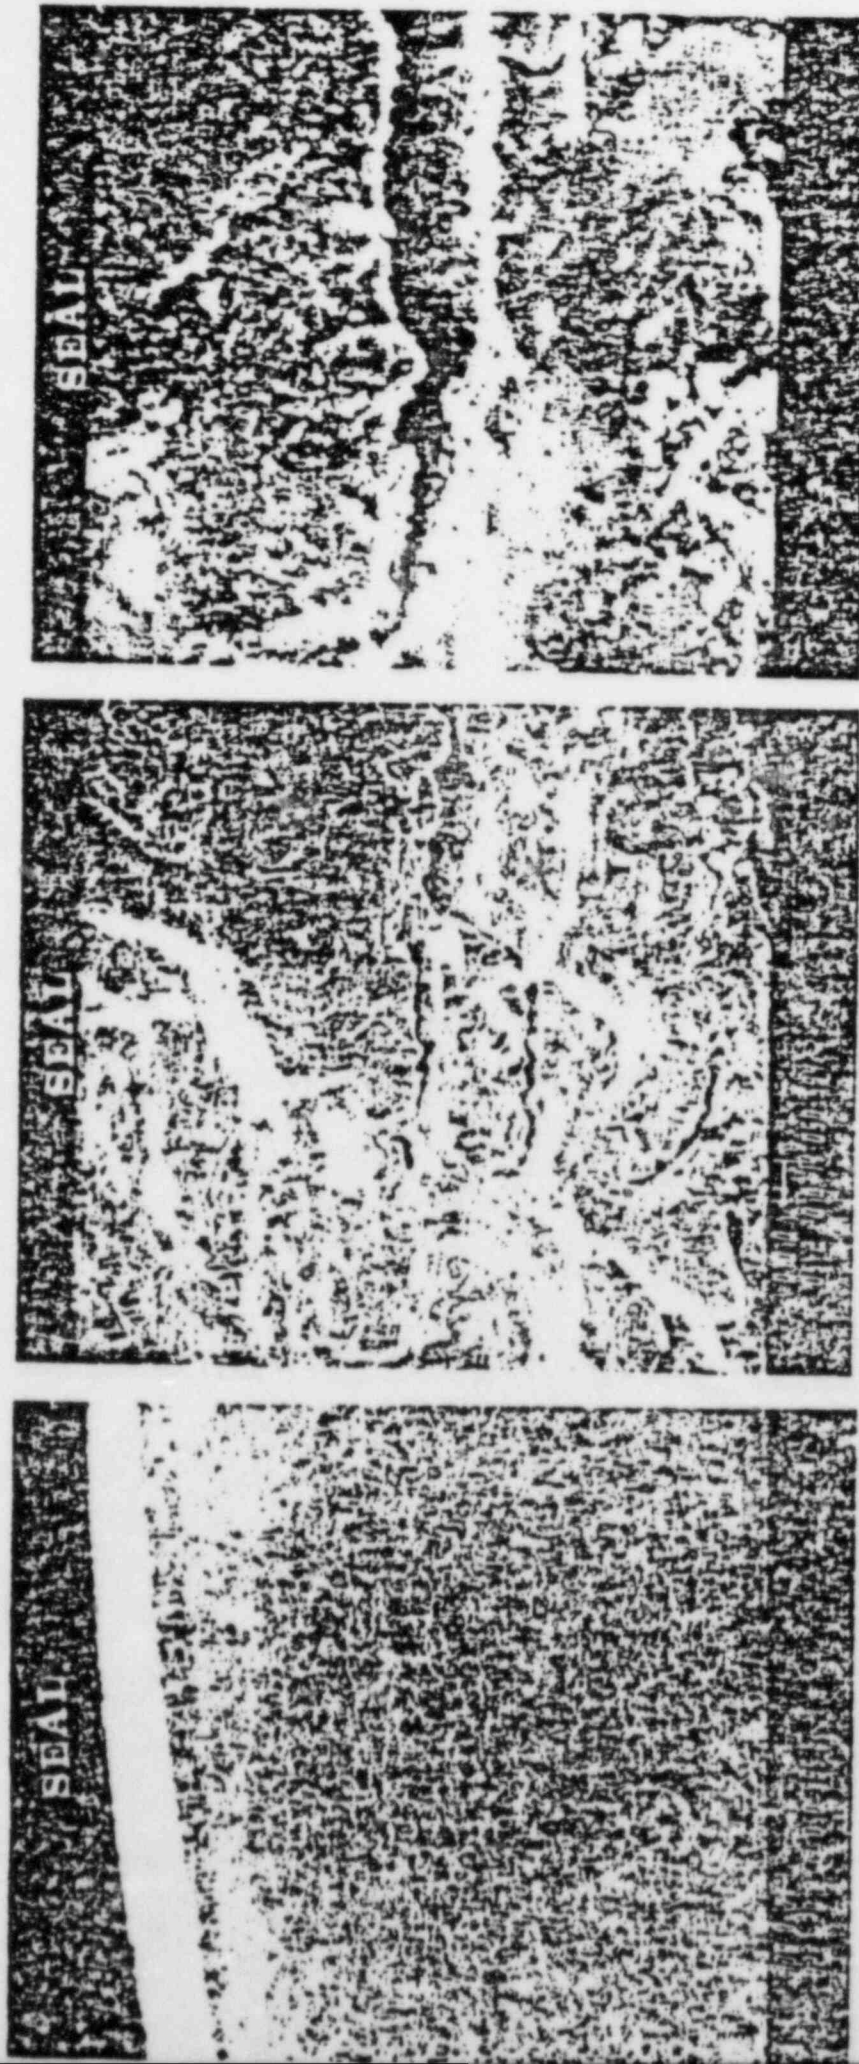
Figure 4. Surface of main fracture which was in the heat affected zone (HAZ) of the nozzle, Specimen #1, showing oxidized surface with crack branching. a. 20X (50595). b. 500X (50594). c. 2000X.

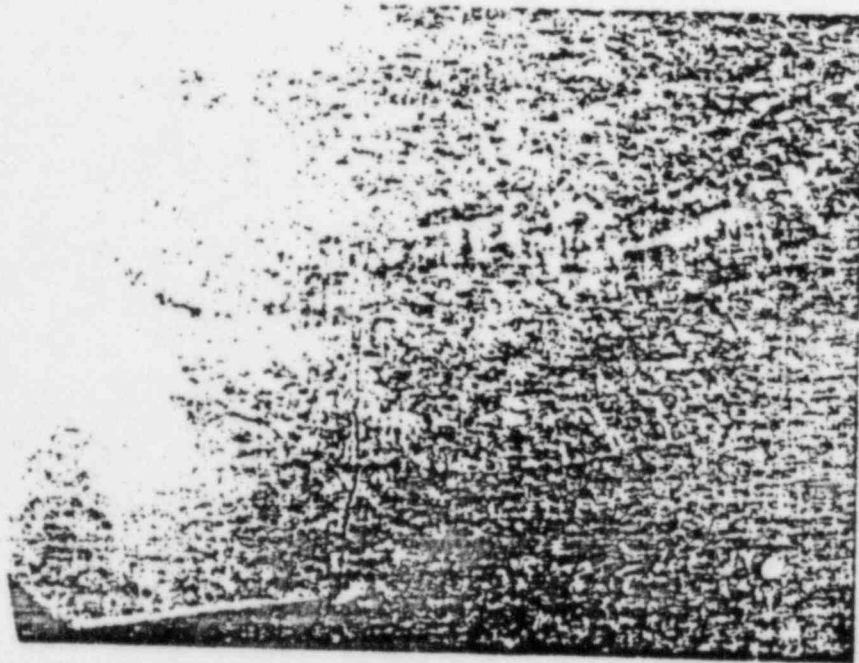
7.) Figure 5 showing the crack in a macroexamination has the pipe and nozzle identifications reversed.

Figure 5. Polished cross section of the main fracture. The pipe is on the bottom left, the weld root is bottom center and the nozzle is bottom right. The bottom of the picture is the pipe I.D. The small bright dots are micro hardness indentations. 7 x magnification.

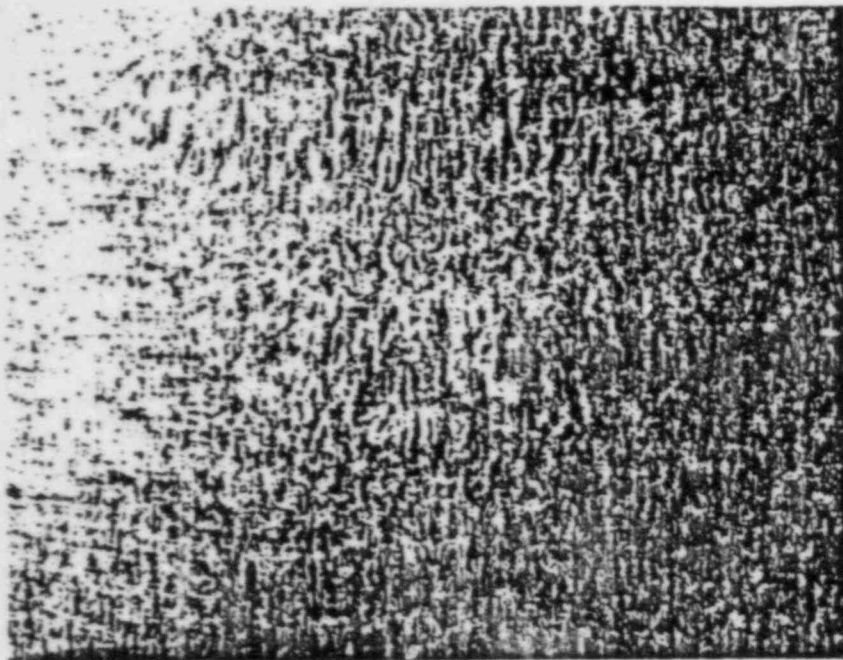
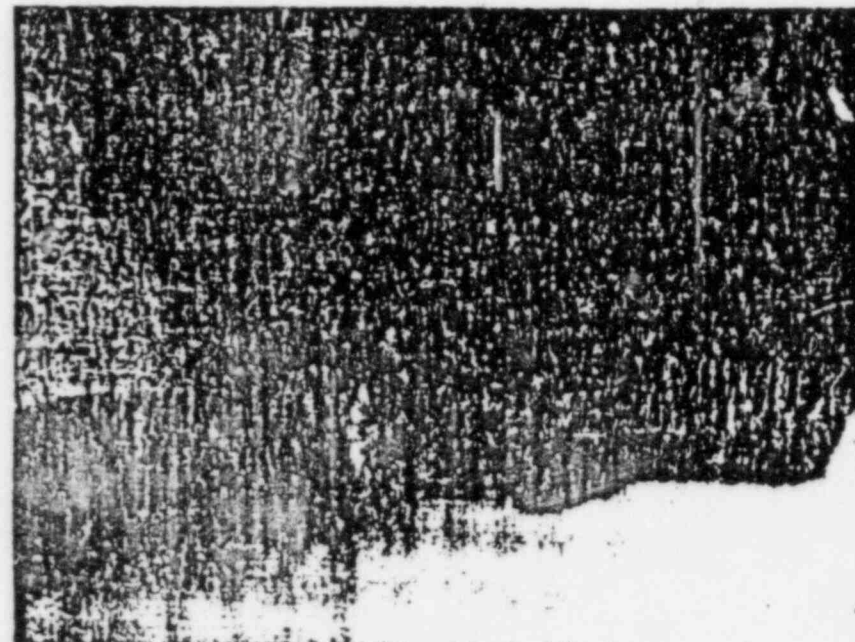
Figure 6. Cross section of Specimen #3, Figure 1, which shows small secondary cracks similar to those noted adjacent to the main fracture. The tilted view shows the coincidence of the cracks with grinding marks on the pipe and nozzle I. D., as well as in the unground weld.

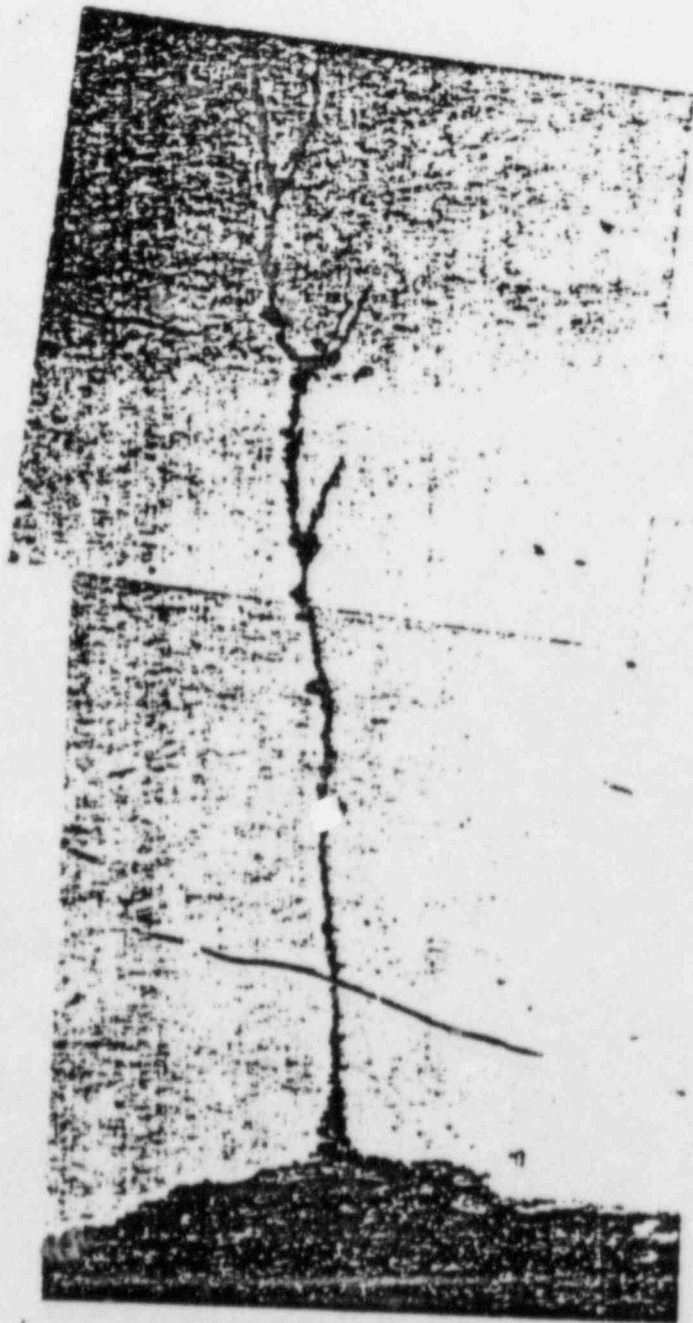
Figure 7. Polished cross section from main fracture area showing a crack, filled with oxide, with crack branching and sulfide inclusion stringers; 450X.

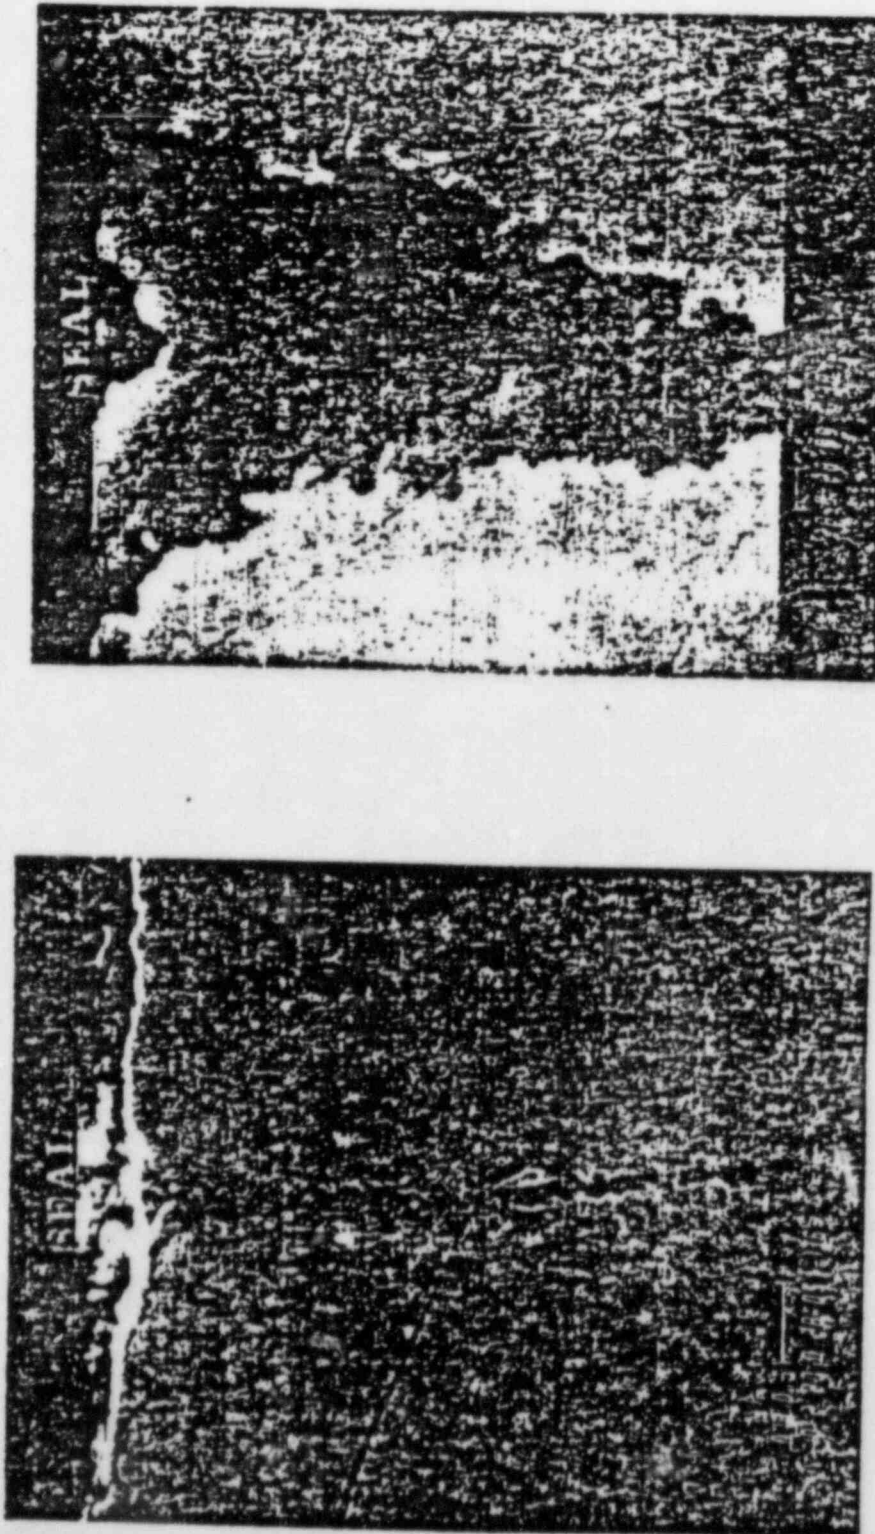
a. b.  
Figure 8. Details of polished cross section shown in Figure 7 a. 1000X.  
(51136). b. 5000X (51138).

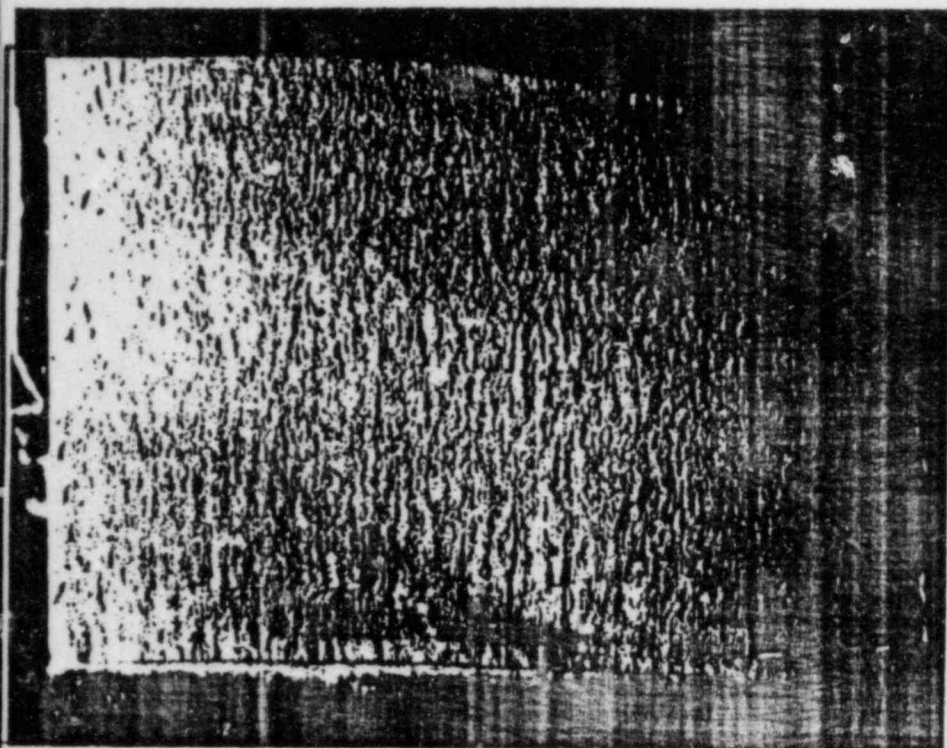
Crack "Front" Face; Viewed Toward  
Pipe Component.

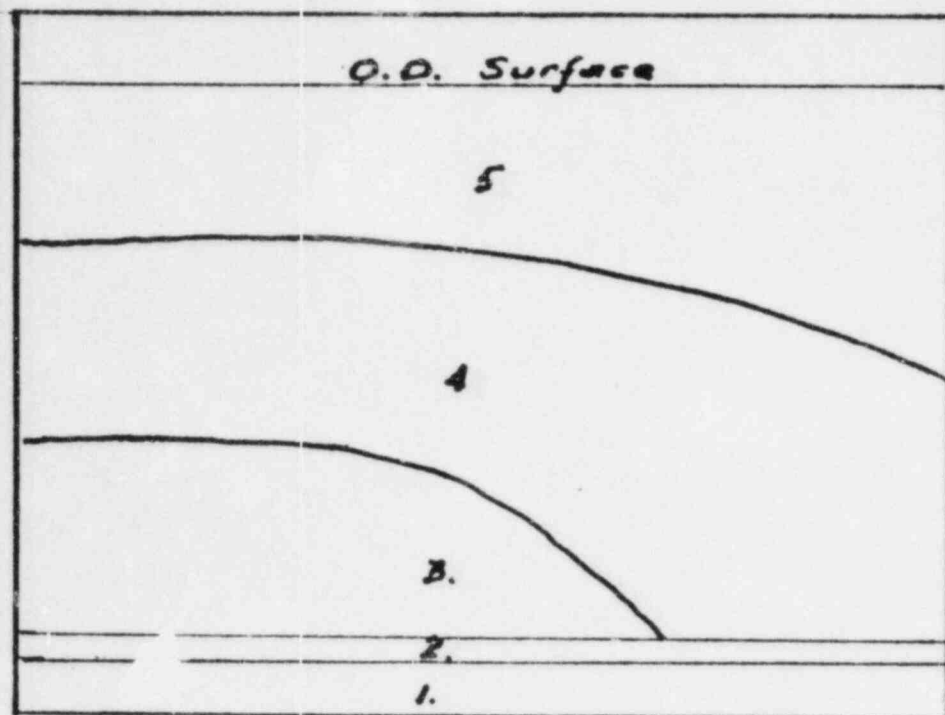
Fig. 1

1. K-insert, weld reinforcement.
2. Remanent weld bevel land; probable crack initiation region. Refer to photomicrograph, Fig. 2.
3. 2nd-crack stage.
4. 3rd-crack stage.
5. Final stage, thru wall penetration.

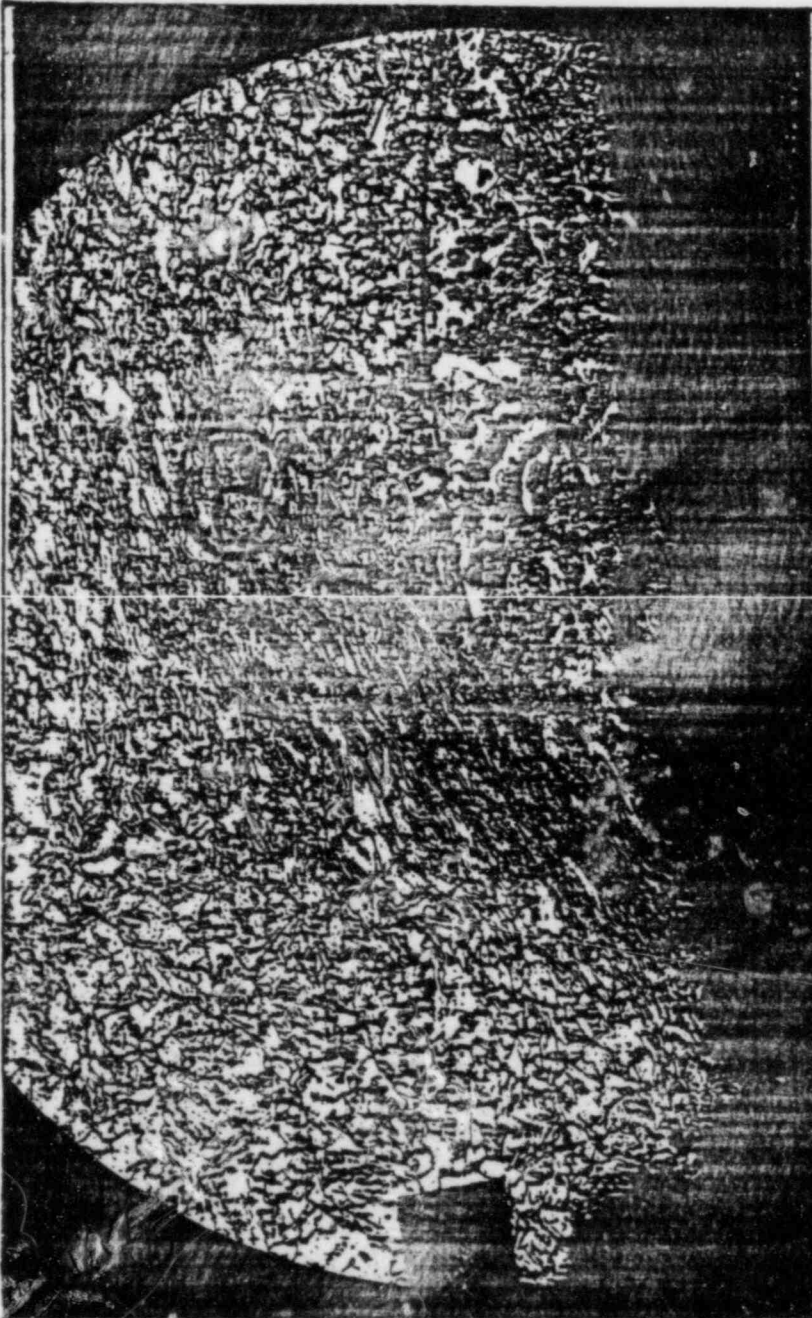
- A. Remanent weld bevel land in forged nozzle.
- B. K-insert, weld I.D. Reinforcement.

Photomicrograph  
Crack Evidence in Initial Weld Bevel Land

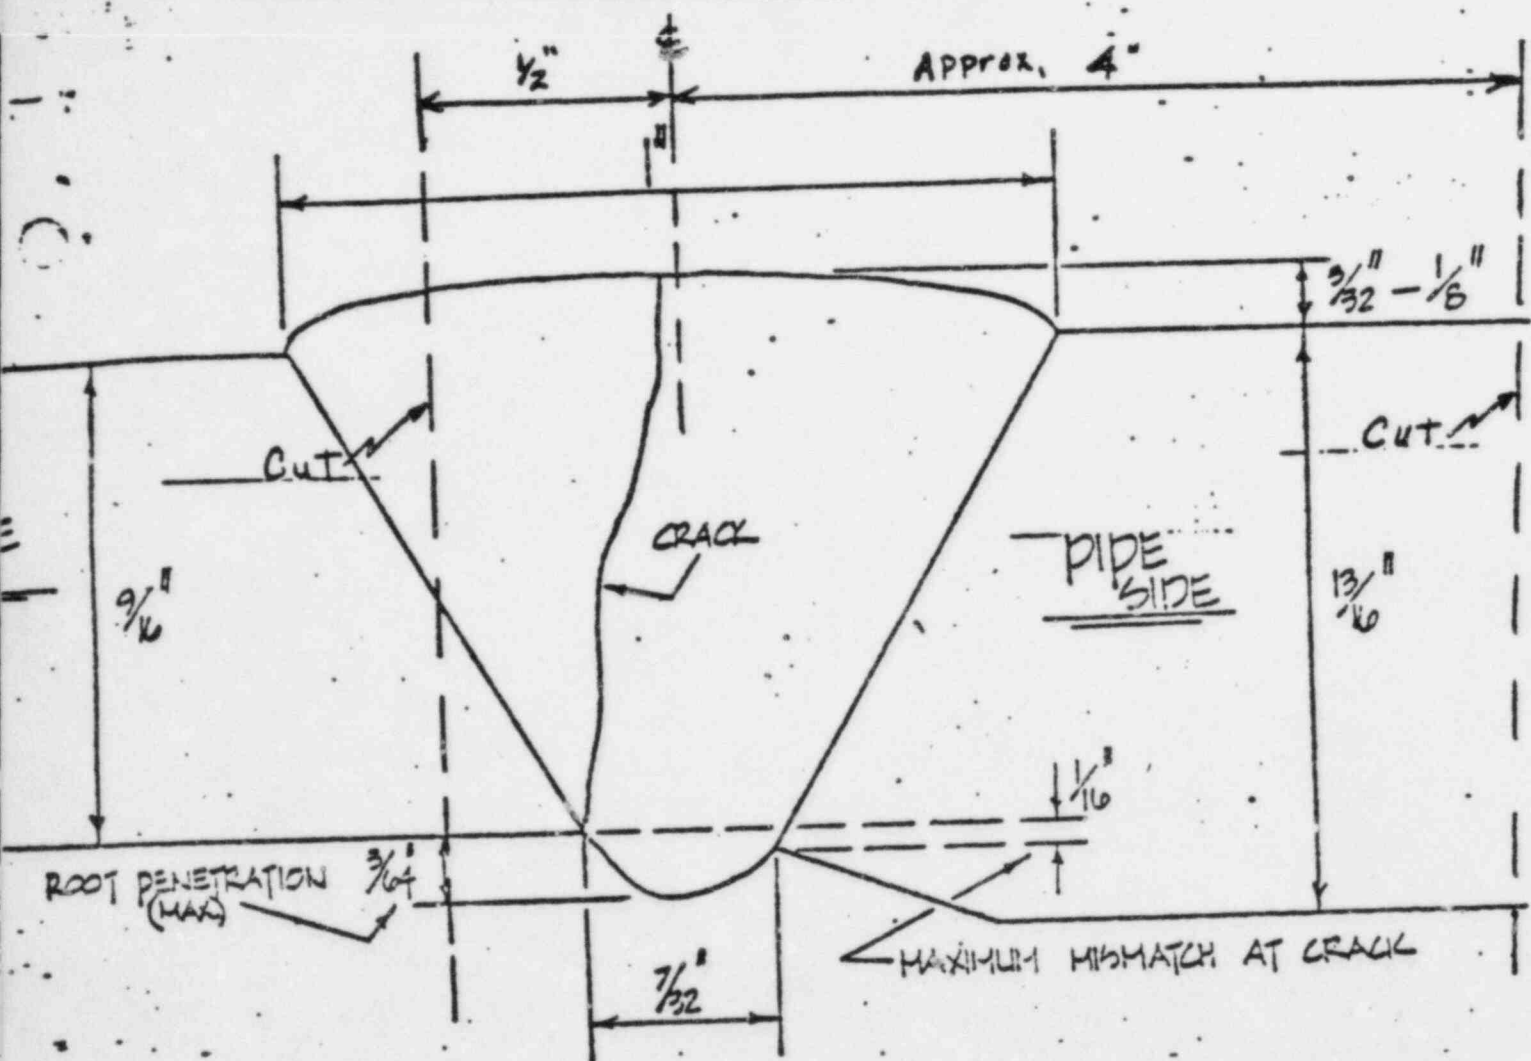
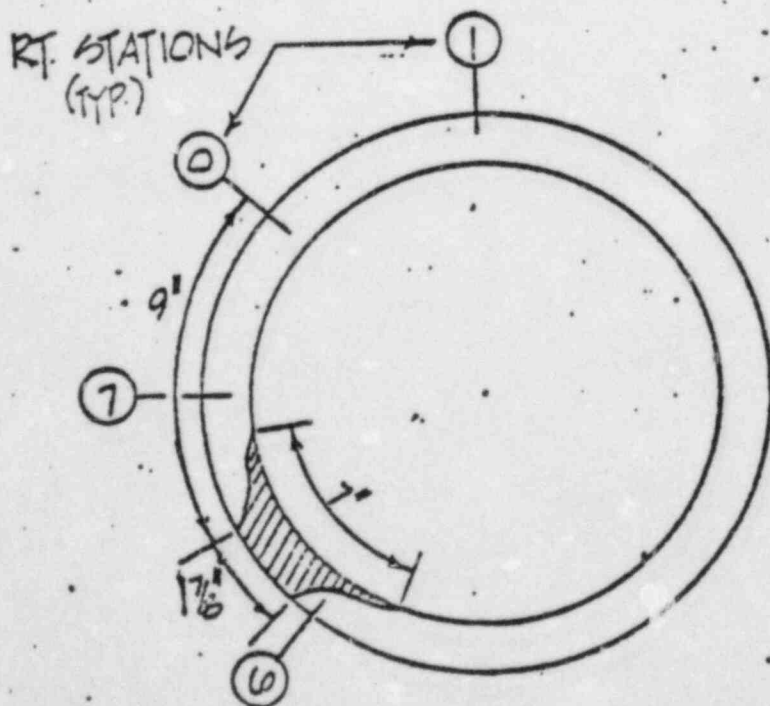
1. WALL THICKNESS MEASR. ARE APPROXIMATE
2. REF. TO DR. 3366 REV. A
3. STEAM GENERATOR 1-2  
F.W. #212  
NO. 500146  
LINE # K16-555-16 IV

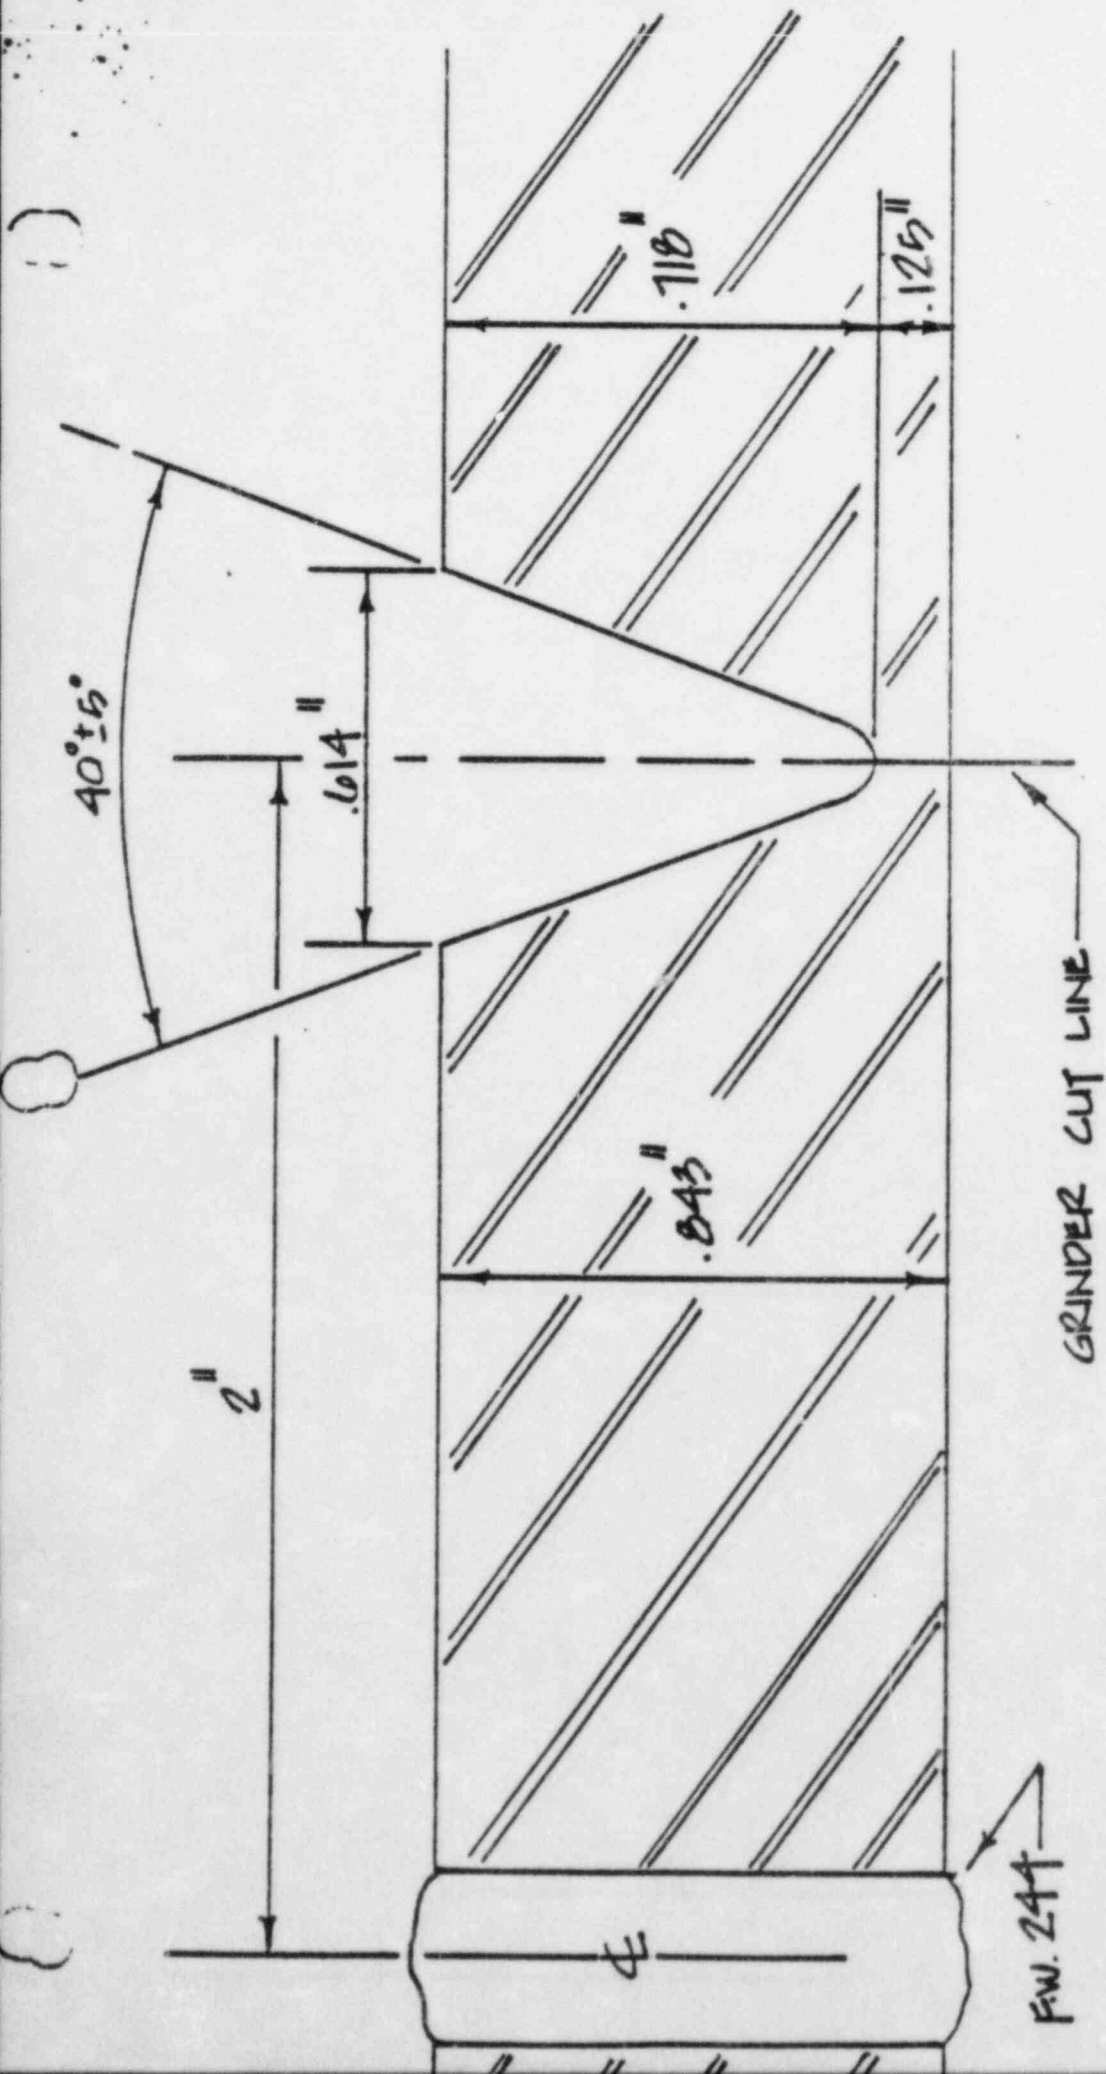
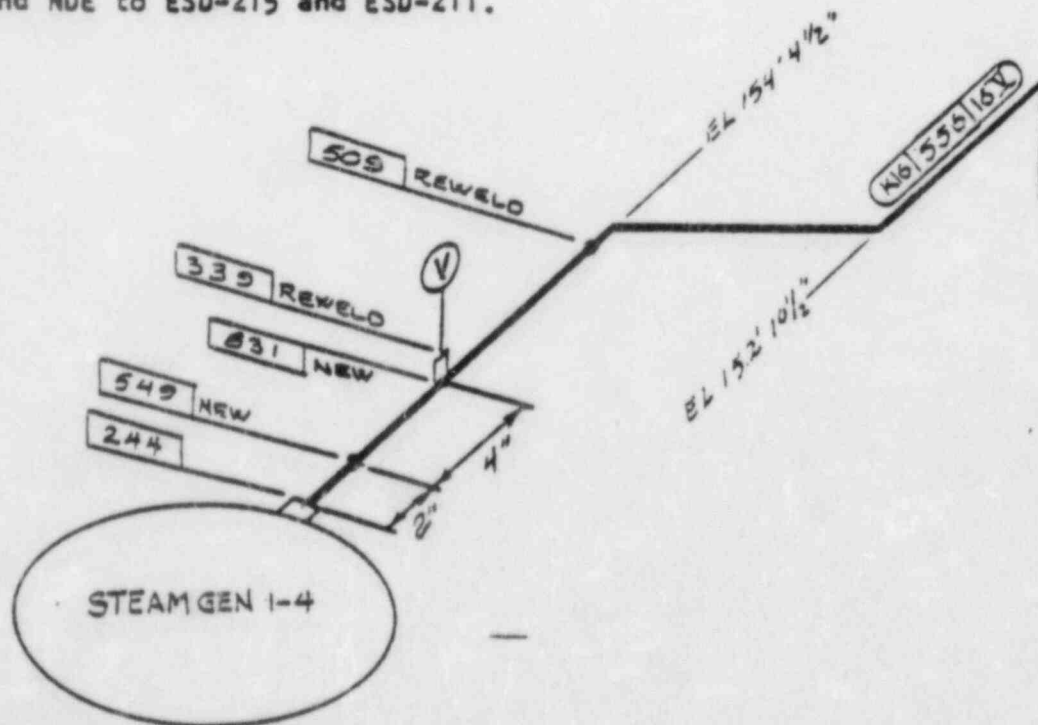
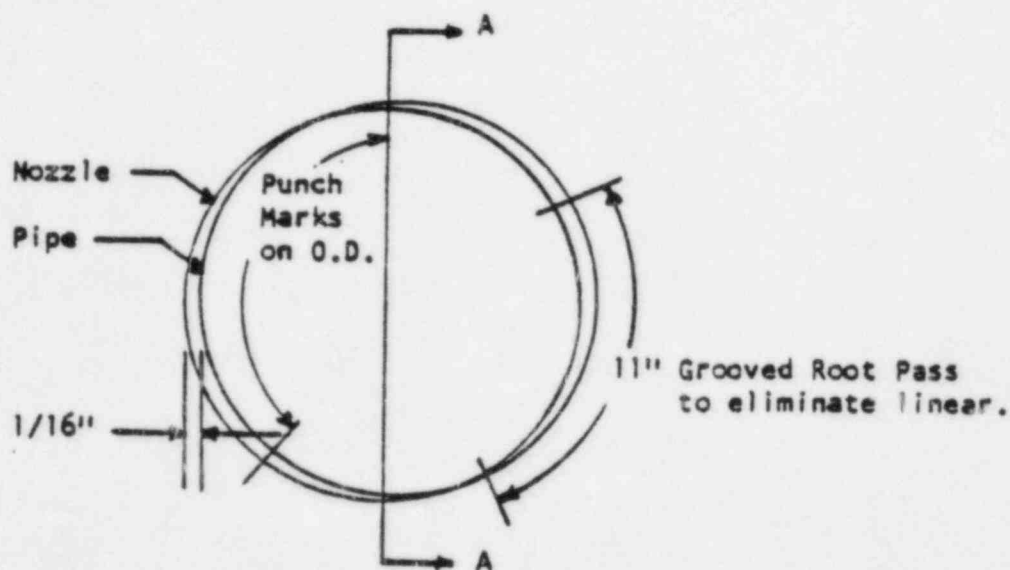
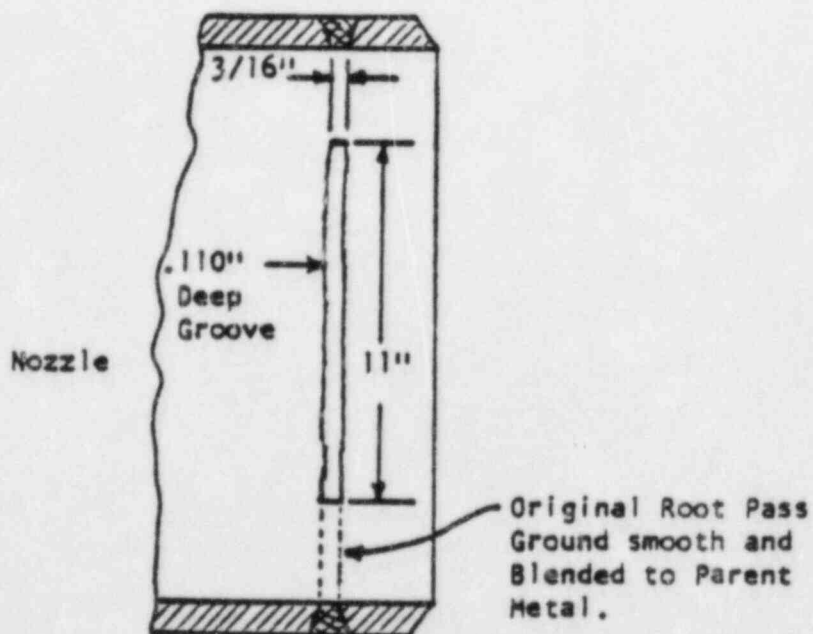
# DR-3453

NOTE: Average Wall Thickness = .580" to .600"  
Remaining Wall At Groove = .450"  
Punch Marks On The O.D. = .047" Deep  
(Punch Marks are directly on the fusion line of F.W. 244 to 1/8" inside the fusion line .047" deep.)

- Stress relieve at F.W. 244 R1 and F.W. 549 1100°F to 1150°F per ESD-218.
- NDE F.W. 244 R1 and F.W. 549 to ESD-207.
- " " " " to ESD-211 PG&E 9/30/77
- Add information to process sheets.

8. Reweld F.W. 339, as shown on Iso. 3-246, maintain original line configuration.
9. Clean and Fit-up to ESD-215 and ESD-220.
10. Weld out with procedure 92/93.
