AFFIDAVIT

Response to PG&E Report 411-77.55

Subject: Failure Analysis of Cracked Field Weld No. 212, Diablo Canyon Unit 1, Steam Generator 1-2, Nozzle-To-Pipe Weld.

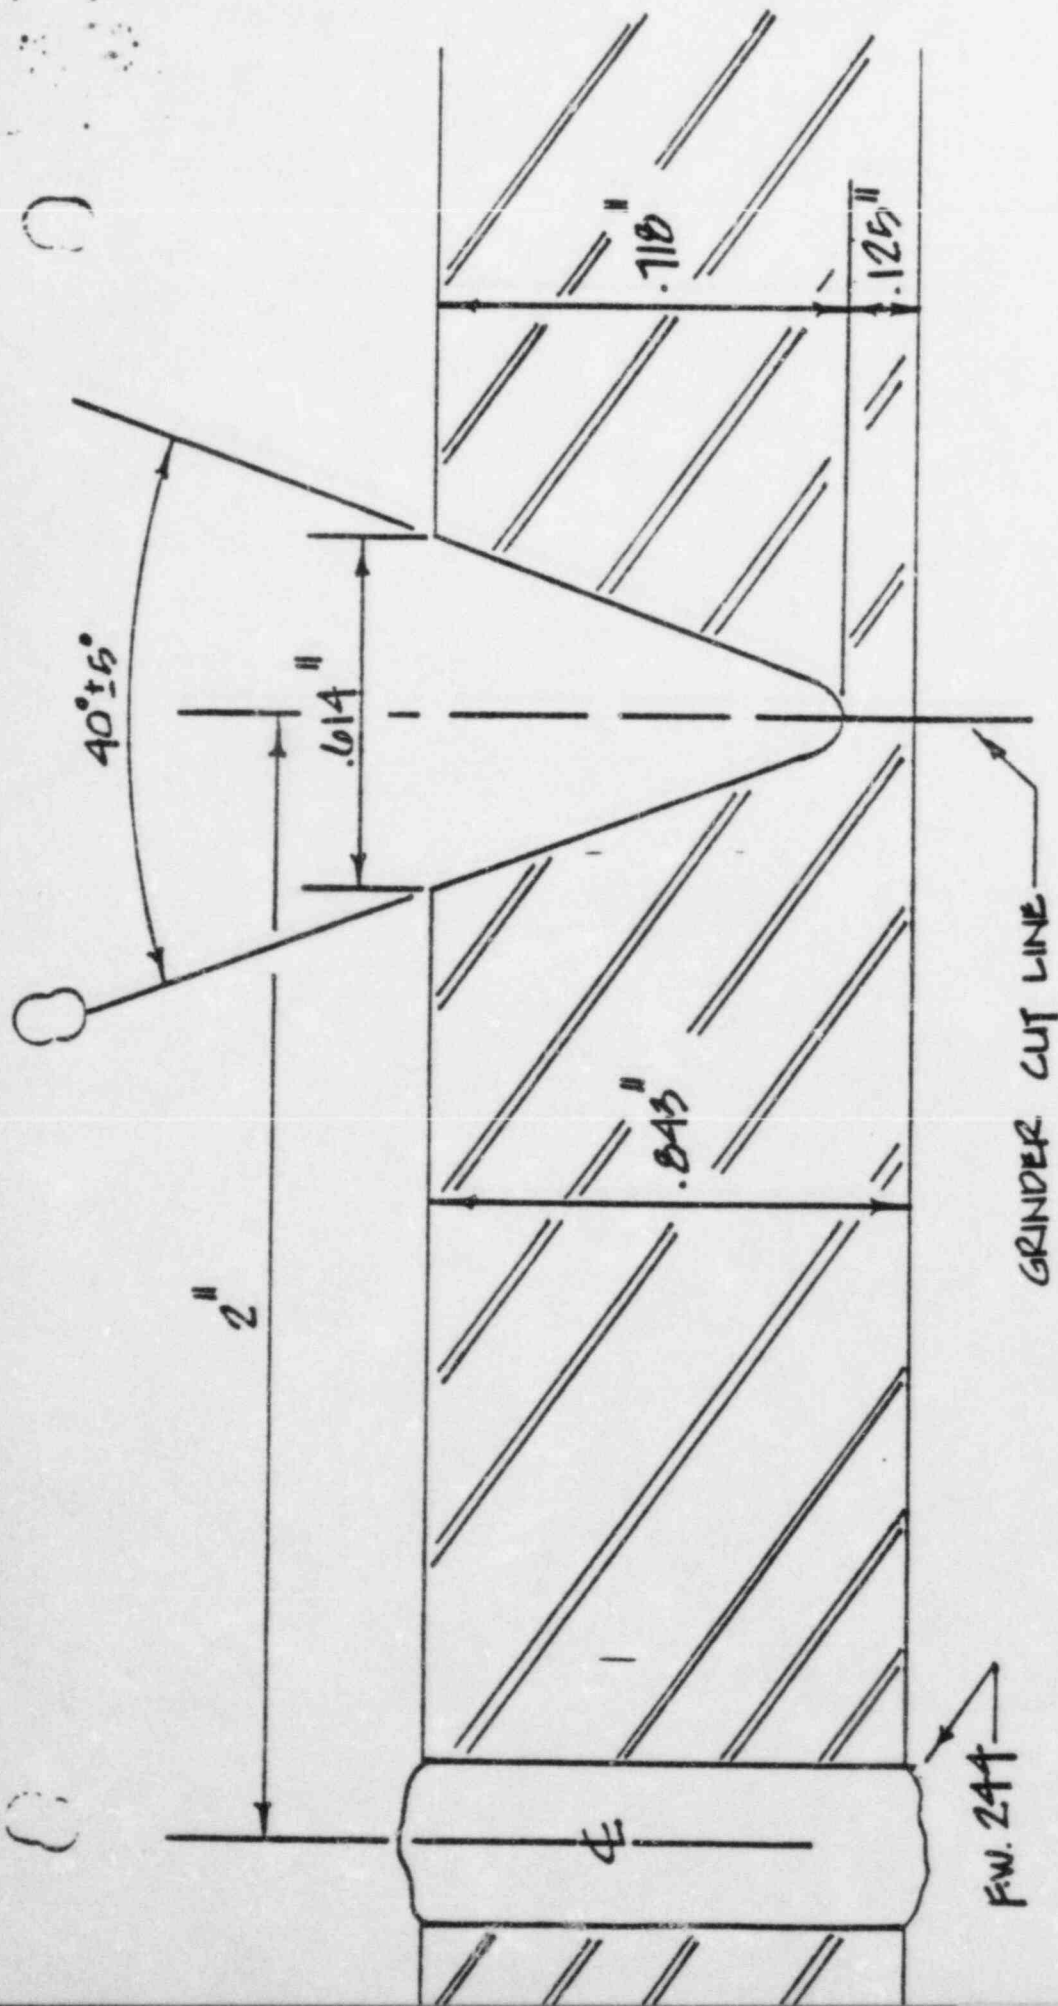
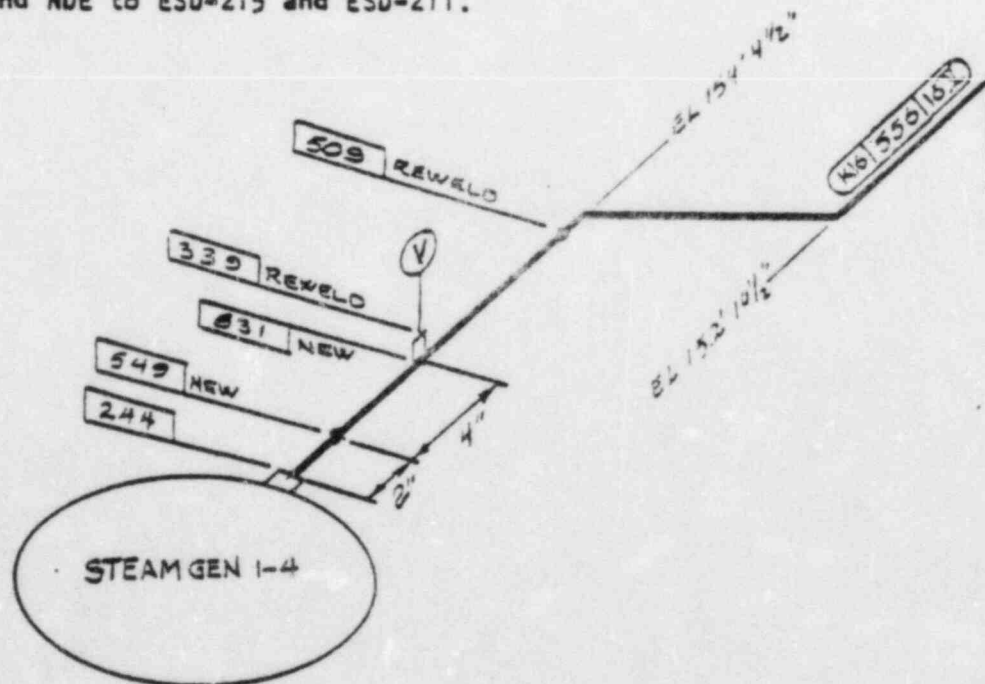
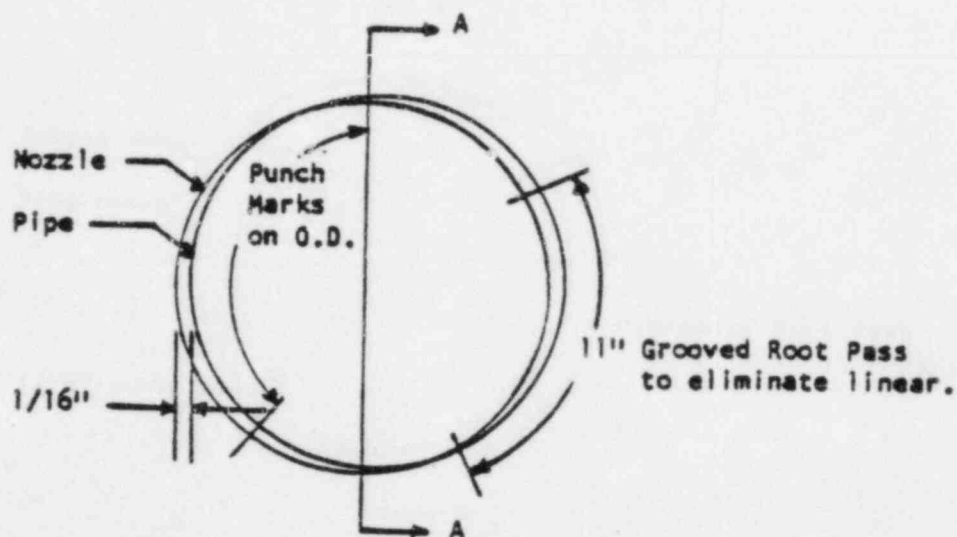
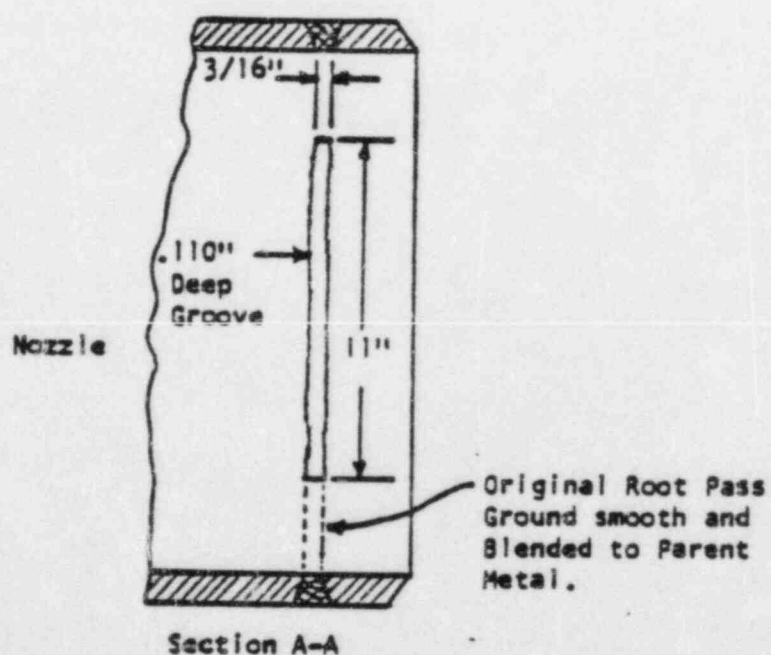
Findings at F.W. 244

NOTE: Average Wall Thickness = .580" to .600"  
Remaining Wall At Groove = .450"  
Punch Marks On The O.D. = .047" Deep  
(Punch Marks are directly on the fusion line of F.W. 244 to 1/8" inside the fusion line .047" deep.)

11. Stress relieve at F.W. 244 R1 and F.W. 549 1100°F to 1150°F per ESD-218.
12. NDE F.W. 244 R1 and F.W. 549 to ESD-207.
13. " " " " to ESD-211 *add 9/30/77*
14. Add information to process sheets.

8. Reweld F.W. 339, as shown on Iso. 3-246, maintain original line configuration.
9. Clean and Fit-up to ESD-215 and ESD-220.
10. Weld out with procedure 92/93.

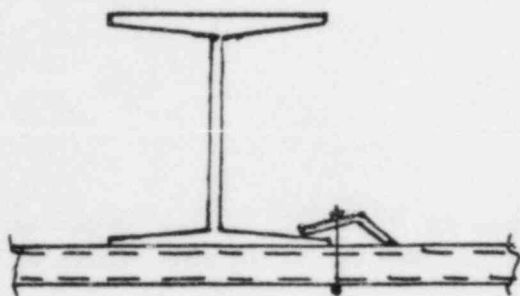
Correct. Notice Line contact at toe and heel of plate. When bolt is torqued properly, clamp should not be easily displaced.

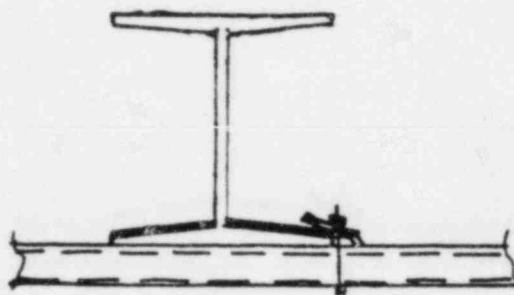
Incorrect. Line contact but not at toe. When torqued, this tends to slip off the steel marker.

In both the examples above, the plate is "cockeyed." One is correct, and if installed correctly, should not be easily moved. On the other hand, the incorrect installation could slip easily. This fact can be checked by consulting engineering manuals from either Unistrut, Superstrut, or other brand names.
