RHO-RE-ST-8 P

EVALUATION OF WEST VALLEY
NEUTRALIZED WASTE TANK PHOTOGRAPHIC,
VIDEO TELEVISION AND ULTRASONIC
MEASUREMENT INSPECTION RECORDS

June 1983

Rockwell International
Rockwell Hanford Operations
Energy Systems Group
Richland, Washington 99352

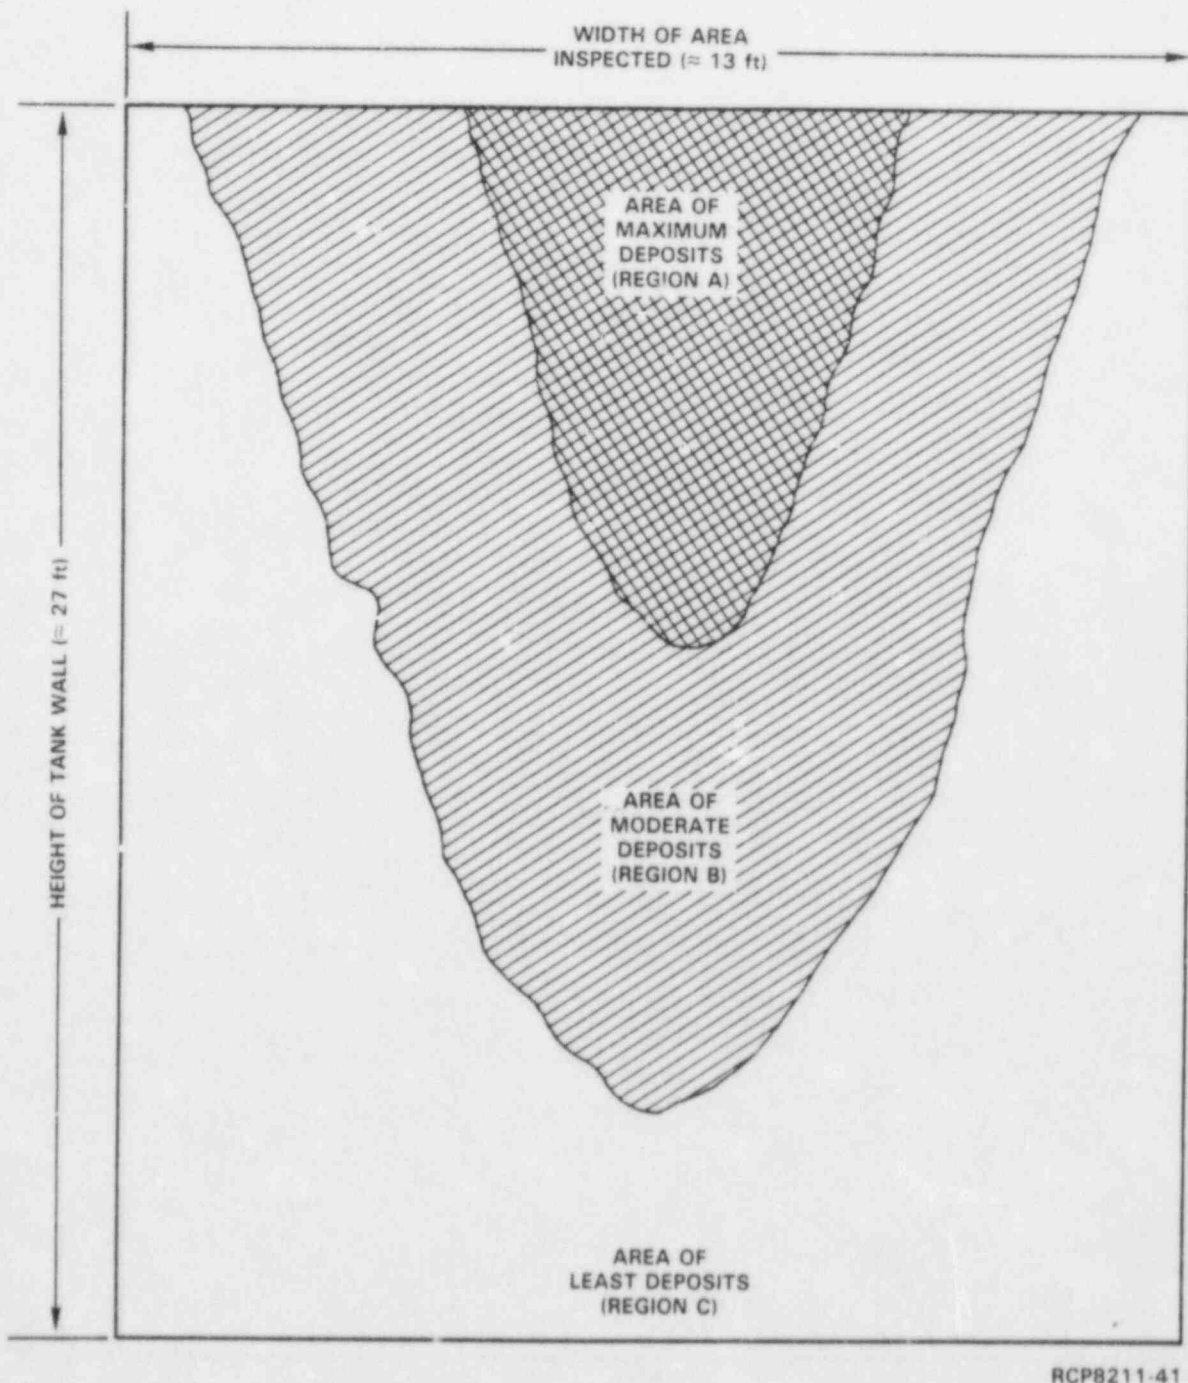
Thickness data was much harder to obtain for tank 8D-1, especially where the photographs and video television showed heavy surface corrosion products and pitting, due to poor coupling. The data did confirm that the area shown in Figure 11 as having greater corrosion also was thinner than the areas showing less corrosion. A lot of data was not readable due to poor coupling (printed as

FIGURE 11. General Description of Areas Covered by Depositing Material.

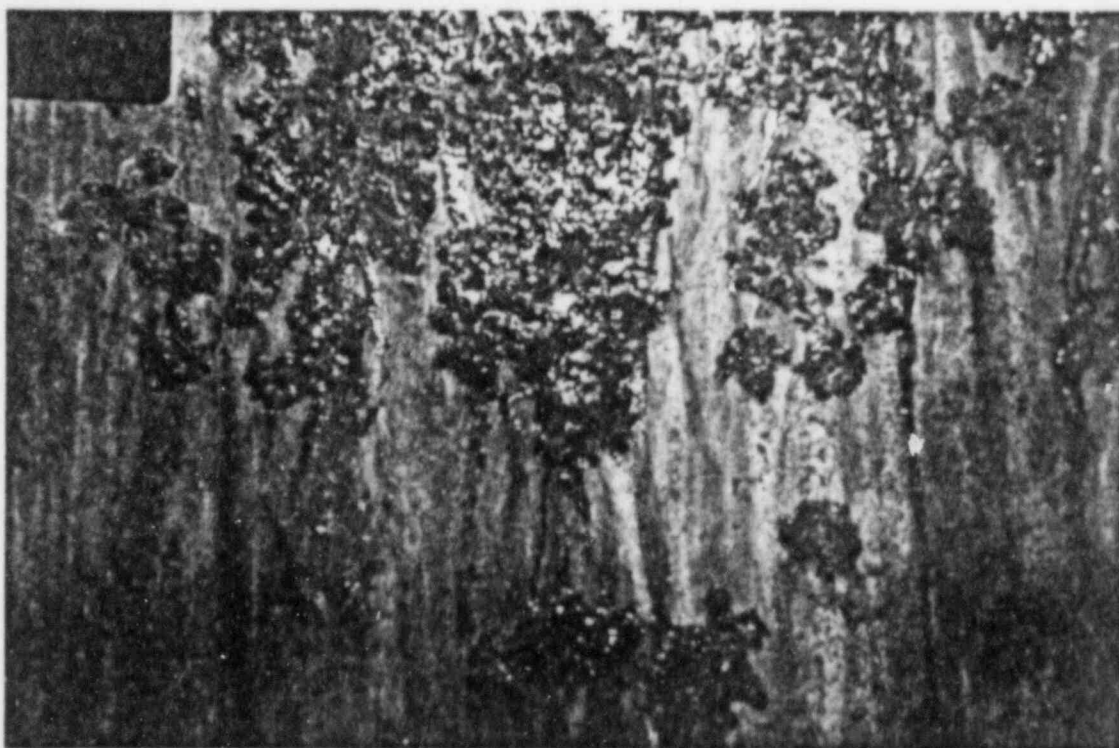
Reviews of photographs taken prior to the wire brushing operation showed a heavy deposit of an unknown whitish material to have accumulated on the outside surface of tank 8D-2 (the hot tank). The heaviest rust concentration was on 8D-1 (the cold tank). Both the rust and whitish deposits were located near the top of the tank and centered under the 30-inch diameter access riser, with decreased deposits being observed near the bottom of the tank and at the outer edges of the surface area investigated. Figure 11 shows the general distribution of deposited material, both rust and whitish material, relative to the area inspected.

Photos representing the typical "before wire brushing" condition of tanks 8D-1 and 8D-2, are shown in Figures 12 through 15 and 20 through 23, respectively.

FIGURE 12. Tank 8D-1 Before Wire Brushing,
Near Center of Area Inspected.

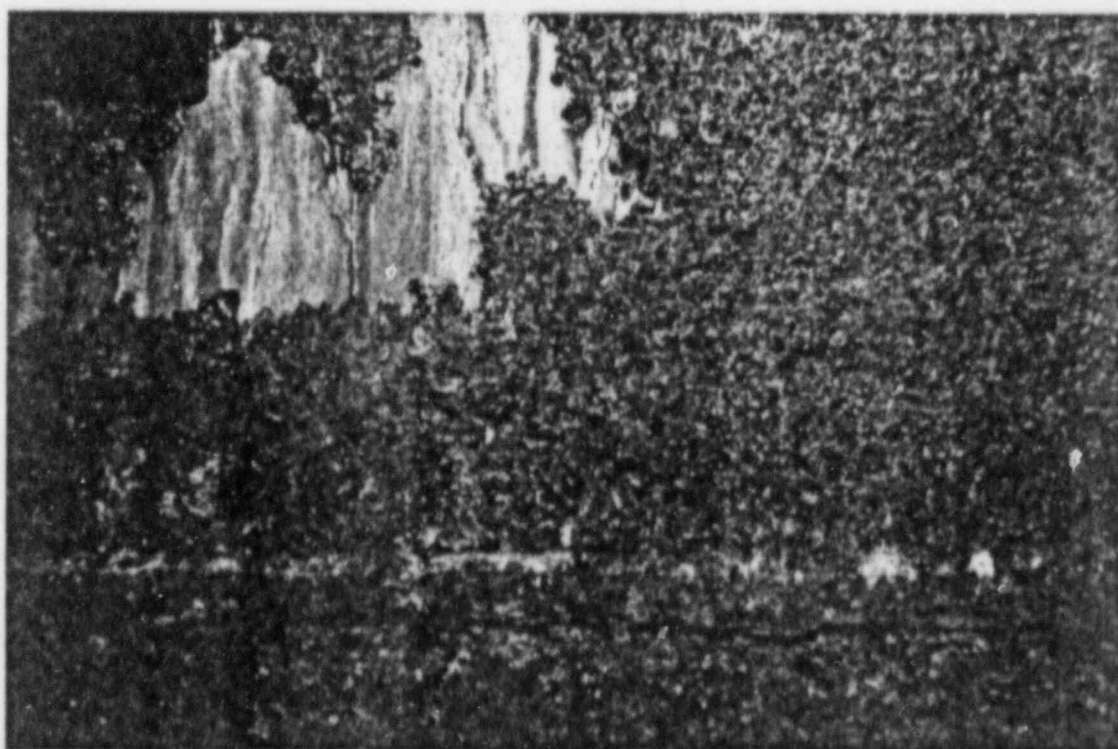
Other localized heavy concentrations of the corrosion material were observed to be accumulated on weldments extending to the limits of the weld heat affected area, or in the form of striations, believed to be associated with surface scratches or marks made during fabrication, which resulted in disturbing the protective action provided by the mill scale.

FIGURE 13. Tank 8D-1 Weldment Before Wire Brushing,
Near Center of Area Inspected.

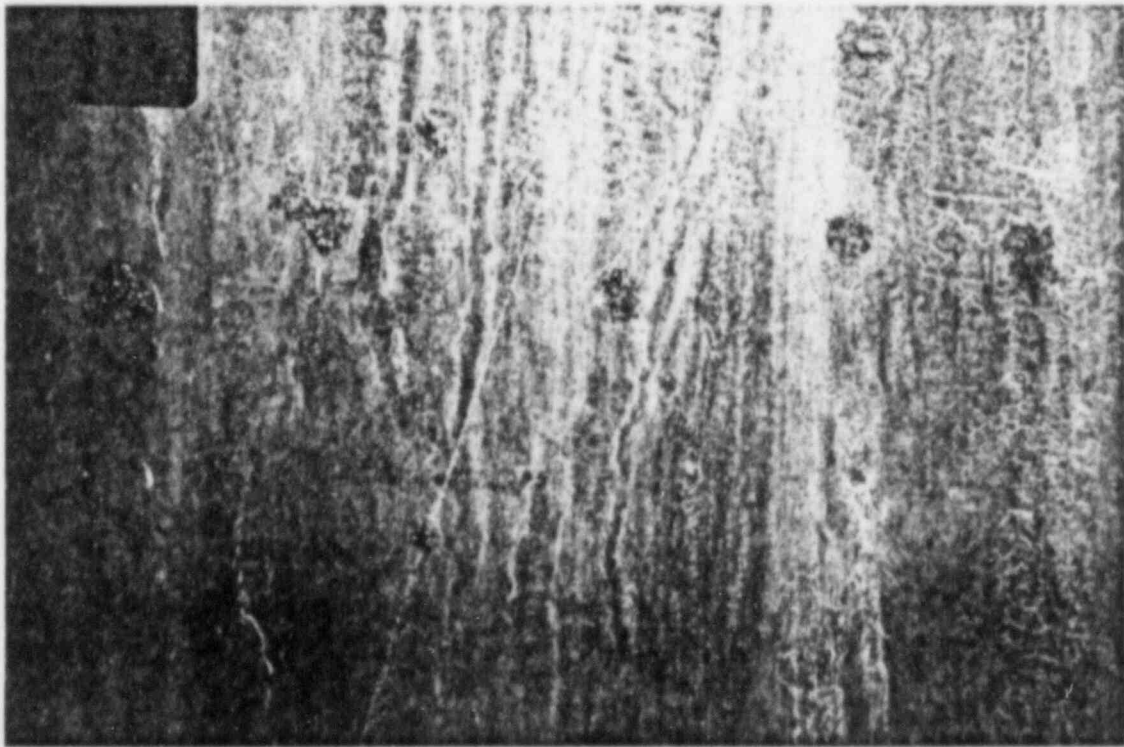
FIGURE 14. Tank 8D-1 Before Wire Brushing,
Near Edge of Area Inspected.

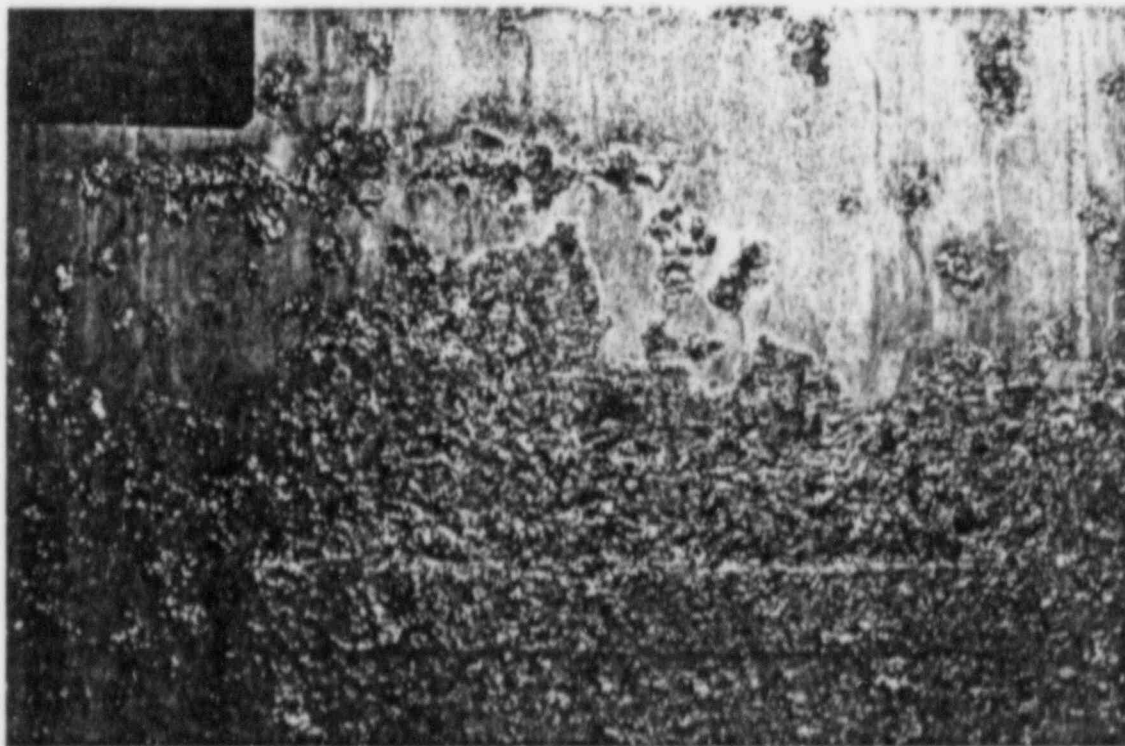
FIGURE 15. Tank 8D-1 Weldment Before Wire Brushing,
Near Edge of Area Inspected.

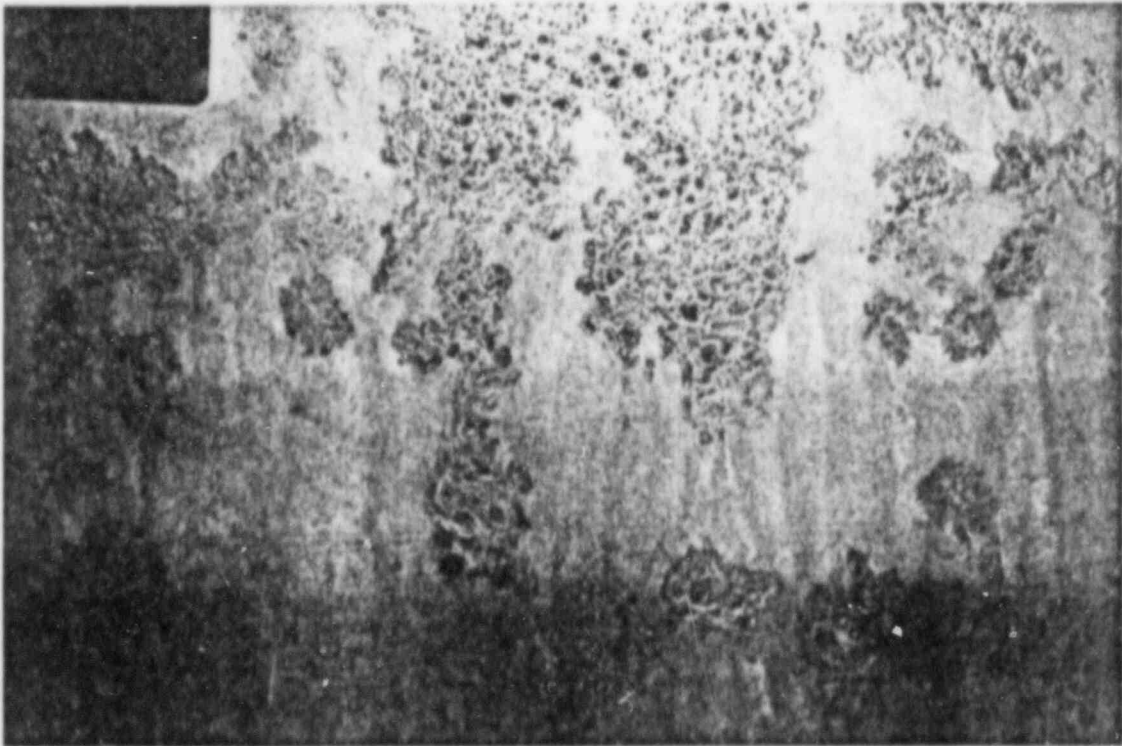
Approximately six hundred twenty-five, 5 inch by 7 inch prints, 225 for tank 8D-1 and 400 for tank 8D-2, showing the steel tank surface after wire brushing were reviewed. These photographs showed that the wire brushing operation was very successful in removing the whitish material deposited on the surface of the tank 8D-2 leaving a relatively clean surface area. Surface pitting, as a result of corrosion, was observed. Most pitting appears to have occurred where the most corrosion material had been deposited. No attempt was made to determine the actual depth of the pitting from these photographs. However, it was estimated by the operators that, in the worst cases, the pits could range from 0.040 to 0.060 inch deep. In areas of heavy rust build-up, poor coupling of the UT head resulted in limited data. In these areas, the photographs were used to augment the data evaluation. Tank 8D-1 has experienced much more severe pitting than tank 8D-2. This is attributed to the fact that since tank 8D-1 is much cooler than 8D-2, the resulting condensation on tank 8D-1 has enhanced the corrosion process.

Typical photos of the most severe pitting observed on tanks 8D-1 and 8D-2 are shown in Figures 16 through 19 and 24 through 27, respectively.

FIGURE 16. Tank 3D-1 After Wire Brushing,
Near Center of Area Inspected.

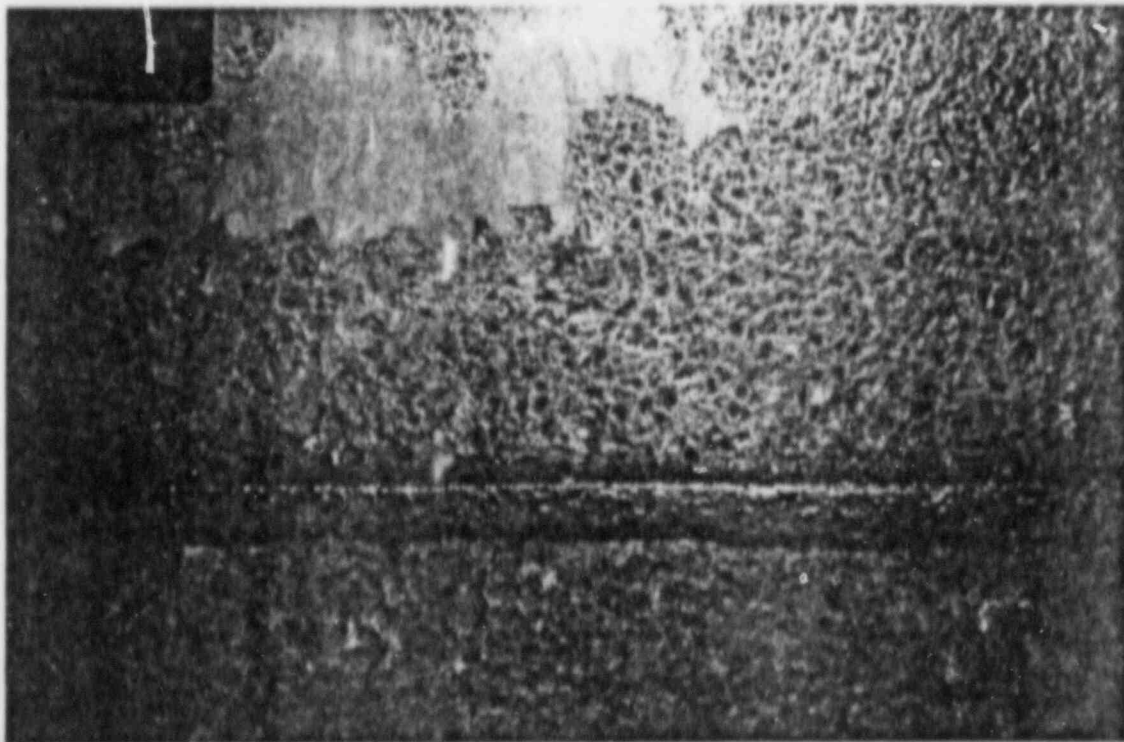
FIGURE 17. Tank 8D-1 Weldment After Wire Brushing,
Near Center of Area Inspected.

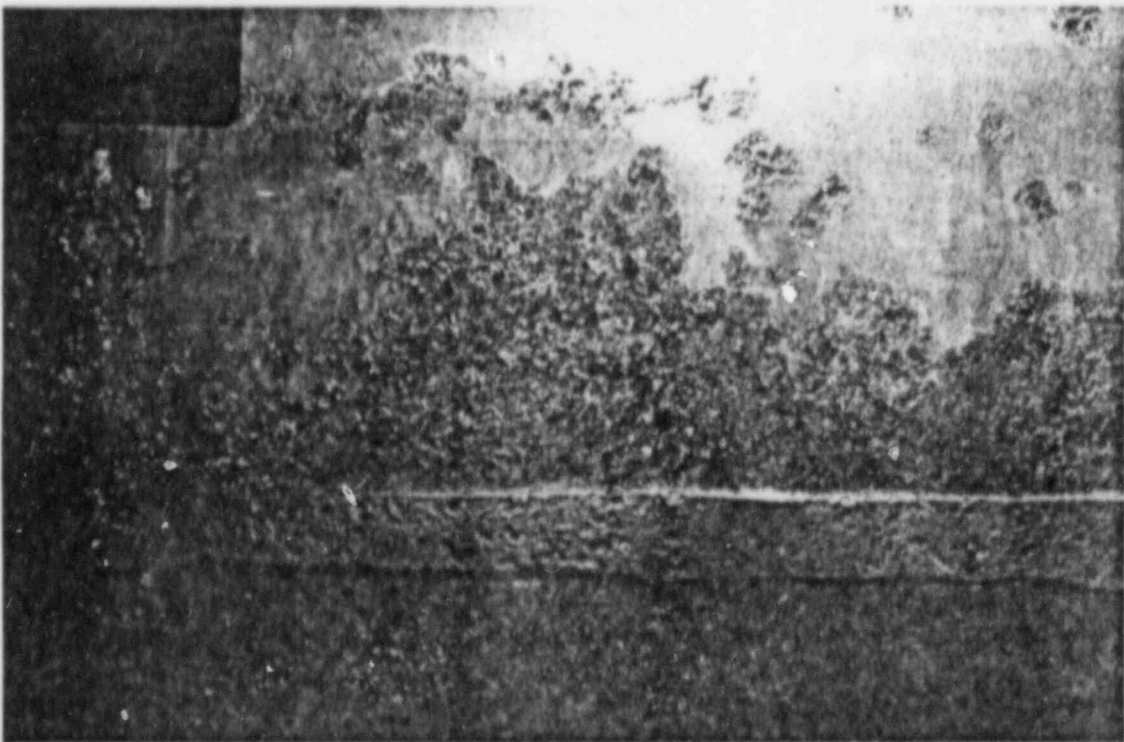
FIGURE 19. Tank 8D-1 Weldment After Wire Brushing,
Near Edge of Area Inspected.

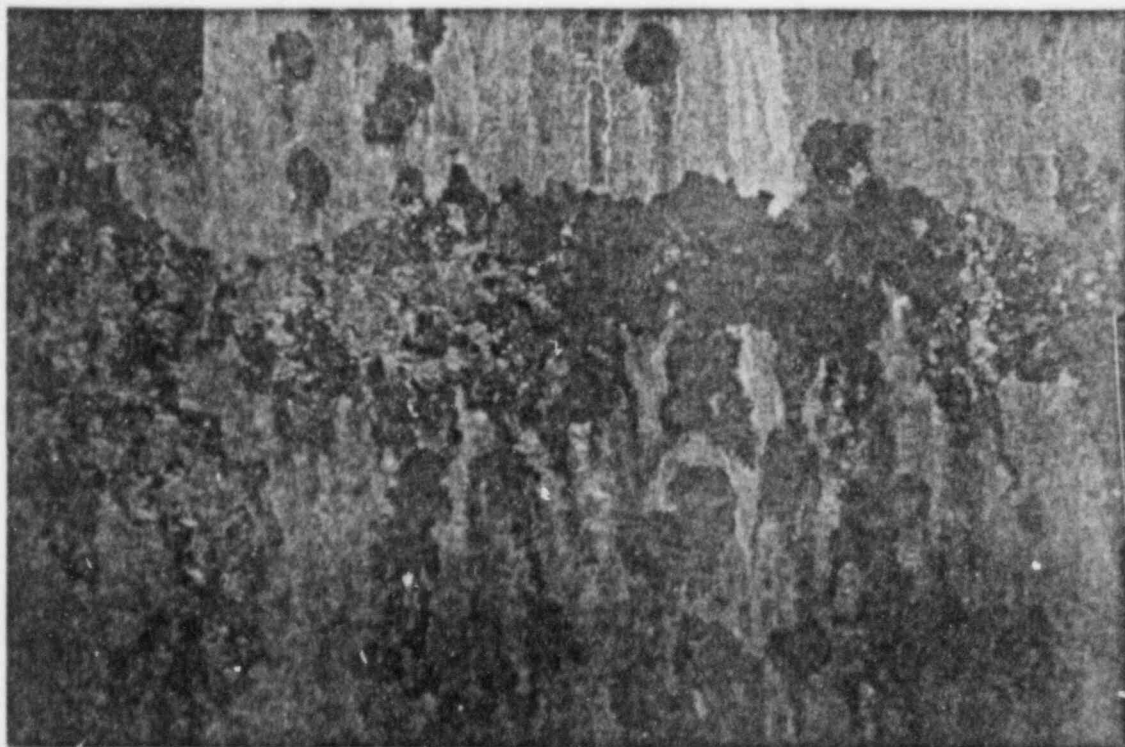
The amount of corrosion deposit accumulated on tank 8D-2 (the hotter tank) was much less than was observed on tank 8D-1. In fact, the amount of deposit over a major portion of the area evaluated on tank 8D-2, near the bottom and the outer edges, was so slight that the construction identification markings placed on the steel plates during fabrication could easily be identified and read; thus, these areas of the tank 8D-2 appeared relatively clean except for a very slight whitish powdery film deposited on the surface over the mill scale. Tank 8D-2 is judged to be in excellent condition.

FIGURE 20. Tank 8D-2 Before Wire Brushing
Near Center of Area Inspected.

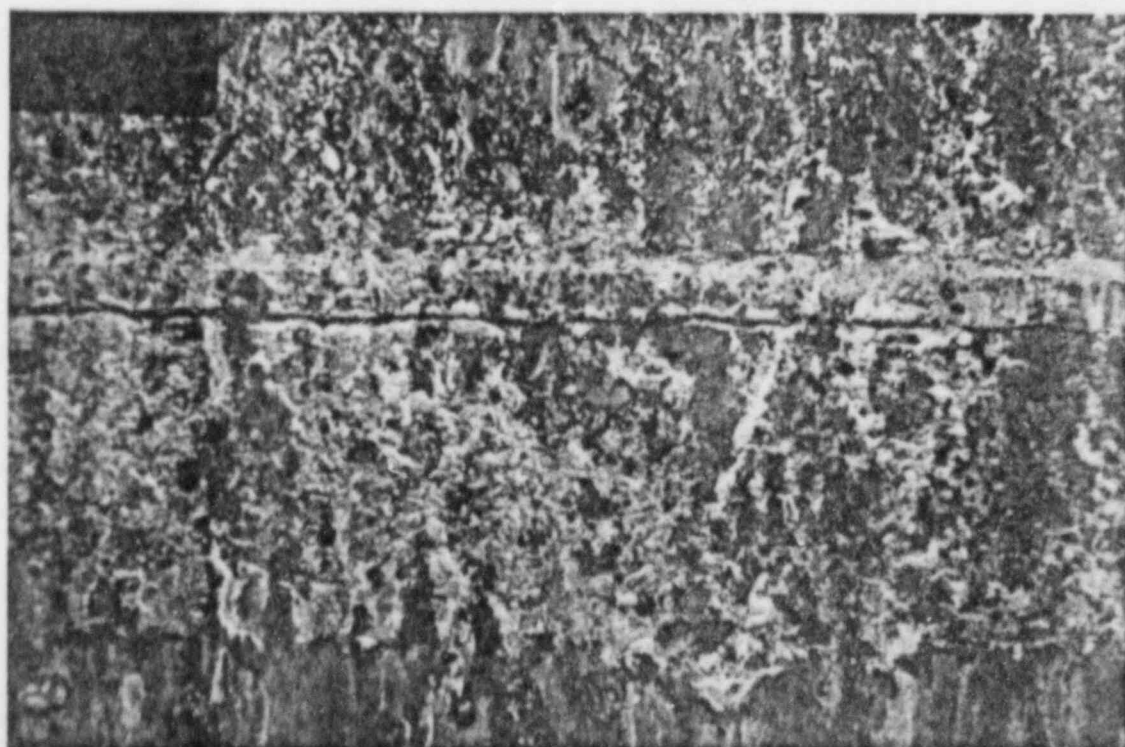
FIGURE 21. Tank 8D-2 Weldment Before Wire Brushing,
Near Center of Area Inspected.

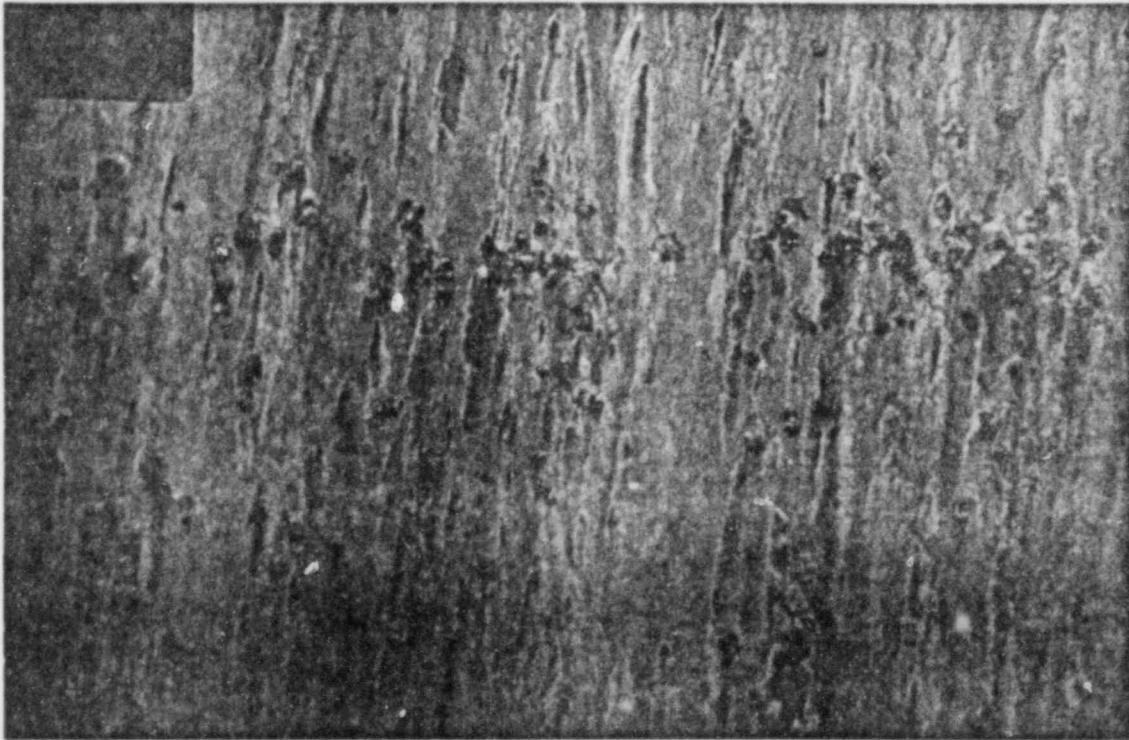
FIGURE 22. Tank 8D-2 Before Wire Brushing,
Near Edge of Area Inspected.

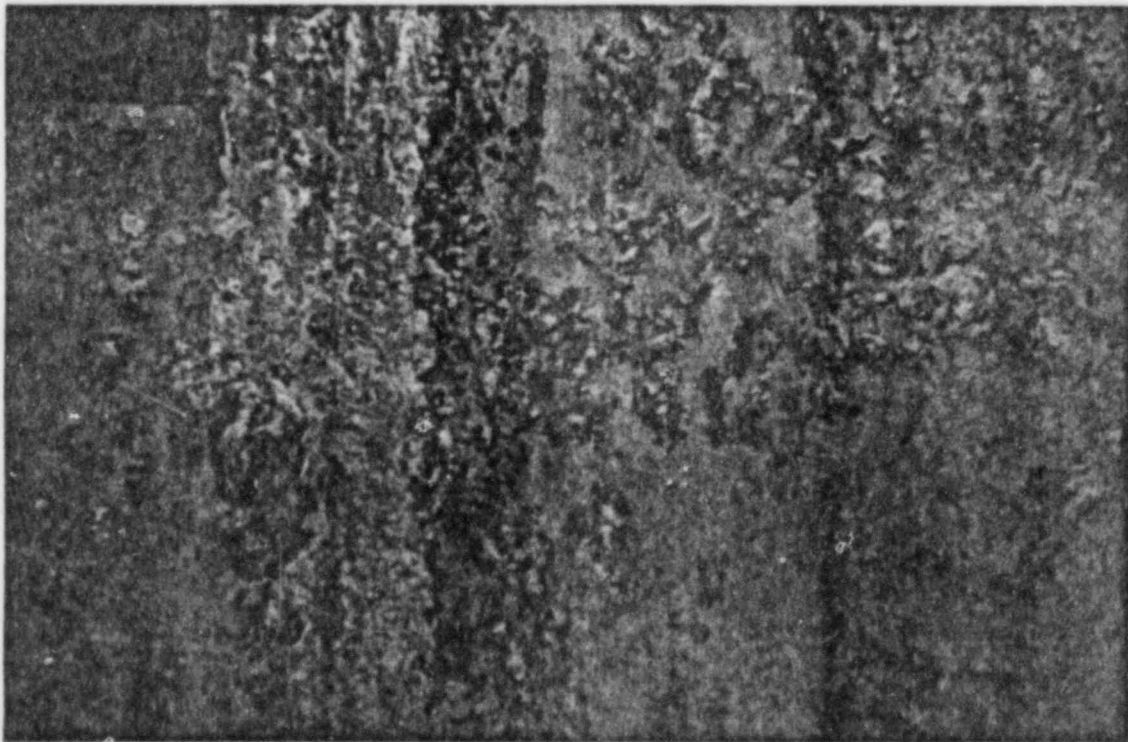
FIGURE 23. Tank 8D-2 Weldment Before Wire Brushing,
Near Edge of Area Inspected.

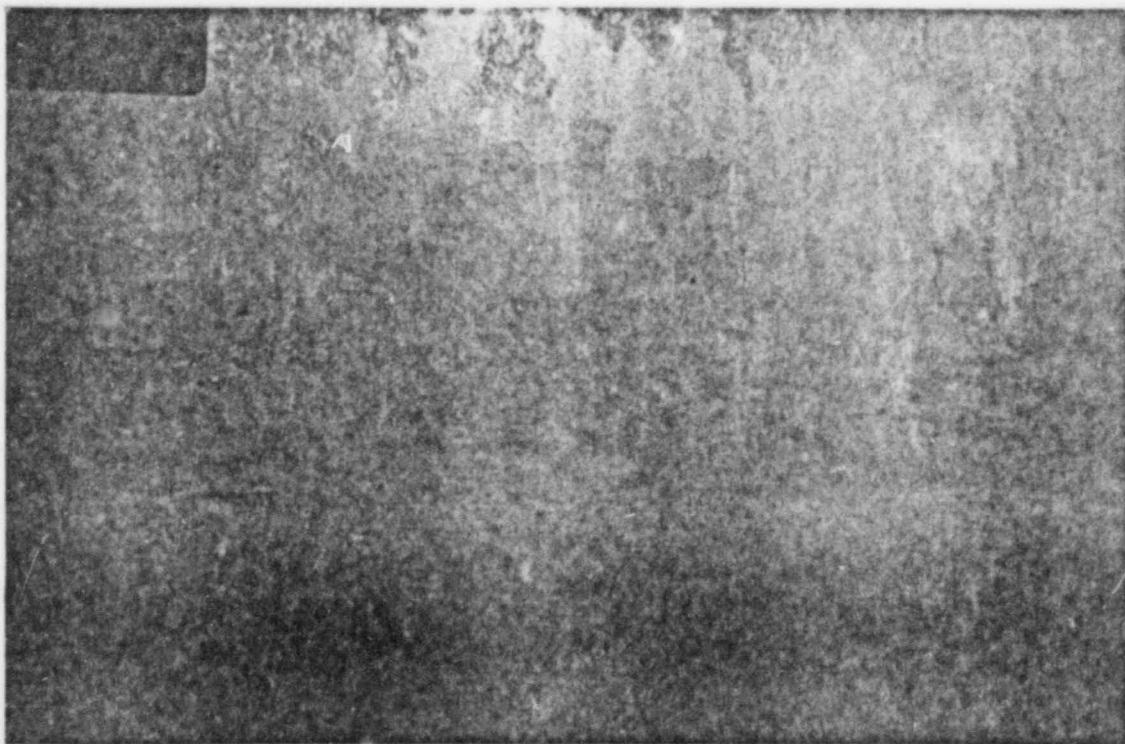
FIGURE 24. Tank 8D-2 After Wire Brushing,
Near Center of Area Inspected.

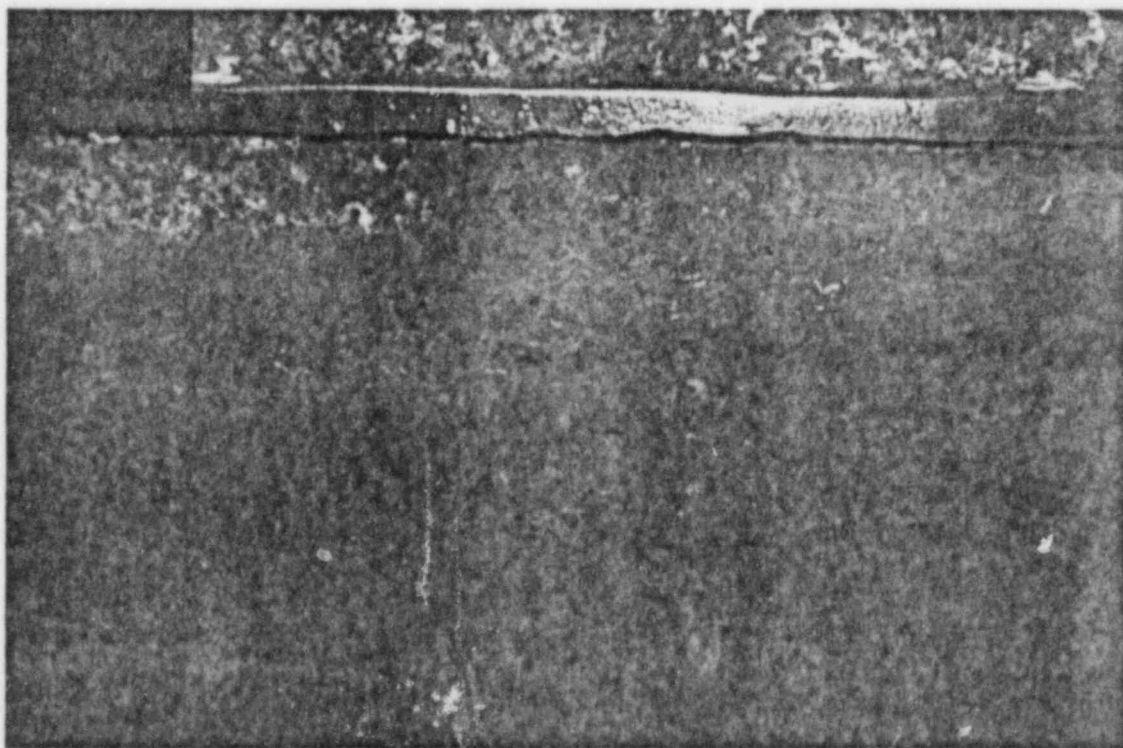
FIGURE 25. Tank 8D-2 Weldment After Wire Brushing,
Near Center of Area Inspected.

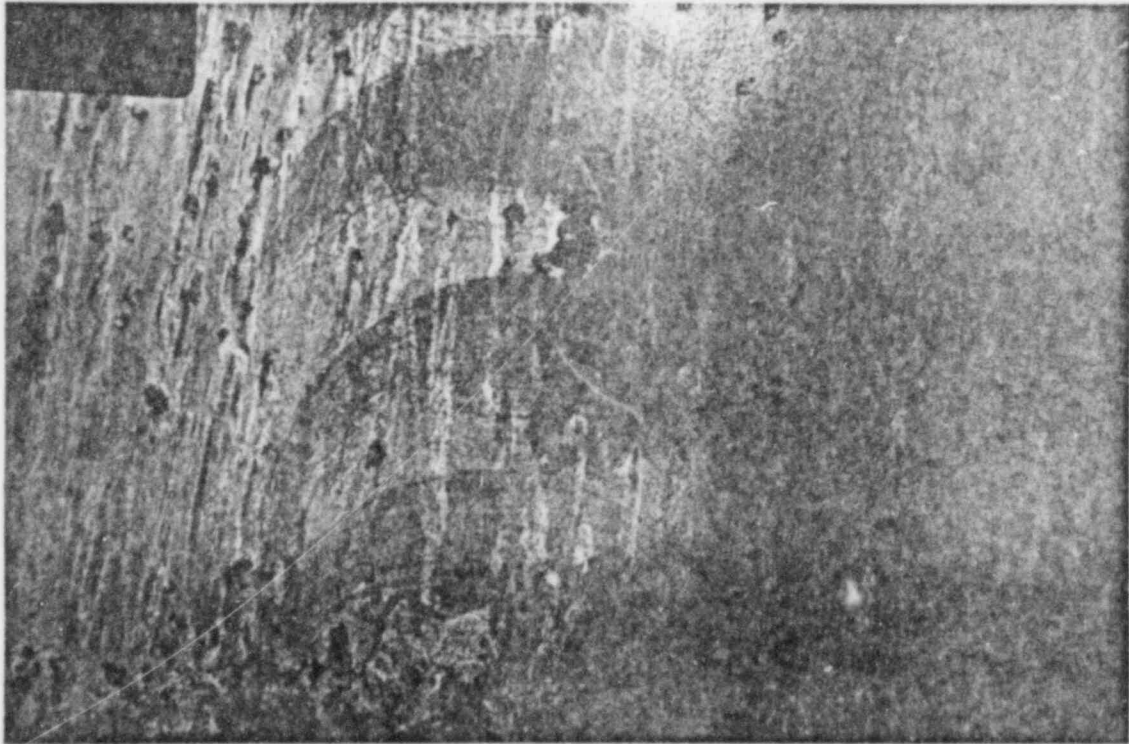
FIGURE 26. Tank 8D-2 After Wire Brushing,
Near Edge of Area Inspected.

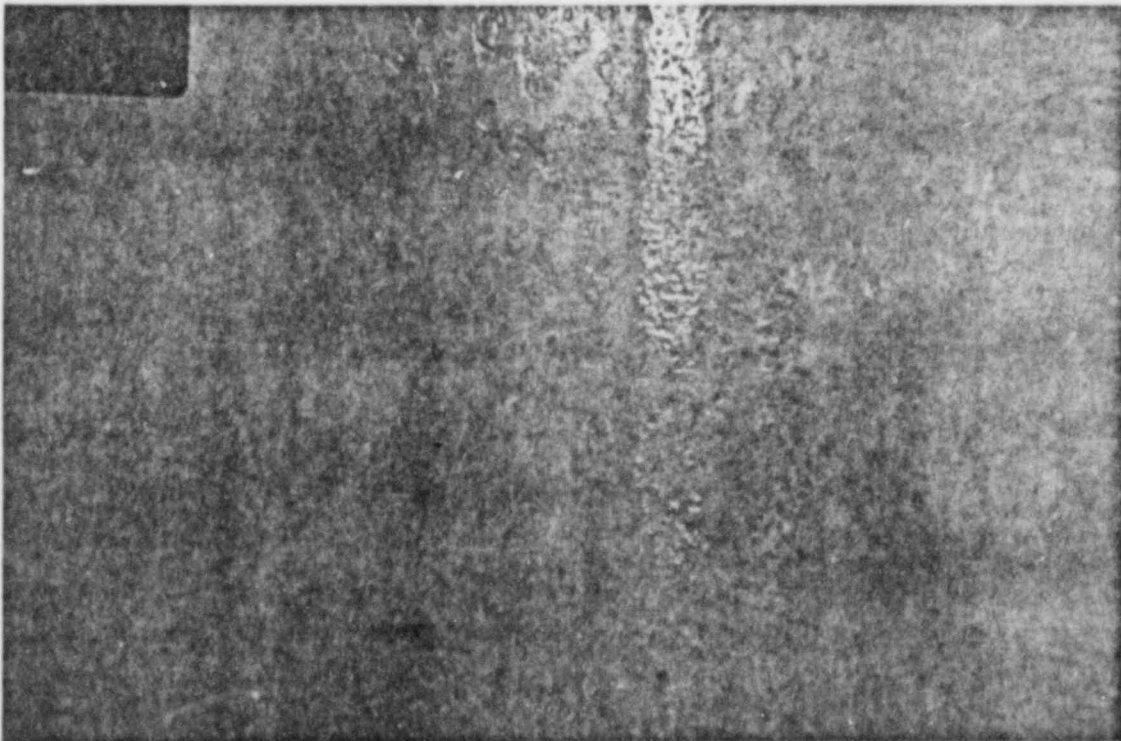
FIGURE 27. Tank 8D-2 Weldment After Wire Brushing,
Near Edge of Area Inspected.
