Hope Creek Generating Station

HOPE CREEK GENERATING STATION
DOCKET NO. 50-354
UNIT NO. 1
LICENSEE EVENT REPORT 92-003-00

LICENSEE EVENT REPORT																				
FACILITY NAME (1) HOPE CREEK GENERATING STATION												DOCKET NUMBER (2) 0 5 0 0 0 3 5 4						PAGE (3) 1 OF 5		
TITLE (4): Engineered Safety System Actuation - Unplanned start of the "A" Control Room Emergency Filter System due to equipment malfunction.																				
EVENT DATE (5)				LER NUMBER (6)						REPORT DATE (7)				OTHER FACILITIES INVOLVED (8)						
MONTH	DAY	YEAR		YEAR	*	NUMBER		*	REV	MONTH	DAY	YEAR		FACILITY NAME(S)				DOCKET NUMBER(S)		
0	1	2	9	9	2	.	0	0	3	.	0	0	0	2	2	6	9	2		
OPERATING (9) MODE 1				THIS REPORT IS SUBMITTED PURSUANT TO THE REQUIREMENTS OF 10CFR: (CHECK ONE OR MORE BELOW) (11)																
POWER LEVEL % 1 0 0				20.402(b)		20.405(c)		xx		50.73(a)(2)(iv)		73.71(b)

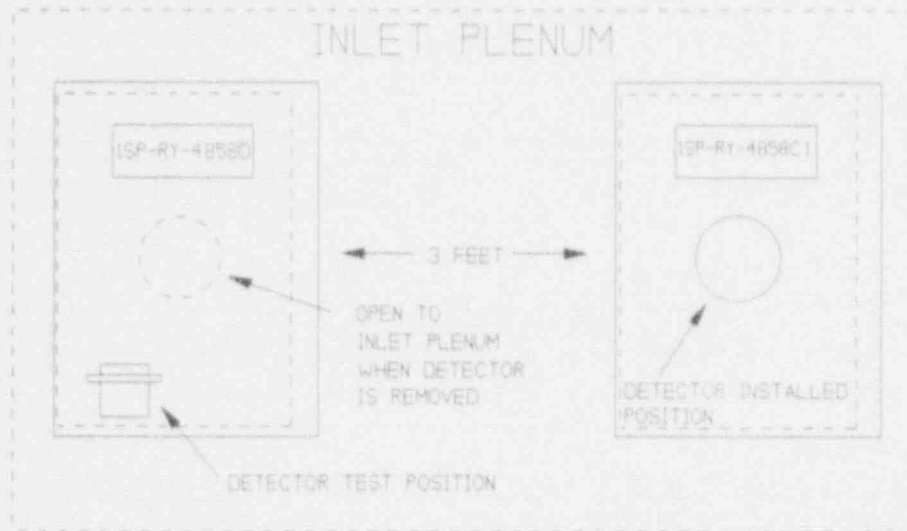
After detailed review of alarm printouts it was determined that the "C1" channel was indicating erroneously during performance of the "D" channel detector testing. Further investigation revealed that during the period the "D" detector was removed from the duct, light was entering through the opening each time the door was opened and closed as the test sources were changed. An inspection of the foil cover for the "C1" detector revealed several imperfections and discoloration of the foil. The defective foil was allowing light to enter the "C1" detector resulting in false high readings and subsequent start of the CREF.

The root cause of the this event is the failed foil cover on the "C1" channel detector. The cause of the foil failure will be determined by laboratory analysis of the foil.

1. Replacement of the foil and recalibration of the detector will be completed by 3/30/92.
2. The Sensor Calibration procedure will be reviewed to determine if additional steps are required for detailed inspection of the foil.
