SUBJECT: COMANCHE PEAK STEAM ELECTRIC STATION (CPSES)
DOCKET NOS. 50-445 AND 50-446
SWING ARMS FOR BORG WARNER CHECK VALVES
10CFR21 REPORT P21R-92-001

10CFR21 REPORTABLE CONDITION INVOLVING
SWING ARMS
FOR BORG WARNER CHECK VALVES

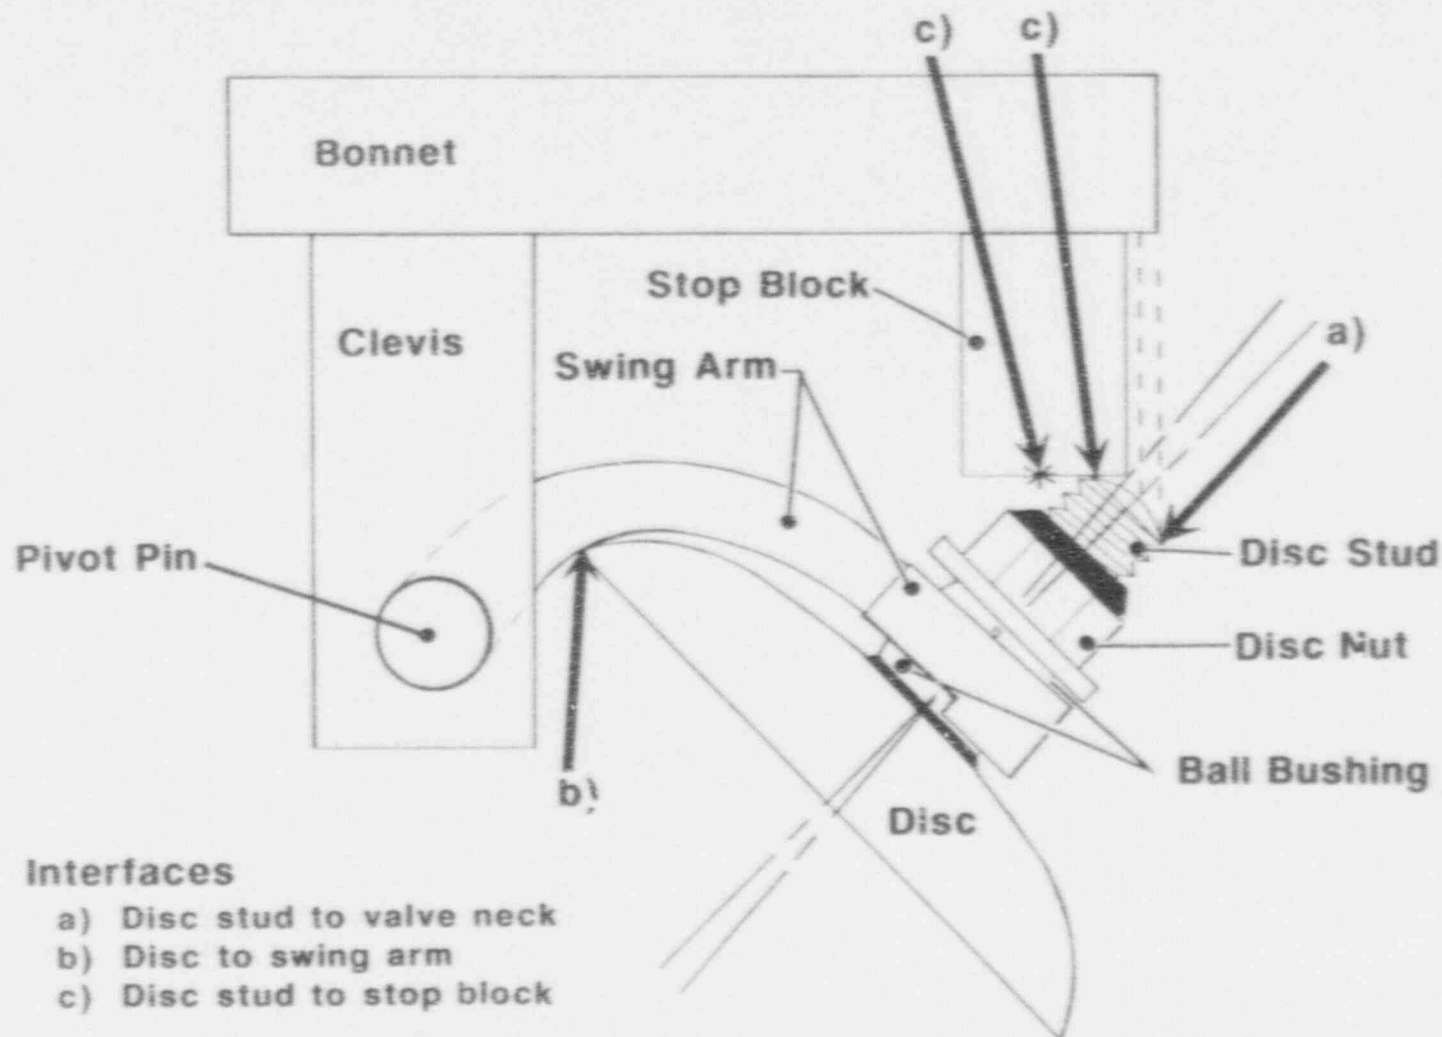
BORG-WARNER CHECK VALVE INTERNALS

The swing arm is a machined steel casting attached via clevis and pivot pin to the valve bonnet (see sketch on Page 4). The bonnet provides a mounting point for the clevis. The valve disc is attached to the swing arm via a disc stud and a disc nut. A ball bushing is located at the point where the disc stud passes through the swing arm. The check valve is in the open or closed position depending on direction of flow through the valve body. When fully open, the arc of the swing arm and disc assembly is limited by contact between the disc stud and a stop block mounted on the valve bonnet. The disc is maintained in the open position when flow is in the required direction. The disc is activated to the closed position when flow is in the other than the required direction. The swing arm is part number 72543 on BW/IP valve model number 75510. This valve is a 3" - 900# swing check valve.

An engineering evaluation prior to reinstallation of the reworked bonnet assembly with the new swing arm revealed several concerns regarding the operability of the check valve with the new swing arm installed. When the new swing arm is in the up position:

- a) An increase in the maximum arc length of the disc stud increases the possibility of contact with the valve neck which could possibly contribute to valve hang-up or valve damage.
- b) The disc may impact the swing arm which could lead to valve damage, and
- c) The disc stud makes contact closer to the far edge of the stop block resulting in a possible hang-up location.

Based on the above, TU Electric has concluded that the replacement swing arms supplied and certified as like for like items, i.e., fit, form and function, are not interchangeable with the original swing arms in the valves modified by TU Electric. Use of the revised part as interchangeable with the original could provide a potential for failure of the valve to close, e.g., lodging open when the disc assembly is forced into an adverse configuration. Backleakage through the valve could lead to degradation or inoperability of associated safety related equipment or systems. This condition is considered a defect.

- (v) Information of the defect was obtained from the TU Electric evaluation which concluded on January 14, 1992, that the deficiency was a defect.
- (vi) As discussed in (vi) above TU Electric has a total of six (6) 3" - 900# class pressure seal bonnet BW/IP check valves.
- (vii) TU Electric reinstalled the old swing arm. A successful backflow test was performed on the subject valve. TU Electric is evaluating the need to modify the valve to facilitate use of the replacement arms supplied by BW/IP Inc. in order to assure acceptable operation.
- (viii) Not applicable.
