COMANCHE PEAK UNITS I AND II

DEMONSTRATION OF ULTRASONIC
EXAMINATION TECHNIQUES APPLIED
TO WELDS IN MAIN COOLANT
LOOP PIPING

D. C. ADAMONIS

JUNE 28, 1984

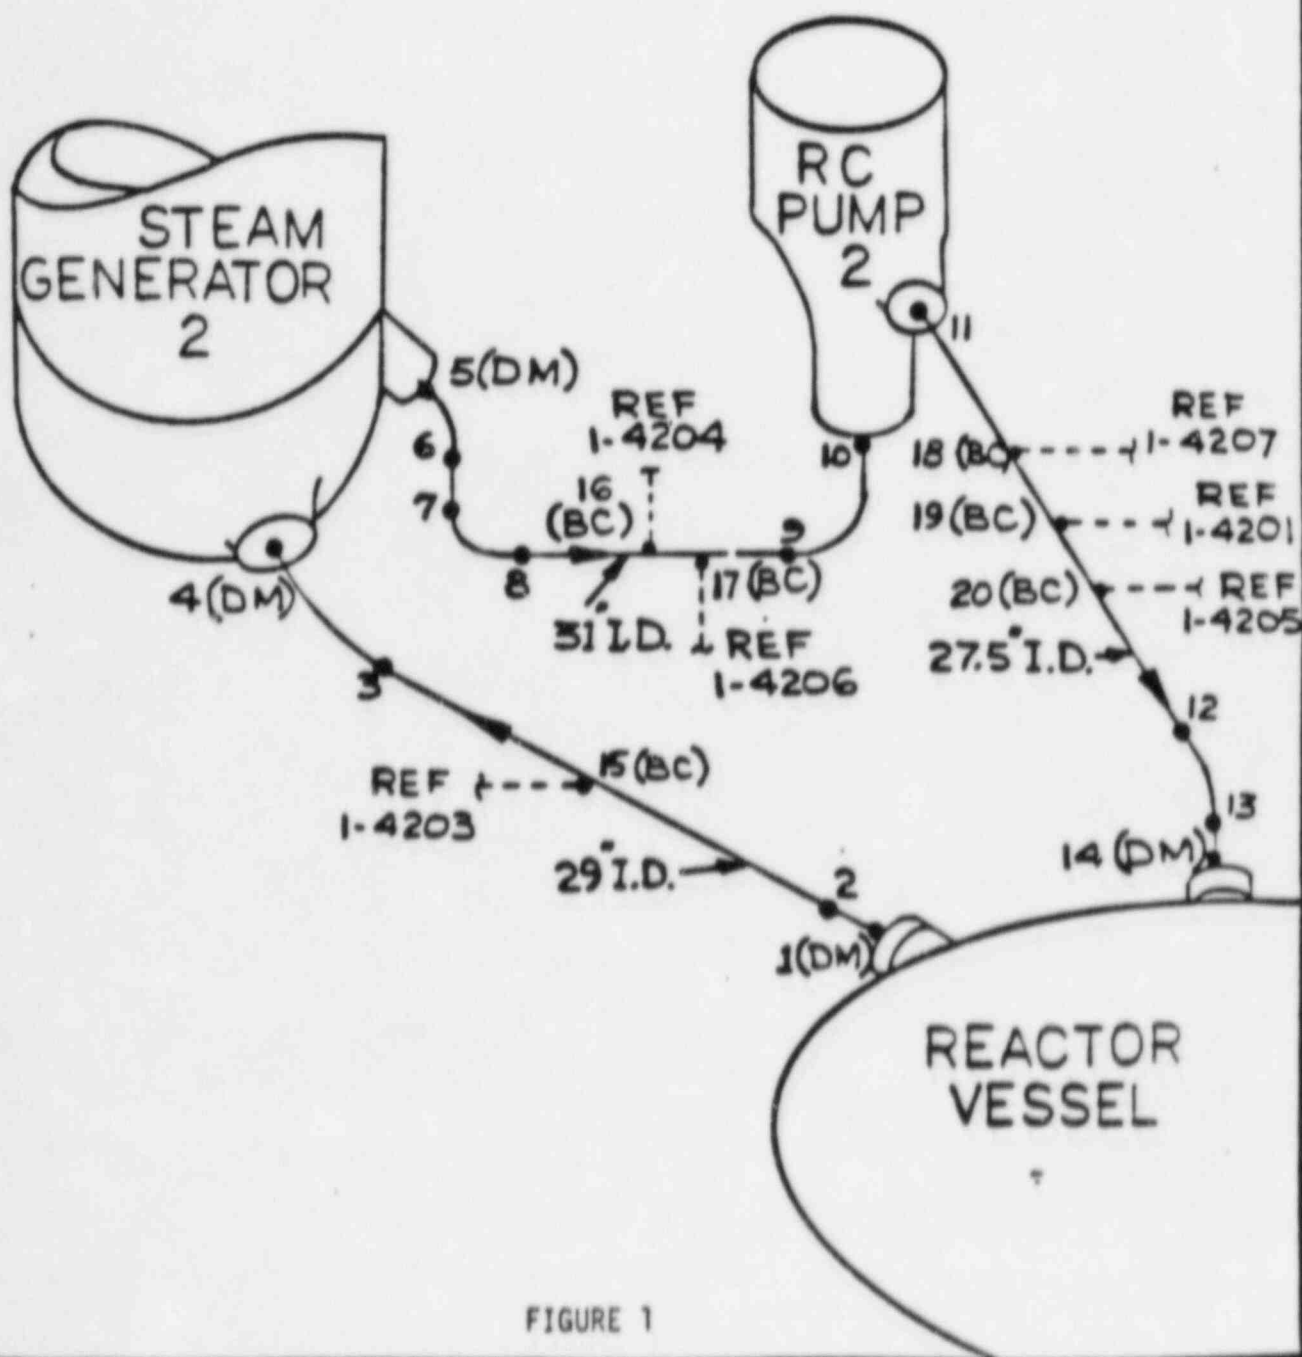
FIGURE 1

The weld selected for field demonstrations in Unit I was the loop 2 reactor vessel inlet nozzle safe end-to- 27½" x 22° cast elbow weld identified as weld #13 on Comanche Peak isometric drawing TBX-1-4200, attached as Figure 1. Source data for the cast elbow is provided below:

The field demonstration conducted on this particular weld confirmed findings noted in the NRC report. The surface condition of the elbow, adjacent to the weld, appeared to be the major factor contributing to the examination difficulties. The condition of the surface was, for the most part, as-cast. As such, it is typical of cold leg 22° elbows in other four loop plants. The configuration of the 22° elbow did not allow the supplier to machine the OD surface for a significant distance as measured from the edge of the weld prep. Complete coupling of the straight beam search unit was difficult, thus a consistent backwall reflection could not be maintained during scanning. The CRT display during 40° refracted longitudinal wave angle beam scanning was saturated with noise over to about one-half the calibrated sweep length. This condition was not considered extremely significant as the inner 1/3 of the pipe thickness constitutes the required examination volume per Section XI of the ASME Boiler and Pressure Vessel Code, 1980 Edition. No evidence of the counterbore was detected via angle beam from the elbow side of the weld.

A continuous back reflection was maintained during straight beam scans on the nozzle safe end side of the weld. Evidence of the counterbore was detected during 40° refracted longitudinal wave examinations from the safe end of the weld.

- (1) Demonstrations performed on Unit I, loop 2, weld #13 confirmed the observations of NRC inspection report 50-445/82-19. Surface condition of the elbow appeared to be the major factor contributing to difficulties in obtaining consistent backwall echoes during straight beam scanning and high noise levels during the 40° refracted longitudinal wave scans of this particular weld. This is due to the configuration of the 22° elbow which did not allow the supplier to machine the OD surface for a significant distance as measured from the edge of the weld prep.

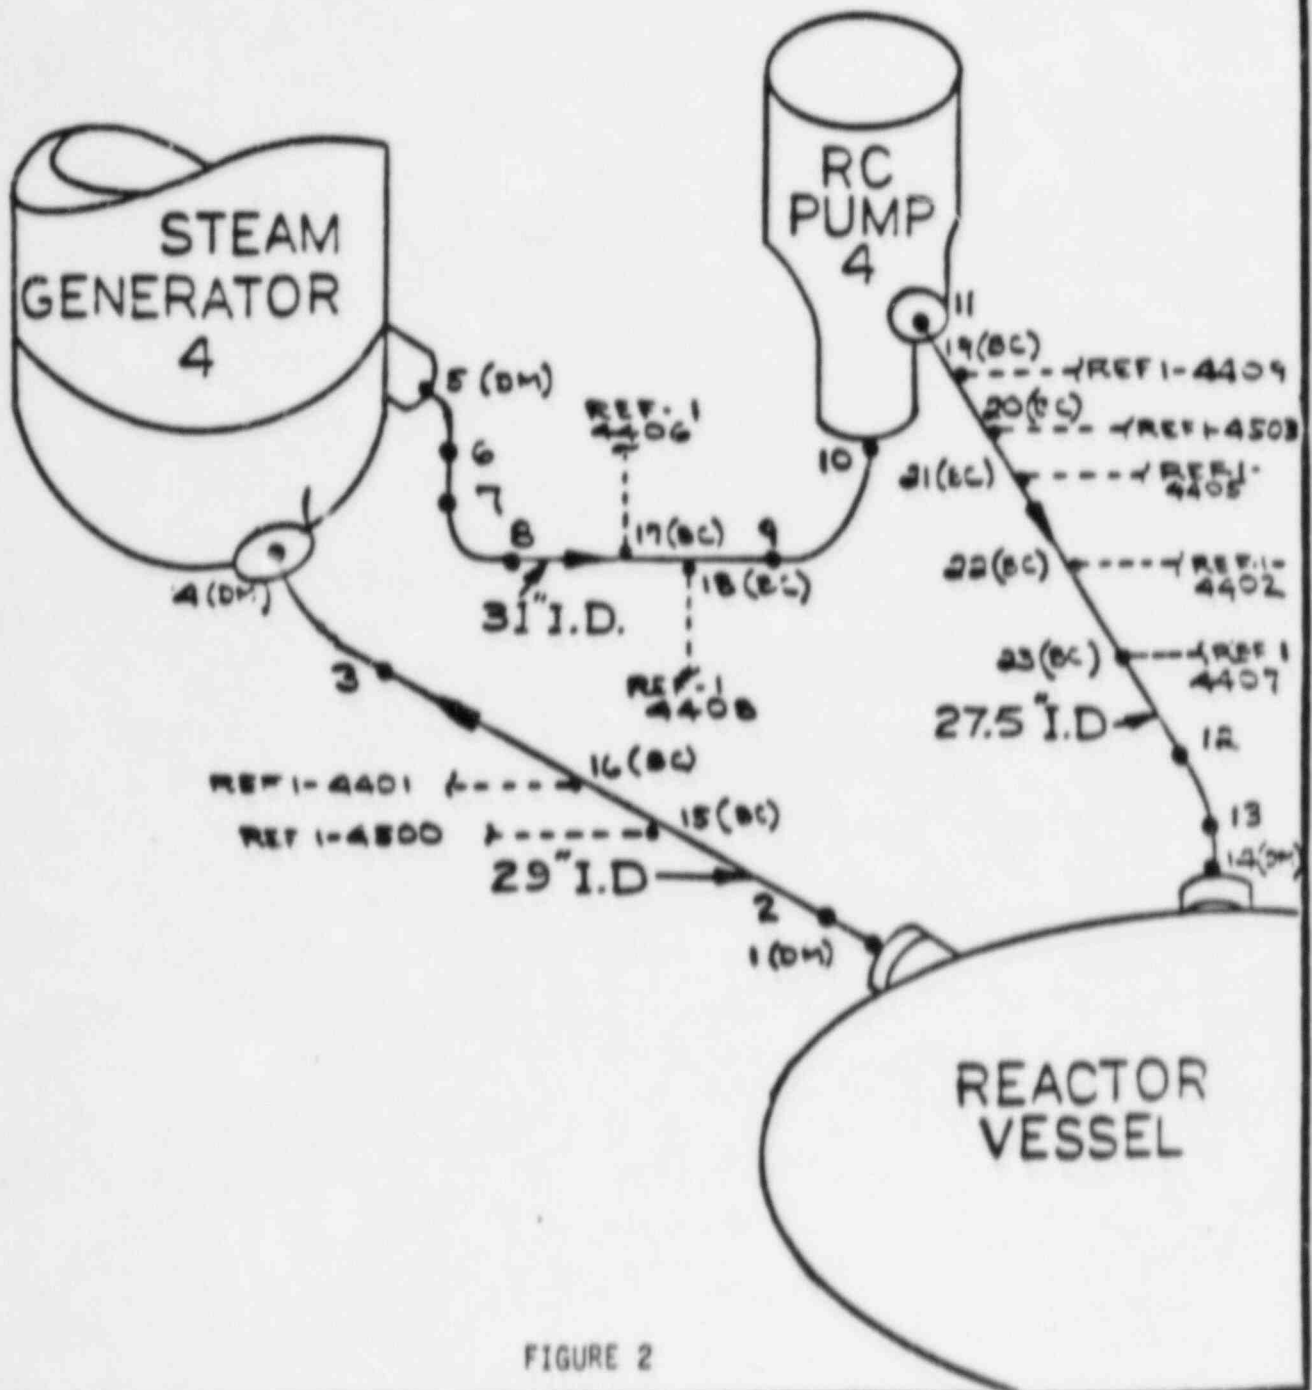
FIGURE 2

The four welds selected for demonstrations in Unit II were in the loop 4 crossover leg, identified as welds #5, #6, #7, and #8 in Comanche Peak isometric drawing TCX-1-4400, attached as Figure 2. Weld #5 joins the steam generator nozzle to a 31" I.D. x 40° cast elbow, weld #6 joins the 31" I.D. x 40° cast elbow to a 4'6-7/8" length of 31" I.D. centrifugally cast pipe, weld #7 joins the 4'6-7/8" length of 31" I.D. pipe to a 31" I.D. x 90° cast elbow and weld #8 joins the 31" I.D. x 90° elbow to a 3'5-3/4" length of 31" I.D. centrifugally cast pipe. Source data for these components of the piping system are provided below:

In contrast to the results from weld #13 in Unit I, consistent backwall reflections were easily maintained during straight beam scanning, noise levels on CRT displays during 40° refracted longitudinal wave examinations were significantly lower, and ID geometry in the form of a counterbore response was consistently detected when scanning weld #5 from both sides. Counterbores adjacent to the other three welds were not detected because of access limitations. Slightly more access though, would have made detection of the counterbores adjacent to the other welds possible. Surface condition adjacent to these welds was better than that noted for weld #13 of Unit I. In particular, the elbow OD surfaces were machined by the supplier for a greater distance as measured from the edge of the weld prep.

- (2) Demonstrations performed on four welds in the Unit II, loop 4, cross-over leg demonstrated the ability to penetrate the welds and adjacent base material on both sides of the welds. Consistent backwall echoes were maintained during straight beam scanning and noise levels during 40° refracted longitudinal wave scans were significantly lower than noted during scans of weld #13 in Unit I. This improvement is attributed to the fact that surface conditions of the elbows adjacent to these welds are good. These particular elbow OD surfaces were machined by the supplier for a greater distance as measured from the edge of the weld prep because of the longer tangent configuration.
- (3) Demonstrations performed on two centrifugally cast pipe weld mock-ups indicates the 40° refracted longitudinal wave technique is capable of detecting mechanically induced fatigue cracks in these materials.
