Houston Lighting & Power

South Texas Project  
Unit 1  
Docket No. STN 50-498  
Licensee Event Report 92-001  
Regarding an Entry into Specification 3.0.3

Entry Into Specification 3.0.3 Due to 2  
Trains of Essential Chillers Being Inoperable

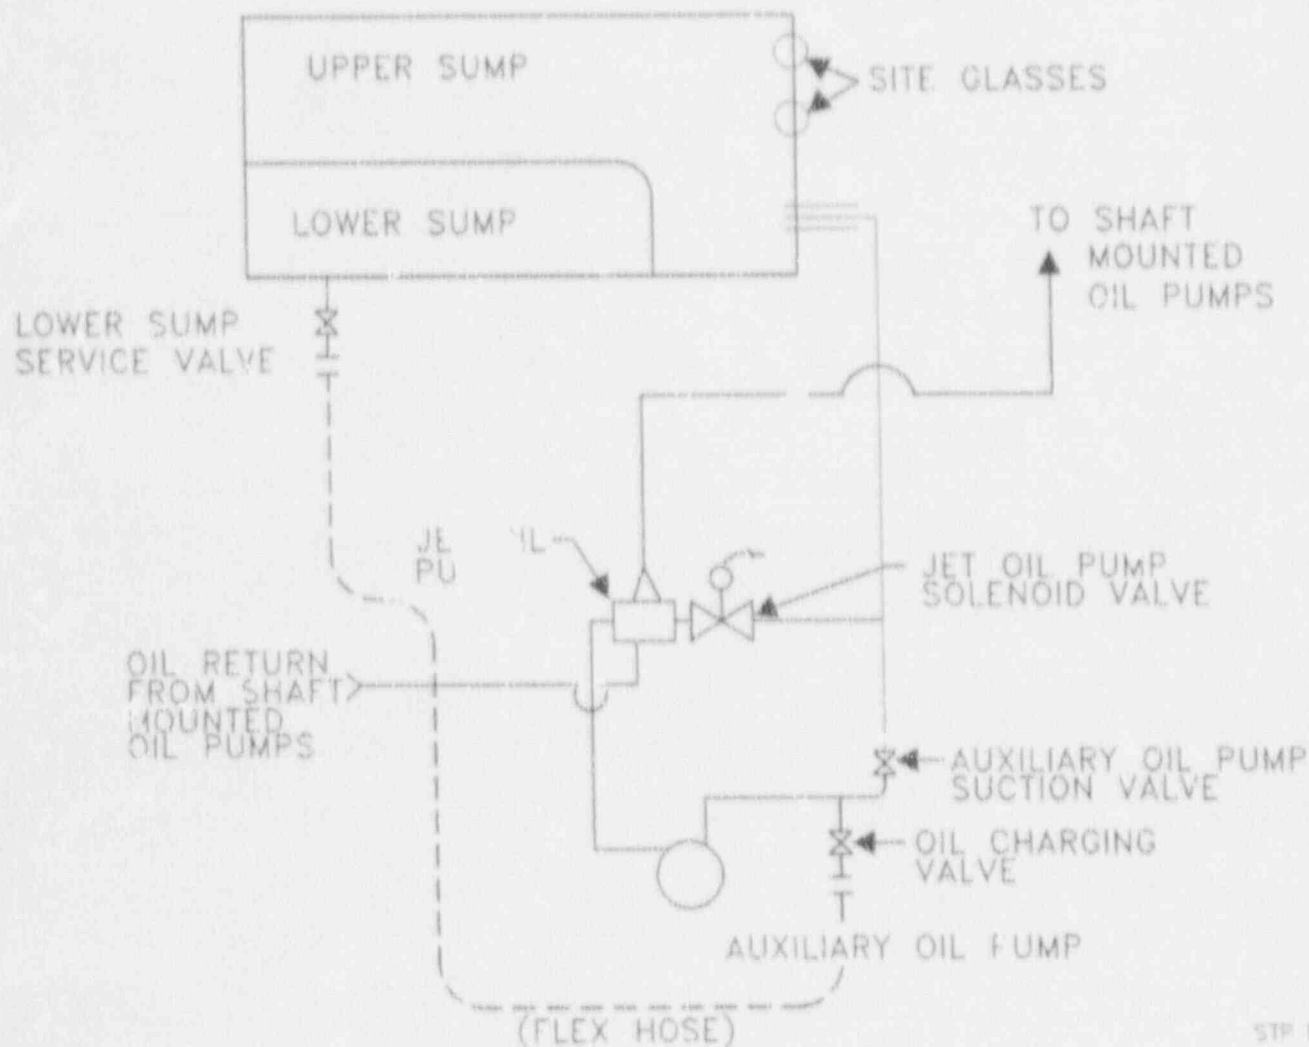
STP D-0824  
REV 0

Refer to the attached figure for clarification of the following. During normal start of the Essential Chillers, a start signal energizes the Auxiliary Oil Pump which takes a suction on the upper sump and discharges to the suction of the shaft mounted oil pumps in the chiller compressor. It is necessary for the Auxiliary Oil Pump to run for 30 seconds and provide a constant pressure, to satisfy the chiller starting circuit and allow Essential Chiller compressor start. When the Essential Chiller is in stand-by, oil will tend to migrate to the lower oil sump, either due to seal leakage or leakage past the Jet Oil Pump Solenoid Valve. When the chiller is in operation, unit differential pressures are such that oil is drawn from the lower sump to the upper sump. The process for transferring oil from the lower sump to the upper sump, with the chiller secured, is contained in a Plant Maintenance Procedure. The procedure requires an oil filled hose to be attached between the Lower Sump Service Valve and the Oil Charging Valve. By closing the Auxiliary Oil Pump Suction Valve, opening the Oil Charging Valve, opening the Lower Sump Service Valve and manually running the Auxiliary Oil Pump, oil is transferred from the lower sump to the upper sump, where indicated level is determined by sight glasses. When in this configuration, the increased resistance to flow via the Auxiliary Oil Pump prevents the pump

from developing sufficient discharge pressure to satisfy the chiller starting circuit. Therefore, the evolution of transferring oil renders the chiller inoperable, a circumstance not addressed procedurally.

The root cause of this event was procedural inadequacy. A Plant Operations procedure requires contacting Maintenance for an unsatisfactory Essential Chiller indicated oil level. A Maintenance procedure provides direction for transferring oil from the lower sump to the upper sump. Neither procedure provides a caution step to indicate that the process renders the chiller inoperable, nor does the Operations Procedure contain guidance for compensatory action that would maintain chiller operability during the evolution.

A contributing factor to the event is the chiller design which results in the need for transferring oil from the lower to the upper sump. With this type unit, some oil migration is expected to occur, a situation exacerbated by excessive valve end/or seal leakage.

1. Plant Operations personnel have been informed by Night Orders of the impact of transferring oil on chiller operability.
2. Plant Engineering and Plant Operations will Field Change the Plant Operating Procedures to provide guidance on manual auxiliary oil pump operation to allow an Essential Chiller with a low indicated oil level to be considered operable and started to restore upper sump oil level. This action will be completed by March 6, 1992.

3. Plant Engineering will provide clarifying information to Plant Operations and Maintenance, regarding conditions which constitute inoperability of Essential Chillers. This action will be completed by April 17, 1992.

4. Plant Operations will revise applicable procedures to provide specific guidance regarding operability of the Essential Chillers and additional instructions regarding maintaining chiller operability. This action will be completed by June 15, 1992.

5. Maintenance will revise applicable procedures for transferring lube oil in the Essential Chillers to clarify the effect on chiller operability and the compensatory actions Plant Operations may take to maintain chiller operability while transferring lube oil in the chillers. This action will be completed by June 15, 1992.
