NIAGARA MOHAWK POWER CORPORATION

Nine Mile Point Nuclear Station
Post Office Box 32
Lycoming, New York 13093

November 29, 1972

Re: Provisional Operation License: DPR-17
Docket No.: 50-220

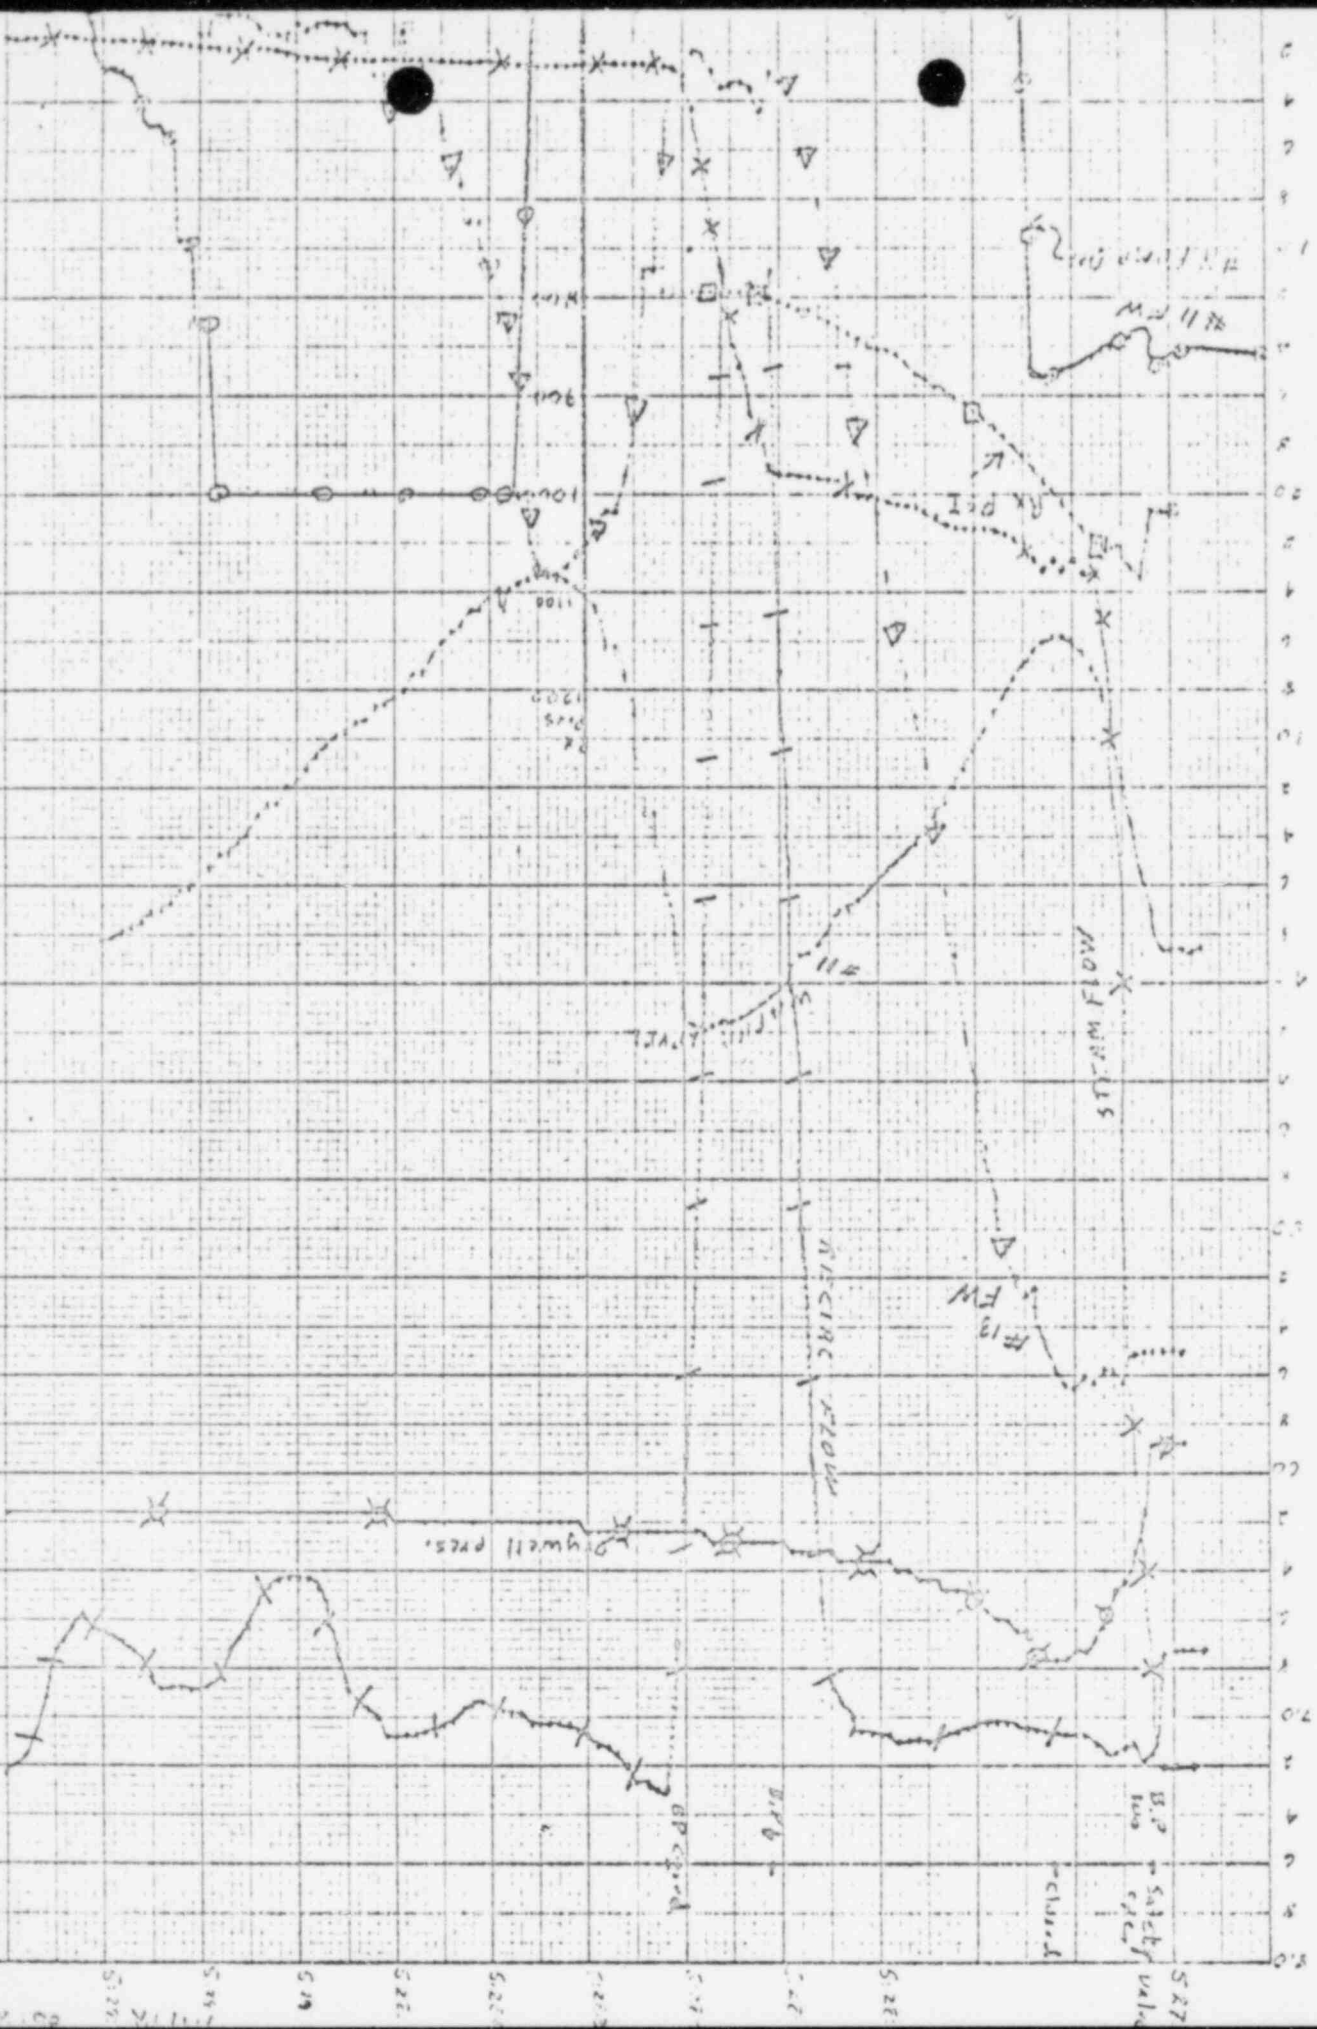
ENCLOSURE 3

4. No emergency systems actuation parameters were reached during the transient. Subsequent analysis of the transient and the parameters plotted for the safety analysis for a turbine trip at this power level showed no inconsistencies in parameter response and range considering the safety valve opening excepting the recirculation system response. See Enclosure 3.

Figure 1 shows the vital parameter changes that occurred as a result of the turbine trip from 1820 MW (t) on November 19, 1972. The comparison with the safety analysis (submitted February 28, 1972) shows an acceptable transient with no significant variation of measured values of thermal, nuclear or hydraulic characteristics from the predicted safety analysis considering the safety valve operation. The recirculation flow reduction, the suspected result of void generation in the loops and/or flow sensing lines, is being analyzed by General Electric and Nine Mile Point Site Personnel. In any event the change in recirculation flow is beyond the time when it would be considered significant to the safety analysis (16 seconds). The excellent response of the bypass system to limit the resultant reactor pressure spike and corresponding neutron flux peak to better than acceptable values (less than 105% on the APRM's) indicates the effort to the "Fine Tune" this system in the past, paid dividends during the transient.

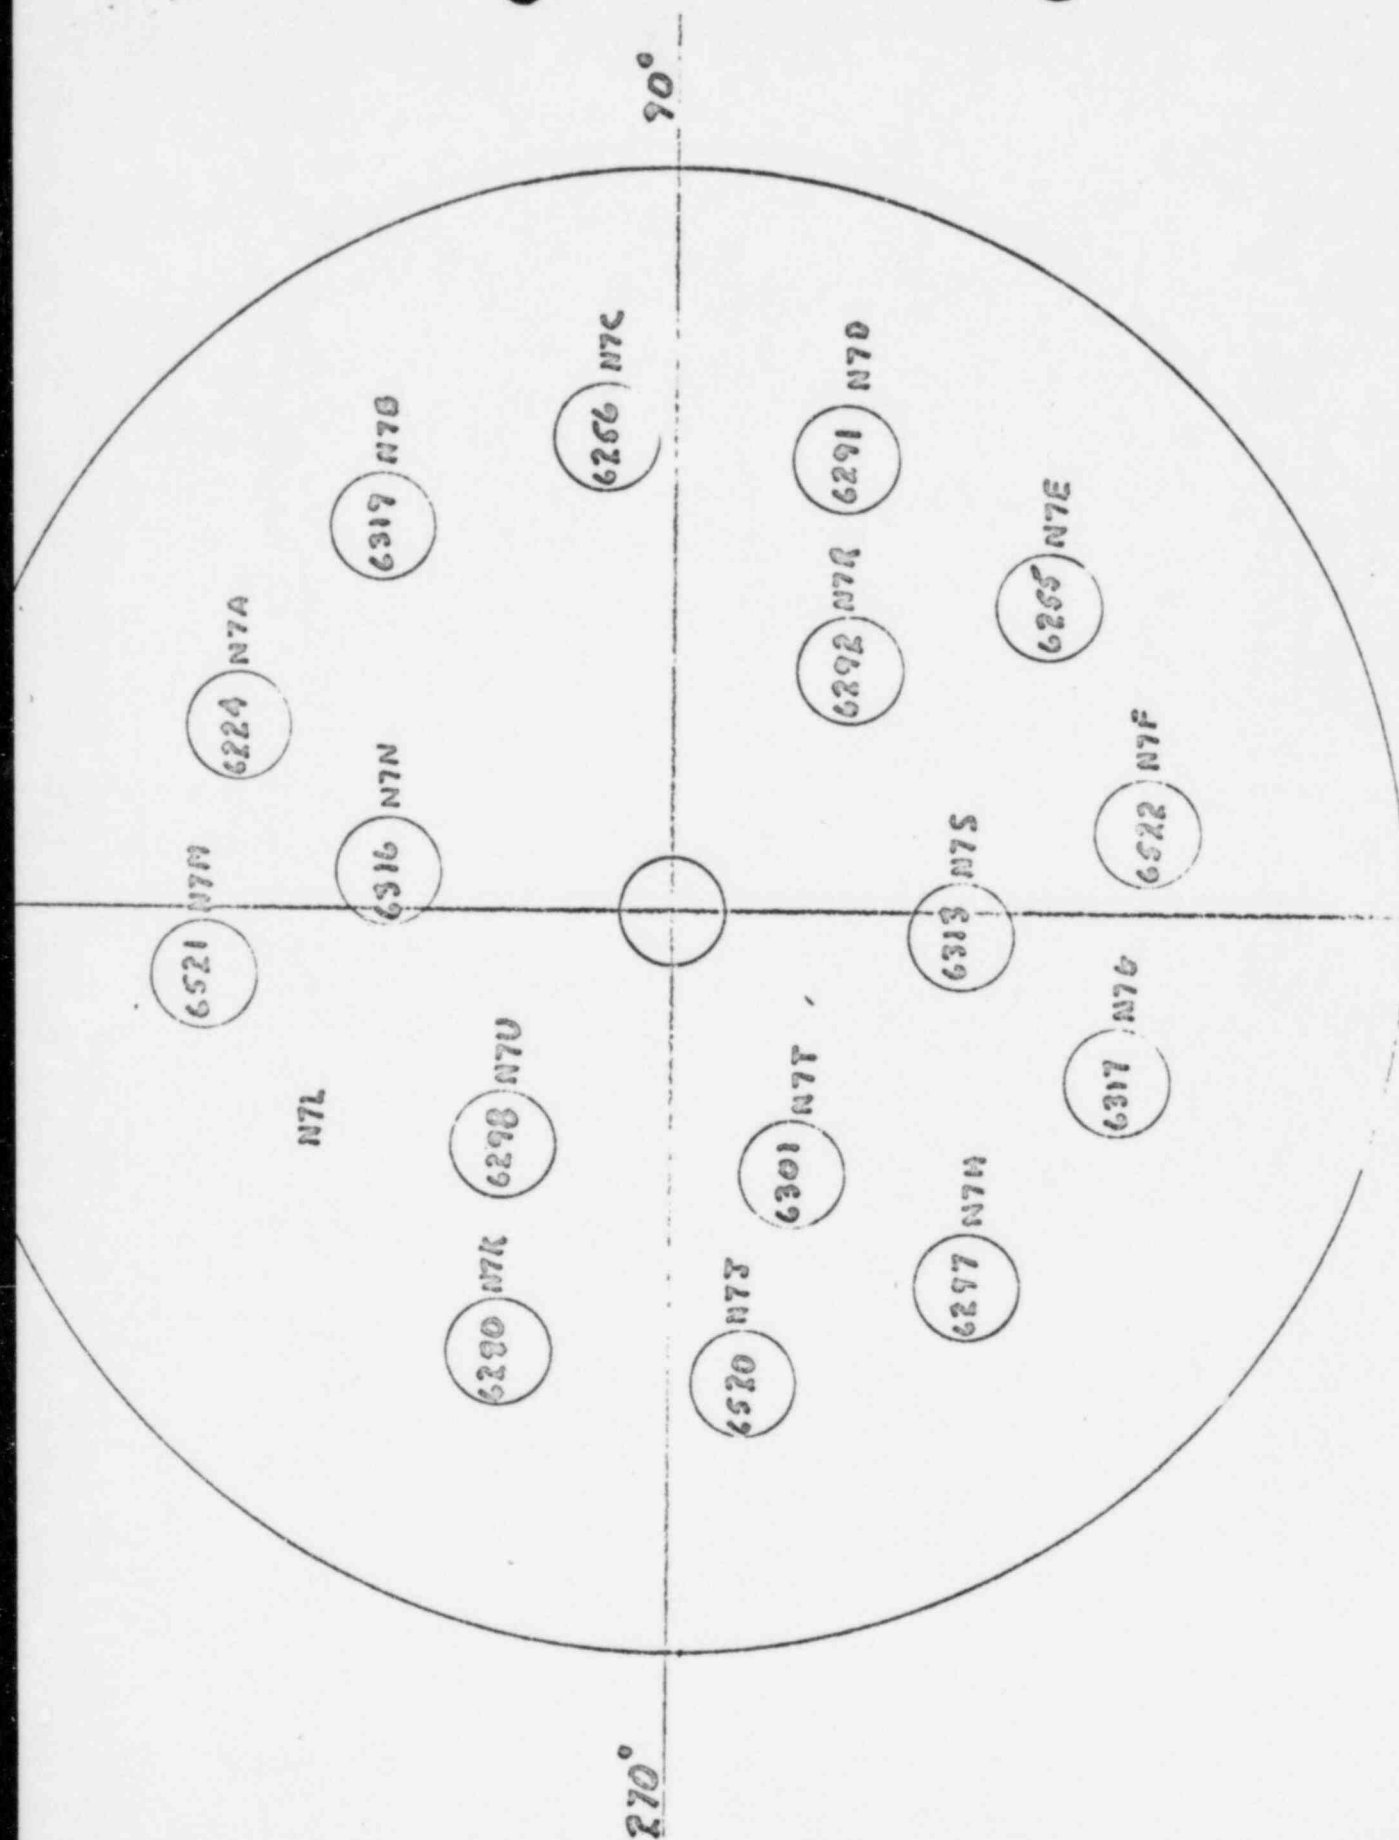
FIGURE 1

The following is a history of the 16 safety valves residing on the reactor vessel head during the transient of November 19, 1972, plus spares. Following the history is the data generated as a result of the nitrogen testing program. Figure 1 shows the present safety valve alignment and Figure 2 shows the nitrogen correlation used to determine the steam relieving pressures.

PRESENT VALUE POSITION 11-20-72

1. To provide the most reliable set of safety valves for the reactor.
 - a. The 7 existing spare safety valves that had recently been steam tested were installed matching relieving pressure for relieving pressure (including the safety valve that relieved early).

- b. The remaining 9 safety valves on the head were nitrogen tested and correlated to steam relieving pressures. Those that met the criteria were placed back on the vessel head.

- c. Two valves were needed from the 7 safety valves initially removed. These were nitrogen tested and correlated to steam providing 16 reliable valves to be installed on the vessel head.
