NIAGARA MOHAWK POWER CORPORATION

Re: Provisional Operating License: DPR-17  
Docket No.: 50-220

# CONSOLIDATED ELECTROMATIC RELIEF VALVE

6" - TYPE 1525-VX

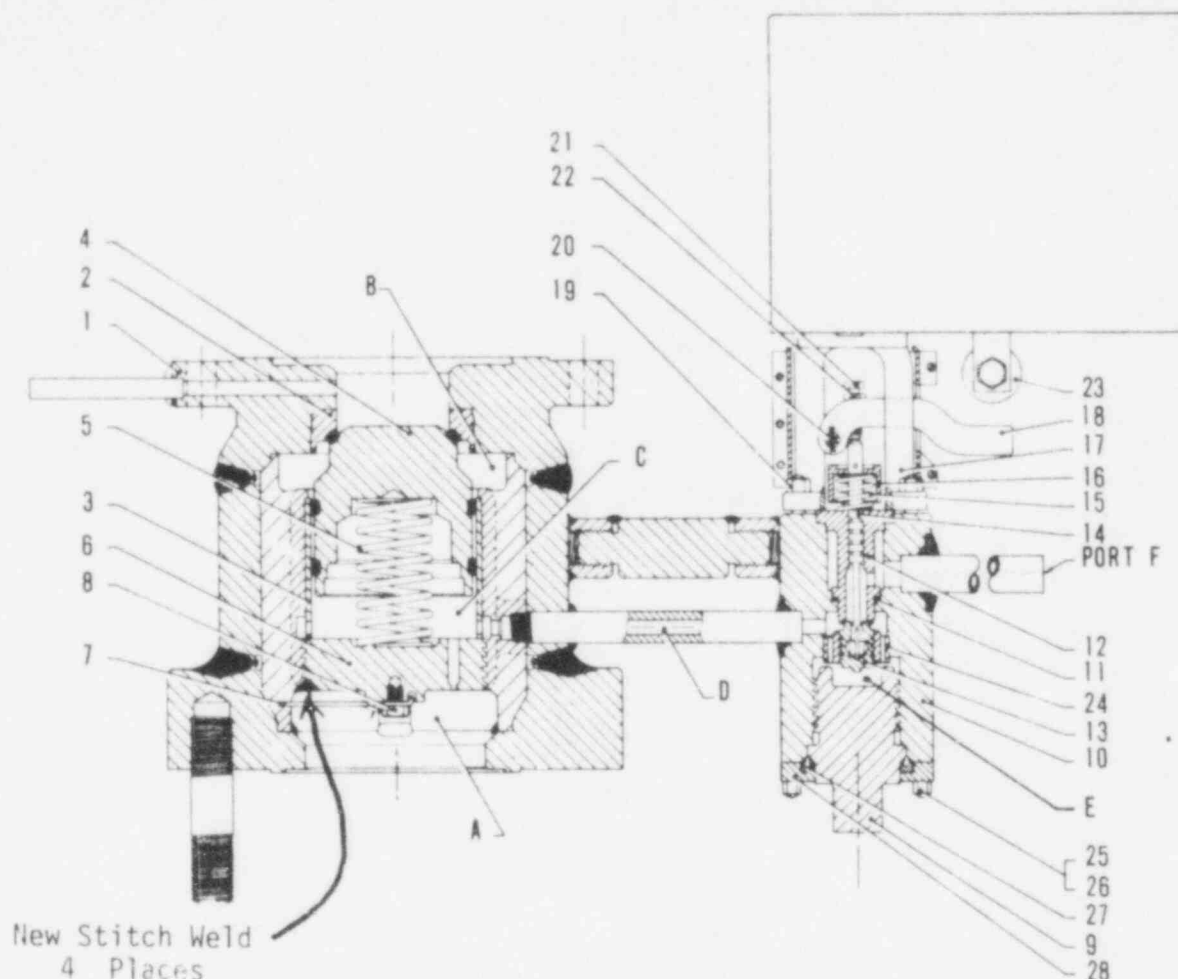
On one valve, the locking screw, Part #8 on enclosed drawing, had become unscrewed allowing lock retainer Plate #7 to fall free (both parts were recovered in the turbine stop valve strainer basket). This permitted the disc retainer, Part #6, to completely back-out falling to the bottom of the valve body. In this condition, it would be impossible to bleed enough steam from Chamber "C" to open the valve as it would be wide open to Chamber "A" and would not have the benefit of the restricting orifice in the retainer plate.

One other valve was found with the locking screw, Part #8, backed out 1/16" but the lock retainer plate and disc retainer had not moved, therefore the valve was operable. Tie-wires holding the locking screws were broken on all six valves.

## Effected Parts

- #4 Valve Disc.
- #6 Disc Retainer
- #7 Lock Retainer Plate
- #8 Locking Screw

Repair was effected to all six valves by removing the locking screw, Part #8, and lock retainer plate, Part #7. In their place, four 1/4" V grooves, 1" long, were cut in the joint between the disc retainer and the valve body insert. These were stitch welded together. Future maintenance may be accomplished by grinding out the stitch weld. In this manner, there can be no loose parts on the valves to drop into the steam lines and dependability of valve operation is increased.
