NUCLEAR REACTOR LABORATORY

Subject: Reportable Occurrence 50-20/1992-1, Improper Increase of Reactor Power
Causing a Brief Excessive Power Level

1. Report No.: 50-20/1992-1
- 2a. Report Date: 2 March 1992
- 2b. Date of Occurrence: 18 February 1992
3. Facility: MIT Nuclear Reactor Laboratory
138 Albany Street
Cambridge, MA 02139

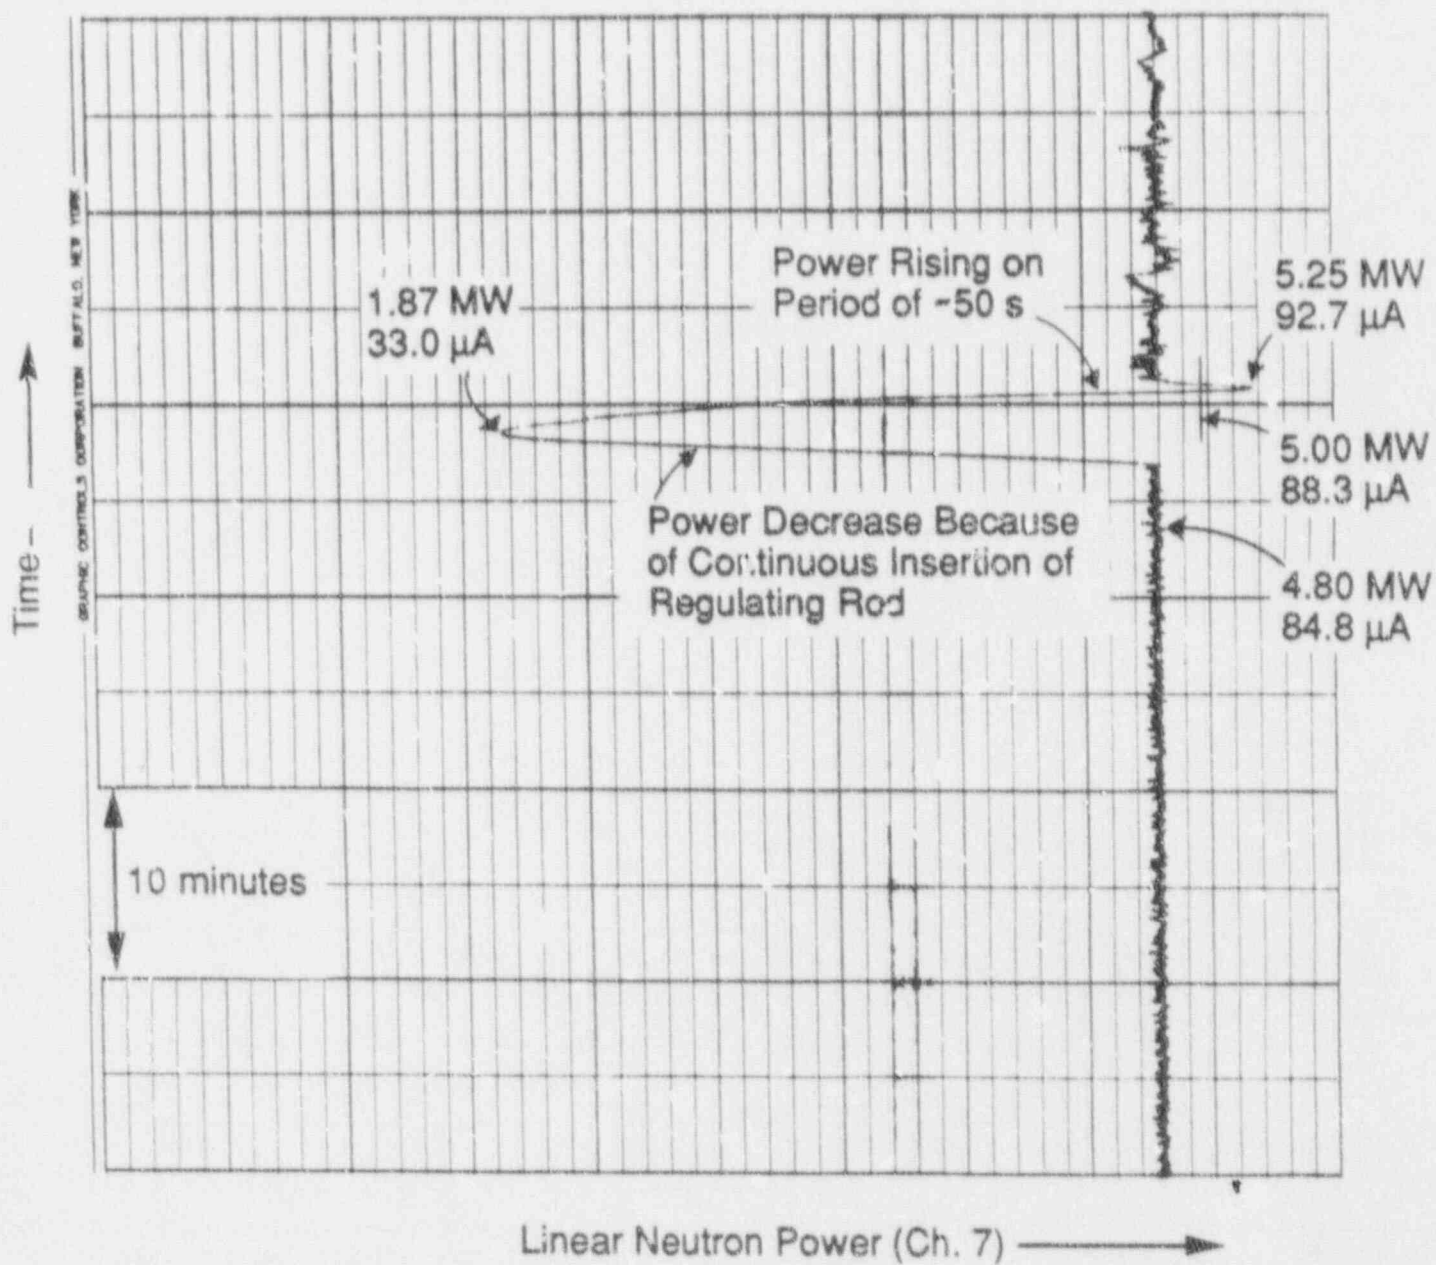
Figure One: Strip Chart Recoding of Linear Flux Channel

offset the reactivity associated with a 50-s period. As a result, an overshoot of the neutronic power occurred. This is shown in the attached figure which is the strip-chart recording of linear flux channel #7. (Note: Once it was apparent that the power would overshoot, the operator drove one of the shim blades in continuously.) An error in judgment was then made in that the console operator did not notify the Reactor Superintendent of the overshoot. As a result, the occurrence was not identified by the MITR's senior staff until the evening of February 20, 1992.

The apparent cause of this occurrence was operator error in that the operator performed a power increase on a period shorter than 100 s while the power was within 80% of the demanded level.

The reactor's neutronic power, as measured by the trace recorded on the strip chart for channel #7 (the linear flux channel) reached 5.25 MW and was above 5.0 MW for 22 s. The reactor safety system is set to activate at 5.5 MW and this level was not reached. Reactor power, as recorded on the thermal power strip chart, did not exceed 4.69 MW. It should be noted that the MITR-II Facility Operating License is written in terms of thermal power and hence no limiting condition for operation was exceeded.

- (a) This occurrence was reviewed verbally with the operator in question with emphasis on the proper conduct of power increases.
- (b) The Senior Review Board met to discuss the occurrence and decided to require that the operator involved complete a special review of the procedures and principles that govern power increases. (Action to be completed by 13 March 1992.)
- (c) The Senior Review Board also decided that the protocol for information exchange between operators, the details of this occurrence, and the criteria for notifying the senior MITR staff of occurrences be reviewed by all licensed operators. (Action to be completed by 30 April 1992.)

- (d) Investigated and repaired analog automatic control system. (Temporary repair completed 25 February 1992. Permanent repair is still pending.)
