DRESDEN NUCLEAR POWER STATION

UNIT 2

Supplementary Information

Special Report
of
Incident of June 5, 1970

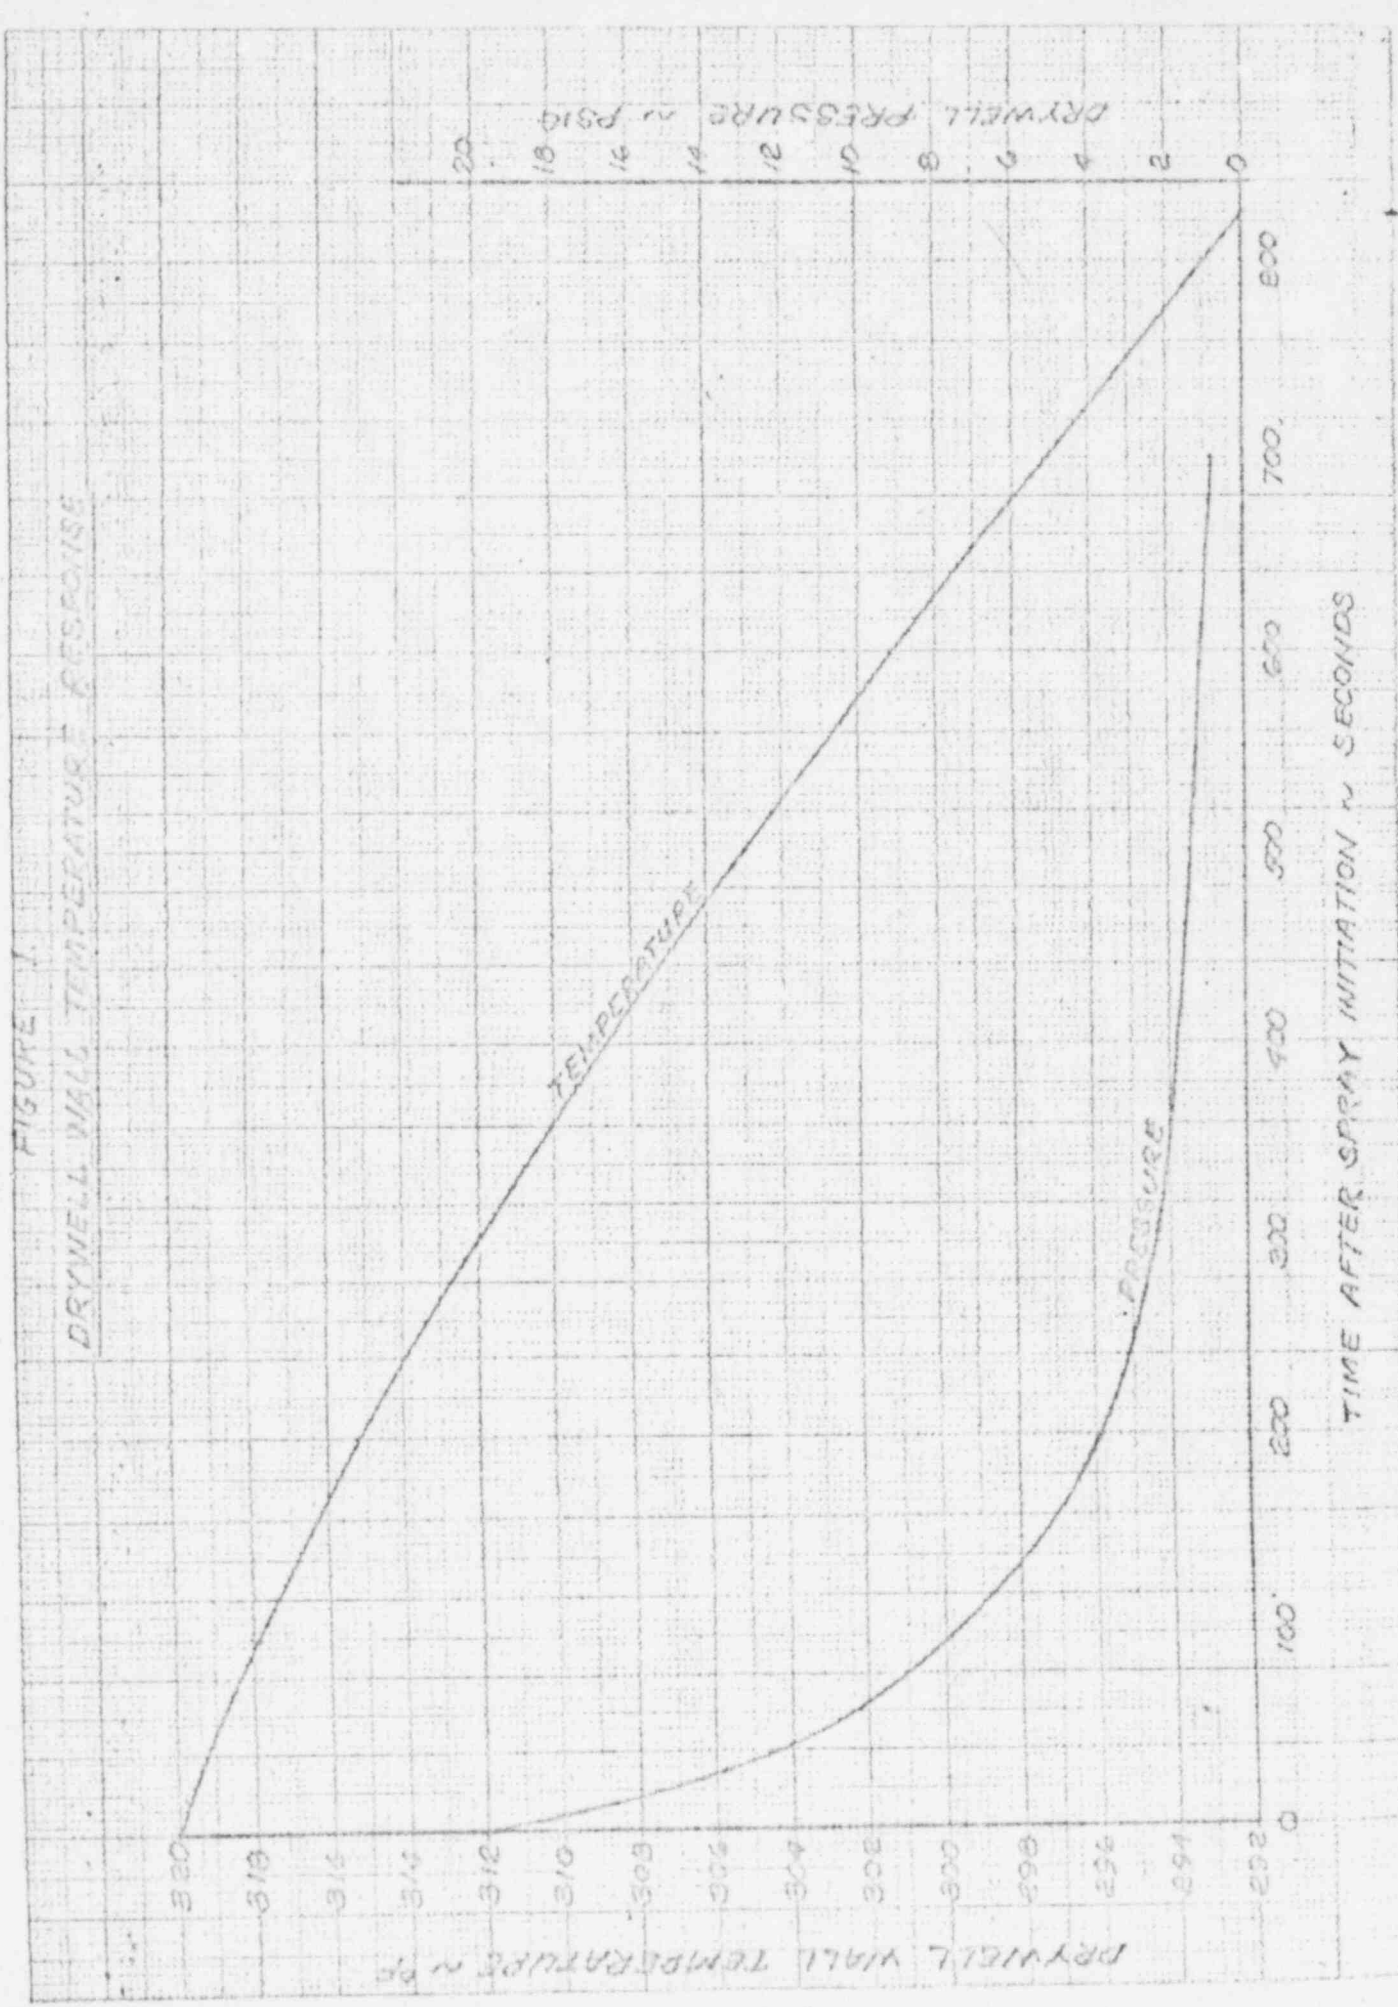
FIGURE 1
DRYWELL WALL TEMPERATURE RESPONSE

from a pure steam leak issuing into the containment. This peak super heat temperature is a function of reactor pressure and approaches a maximum of 340°F at a reactor pressure between 400 and 500 psi (this is readily demonstrated from the Mollier diagram). At rated reactor vessel pressure the maximum super heat temperature approaches 320°F. Needless to say, to approach the peak temperature of 340°F for any duration a very special reactor condition must be postulated where the reactor could remain at ~500 psia and the drywell temperature at 50 psia. Large steam leaks that depressurize the vessel quickly would approach the peak containment temperature quickly, but in this case required valve action would occur within a short duration. Small steam leaks would depressurize the vessel slowly and result in a slower containment temperature rise as demonstrated during the incident.

The very low heat transfer coefficients associated with superheated steam (h of 1 to 5) will result in lower temperatures, and a significant time lag, in the temperature response of the drywell structure and components.

A general case in which the containment wall is postulated to be 340°F has been analyzed to demonstrate the adequacy of the containment.

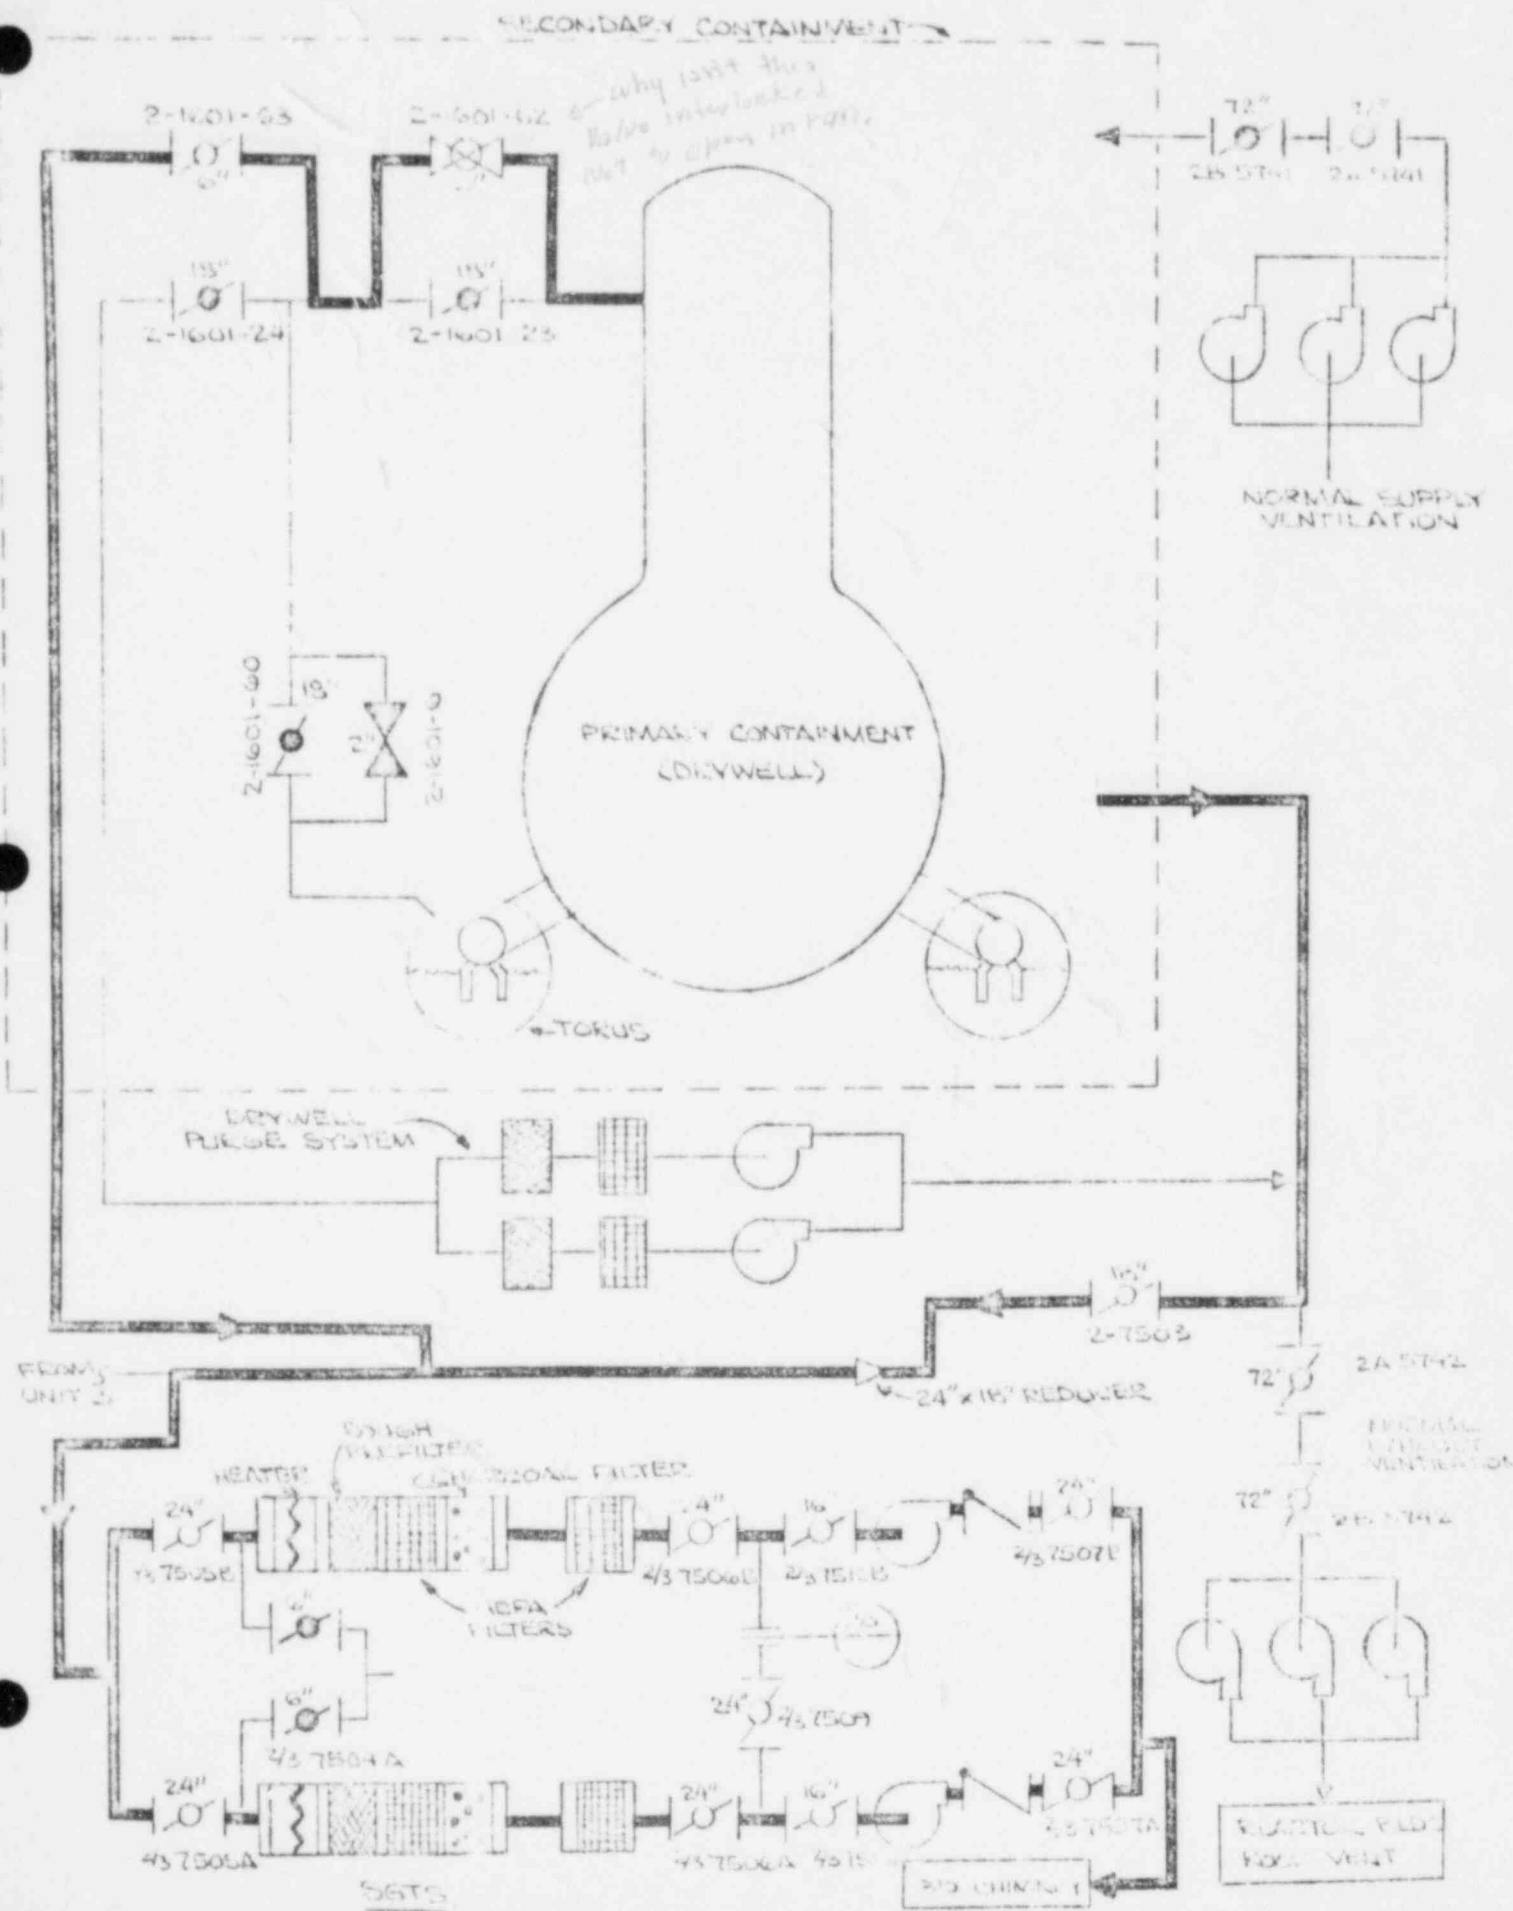
FIGURE 2. DYKESON 2 DRYWELL VENTING SYSTEM. (REVISED) 1970

Our analysis of the previously described events indicate that neither the design pressure or temperature of the SGTS was exceeded. The high efficiency particulate air (HEPA) filters were tested in-place using air generated DOP (dioctyl phthalate) particles about two weeks after the incident. Efficiencies measured were greater than 99.9% for all tests indicating that no damage had occurred to these filters. Because of the complexity of charcoal filter testing, it was elected to replace all charcoal filters in the interest of saving time. Following the installation of new charcoal filters, they were tested in-place using Freon 112. Efficiencies measured were greater than 99.9% for both tests.

A procedure has been issued titled "Primary Containment Post Incident Cooling and Depressurization." This procedure specifies the conditions under which the containment may be vented after an incident and also details the procedures to be followed for post incident cooling and depressurization. This procedure states that:

- (a) No venting of the drywell can be initiated by shift personnel action if any of the following exist:
 - (1) Drywell pressure is greater than 2 psig.
 - (2) Low-low reactor water level.
 - (3) Drywell gross air sample activity exceeds Technical Specification stack release limits.
- (b) Venting through the SGTS is permissible if all of the following conditions are met:
 - (1) Reactor water level and make-up are normal.
 - (2) Drywell pressure is less than 2 psig.
 - (3) Drywell gross air sample activity is determined to be within Technical Specification release limits.

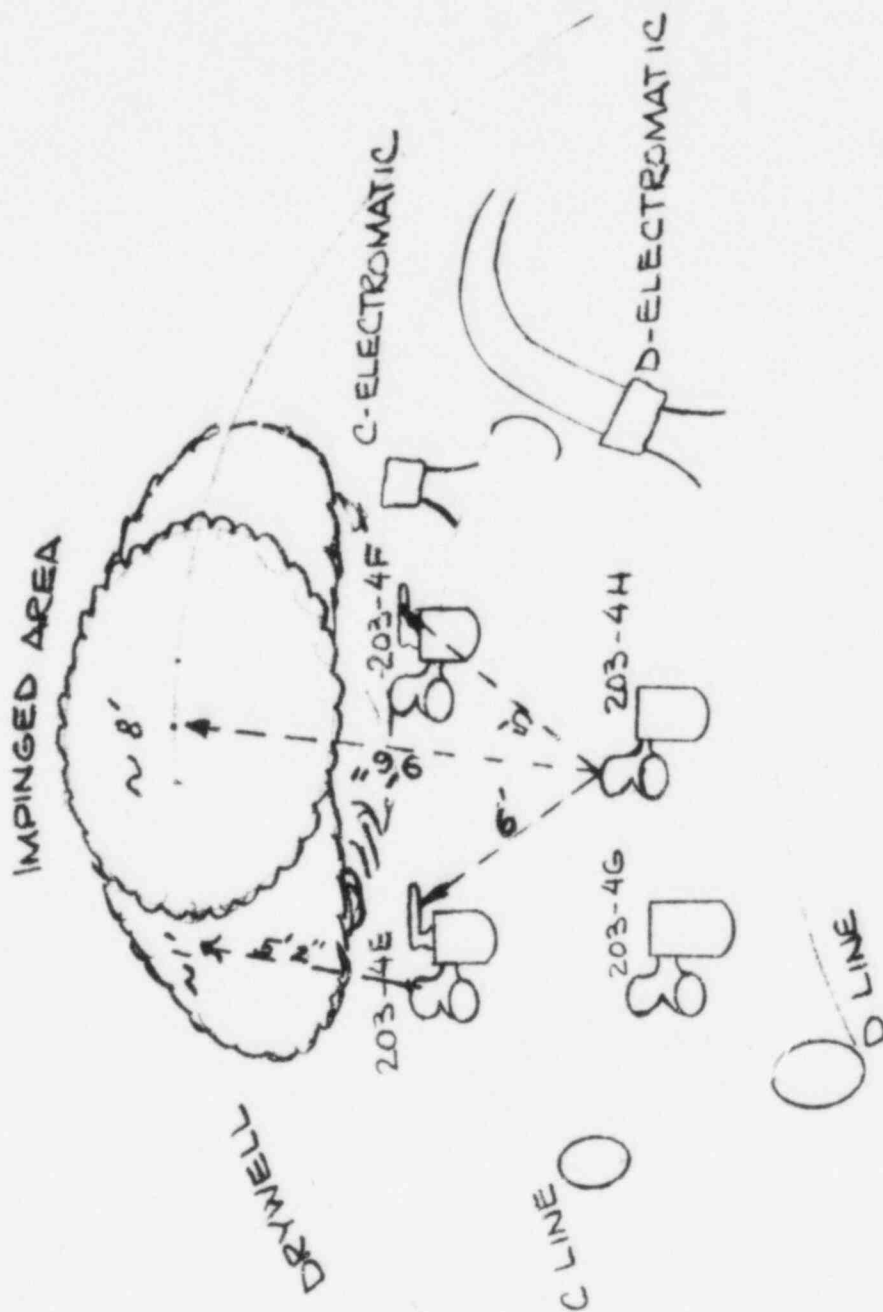
FIGURE 6-1

In the event the original setting is at 200°F for 1220 psig, and the maximum temperature of the spring is 320°F as noted in the June 5 incident report, the set point changes to 1195 psig or a 2% set point change.

In general, the result of impinging fluids is to raise the spring temperature and reduce the set point which tends to be in a safe direction. Also, it is noted that the valve discharges have been rotated at Dresden 2 to assure that impingement will not occur as it did during the June 5 incident.
