"B" STEAM GENERATOR CONTROL VALVE

FAILURE ON JULY 22, 1973

R.E. GINNA NUCLEAR POWER PLANT

"B" S/G FEEDWATER CONTROL VALVE FAILURE ON JULY 22, 1973

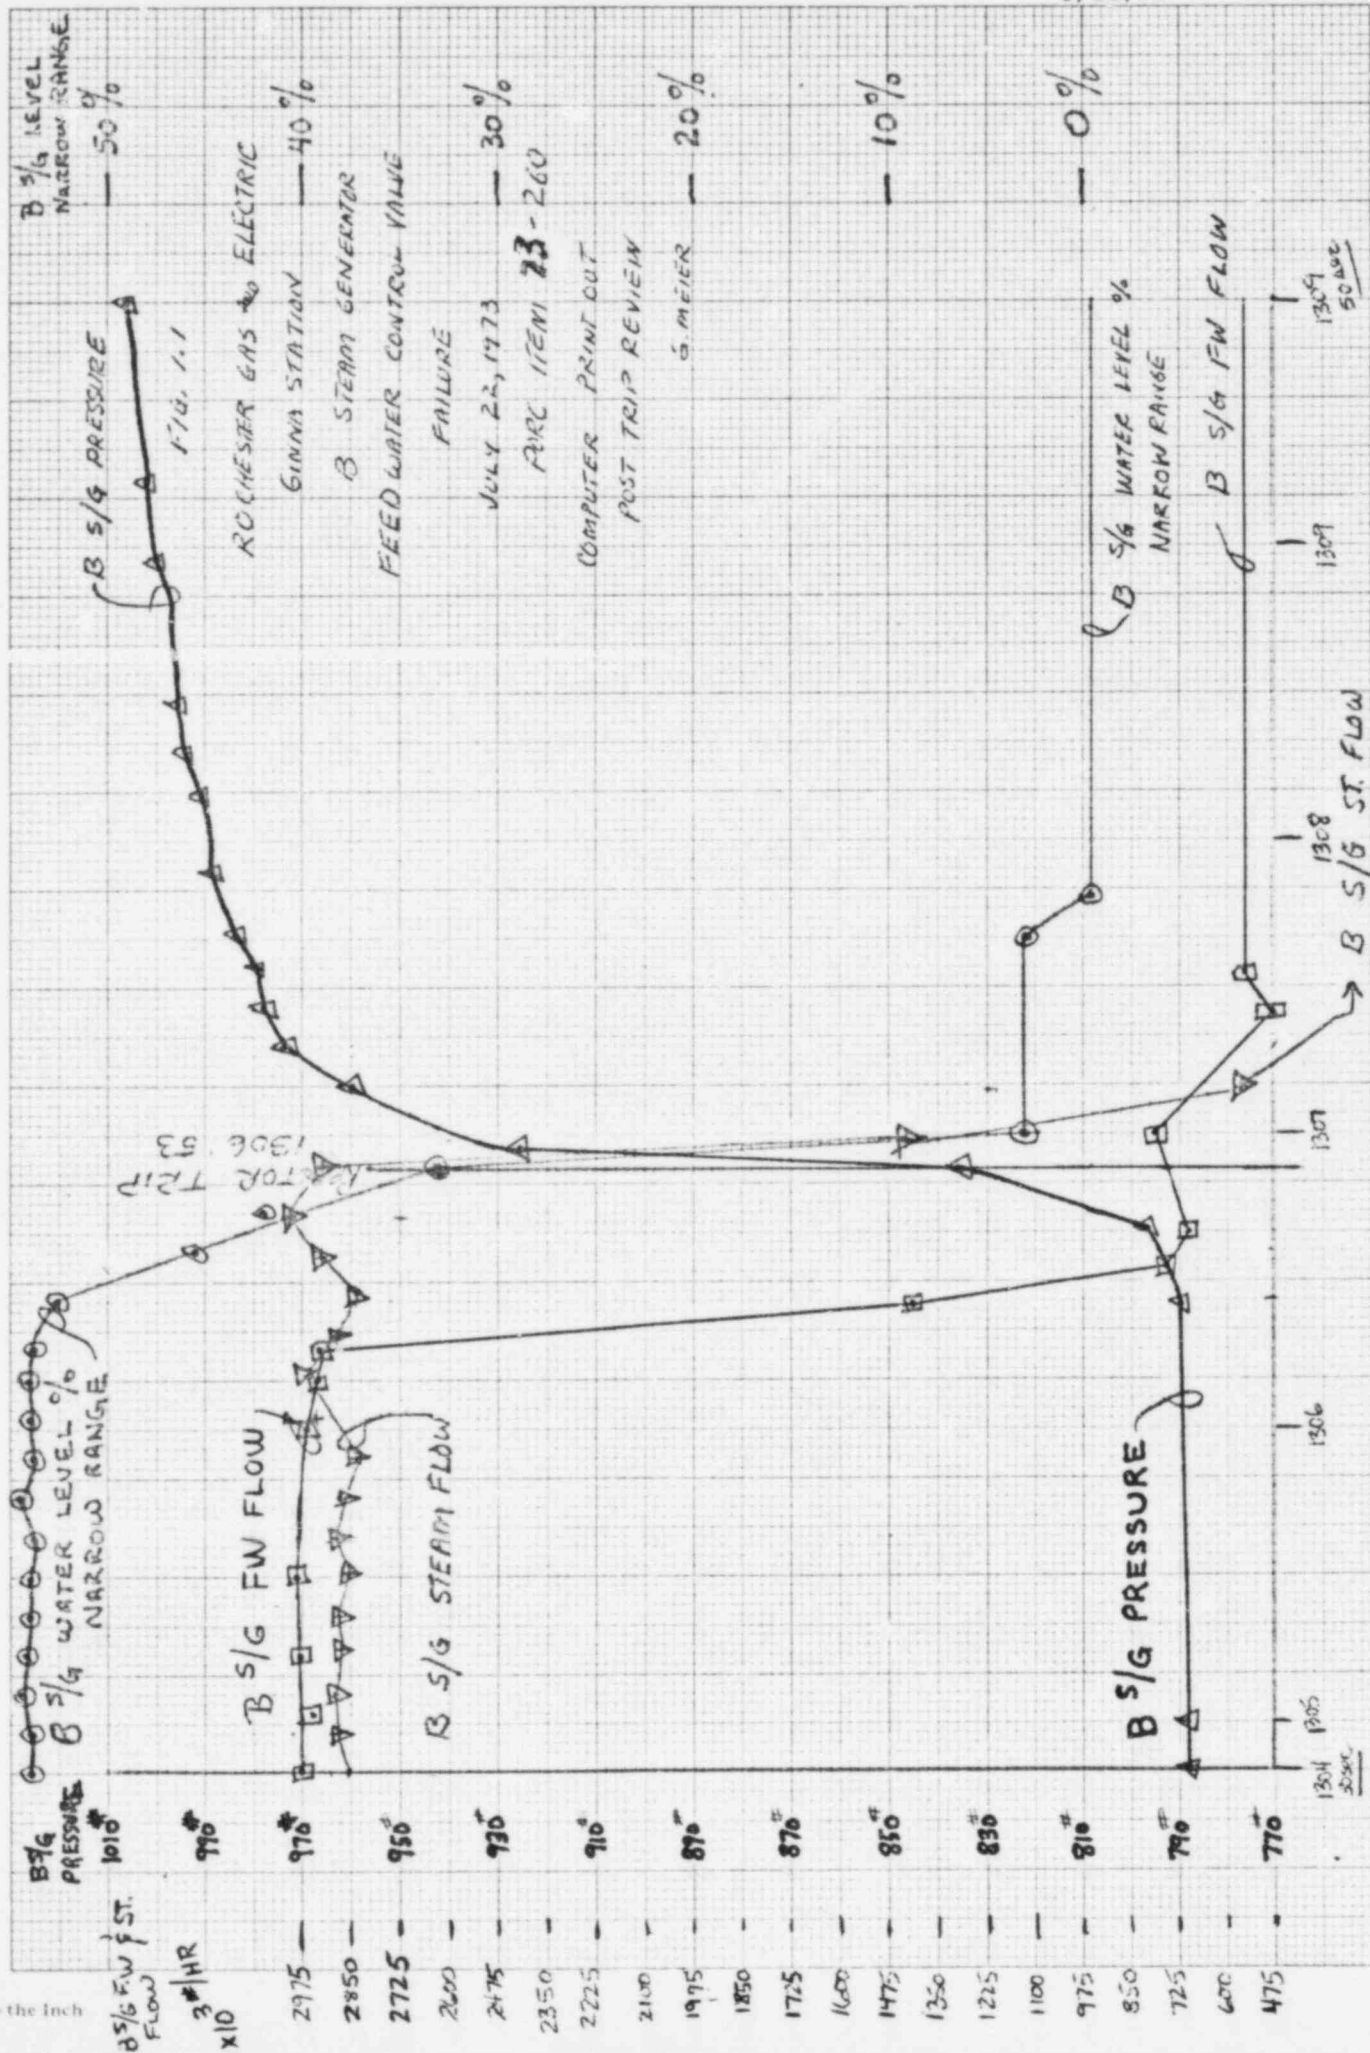
The initial investigation indicated that loss of feedwater must have occurred, but the cause was not immediately evident. The "B" steam generator feedwater control valve was subsequently dismantled which revealed that the plug had become separated from the valve stem. This plug separation caused the loss of feedwater and ensuing reactor trip. Pertinent system parameters are plotted on Figure 1.1. Data for this

figure was obtained from the plant computer. It was theorized that this plug separation induced rapid feedwater flow variations resulting in the vibrations and noises witnessed by the operators on duty.
