TENNESSEE VALLEY AUTHORITY - SEQUOYAH NUCLEAR PLANT UNIT 1 - DOCKET
NOS. 50-327 and 50-328 - FACILITY OPERATING LICENSE DFR-77 - LICENSEE
EVENT REPORT (LER) 50-327/92004

FACILITY NAME (1) Sequoyah Nuclear Plant, Unit 1										DOCKET NUMBER (2) PAGE (3) 050003 27 110F 08									
TITLE (4) Inadequate design results in a lack of selective breaker coordination																			
EVENT DAY (5)					LER NUMBER (6)					REPORT DATE (7)					OTHER FACILITIES INVOLVED (8)				
					SEQUENTIAL REVISION					FACILITY NAMES					DOCKET NUMBER(S)				
MONTH DAY YEAR YEAR					NUMBER NUMBER					MONTH DAY YEAR					Sequoyah, Unit 2				
0 2 0 6 9 2 9 2					0 0 4 0 0 0 3 0 9 9 2					050003 28									
OPERATING MODE (9) 1 20.402(b) 20.405(c) 50.73(a)(2)(iv) 73.71(b)										THIS REPORT IS SUBMITTED PURSUANT TO THE REQUIREMENTS OF 10 CFR 5:									
(Check one or more of the following)(11)																			
POWER 20.405(a)(1)(i) 50.36(c)(1) 50.73(a)(2)(v) 73.71(c)																			
LEVEL 20.405(a)(1)(ii) 50.36(c)(2) 50.73(a)(2)(vii) OTHER (Specify in

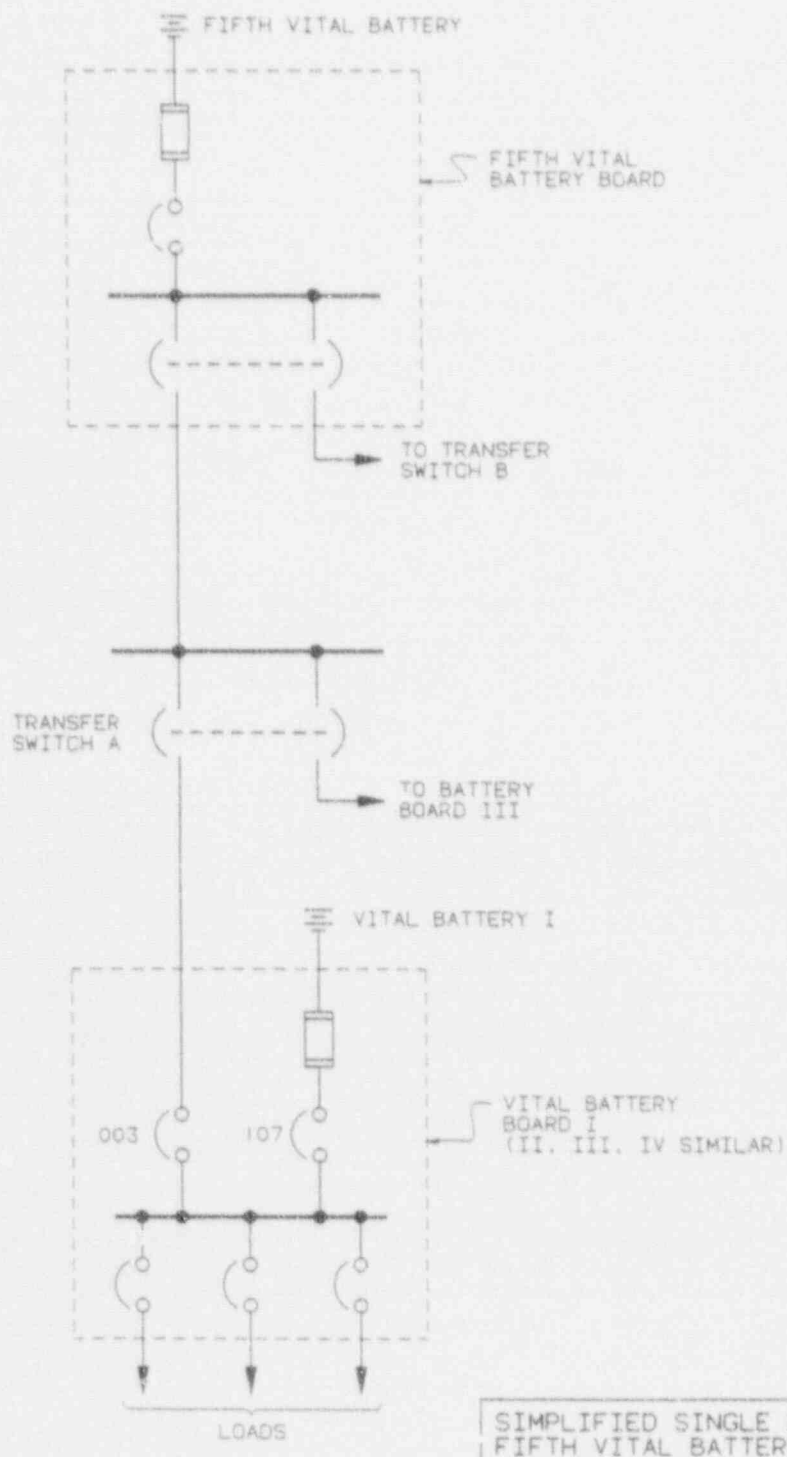
SKETCH

The fifth vital battery was initially installed and declared operable in January 1985. The design change process did not require a formal calculation to be issued to support the addition of the fifth vital battery. In January 1987, the design baseline verification program identified a potential nonselective coordination problem with the fifth vital battery system in that the selective coordination calculation did not include the fifth vital battery. In February 1988, the selective coordination calculation was revised to address the fifth vital battery. However, the preparers and reviewers of the calculation did not address selective coordination for Breaker 003 on each of the vital battery boards in the revision to the calculation. After issuance of the calculation, the design baseline and verification program item was closed. (See attached sketch for identification of the location of the breakers involved.)

Circuit Breaker 003 in each of the 125V vital battery boards had a long-instantaneous type overcurrent protection device. This device was set at 400 percent on the instantaneous setting. The long delay setting is not of concern since it was set at 110 percent of the 800 amperes (amps) nominal breaker rating, or 880 amps. The maximum continuous current is documented in calculation SQN-CPS-034 R3 as less than 500 amps. The limiting potential scenario for consideration is that a single failure in addition to Breaker 003 tripping due to a faulted load results in a loss of two battery boards. Three of the four boards are required to achieve and maintain safe shutdown. This evaluation considered the following events: loss of offsite power; station blackout; 10 CFR 50 Appendix R fire, and a seismic event. The seismic event is considered to be worst case because of the possibility of losing more than one battery board.

The instantaneous setting of 400 percent allows Circuit Breaker 003 to trip instantaneously when the current exceeds four times the trip unit rating. For this case, the instantaneous region begins when fault currents exceed 3200 amps. Coordination is assured for all fault magnitudes less than this value.

3. A design change was implemented to disable the automatic trip function of Breaker 003.
4. The design criteria was revised to address Breaker 003.
