Subject: Final Report - DER 84-23  
A 50.55(e) Reportable Condition Relating To Auxiliary  
Feedwater Pump 'B' Discharge Valve To The Condensate Storage  
Tank.  
File: 84-019-026; D.4.33.2

FINAL REPORT - DER 84-23  
DEFICIENCY EVALUATION 50.55(e)  
ARIZONA PUBLIC SERVICE COMPANY (APS)  
PVNGS UNITS 1, 2, 3

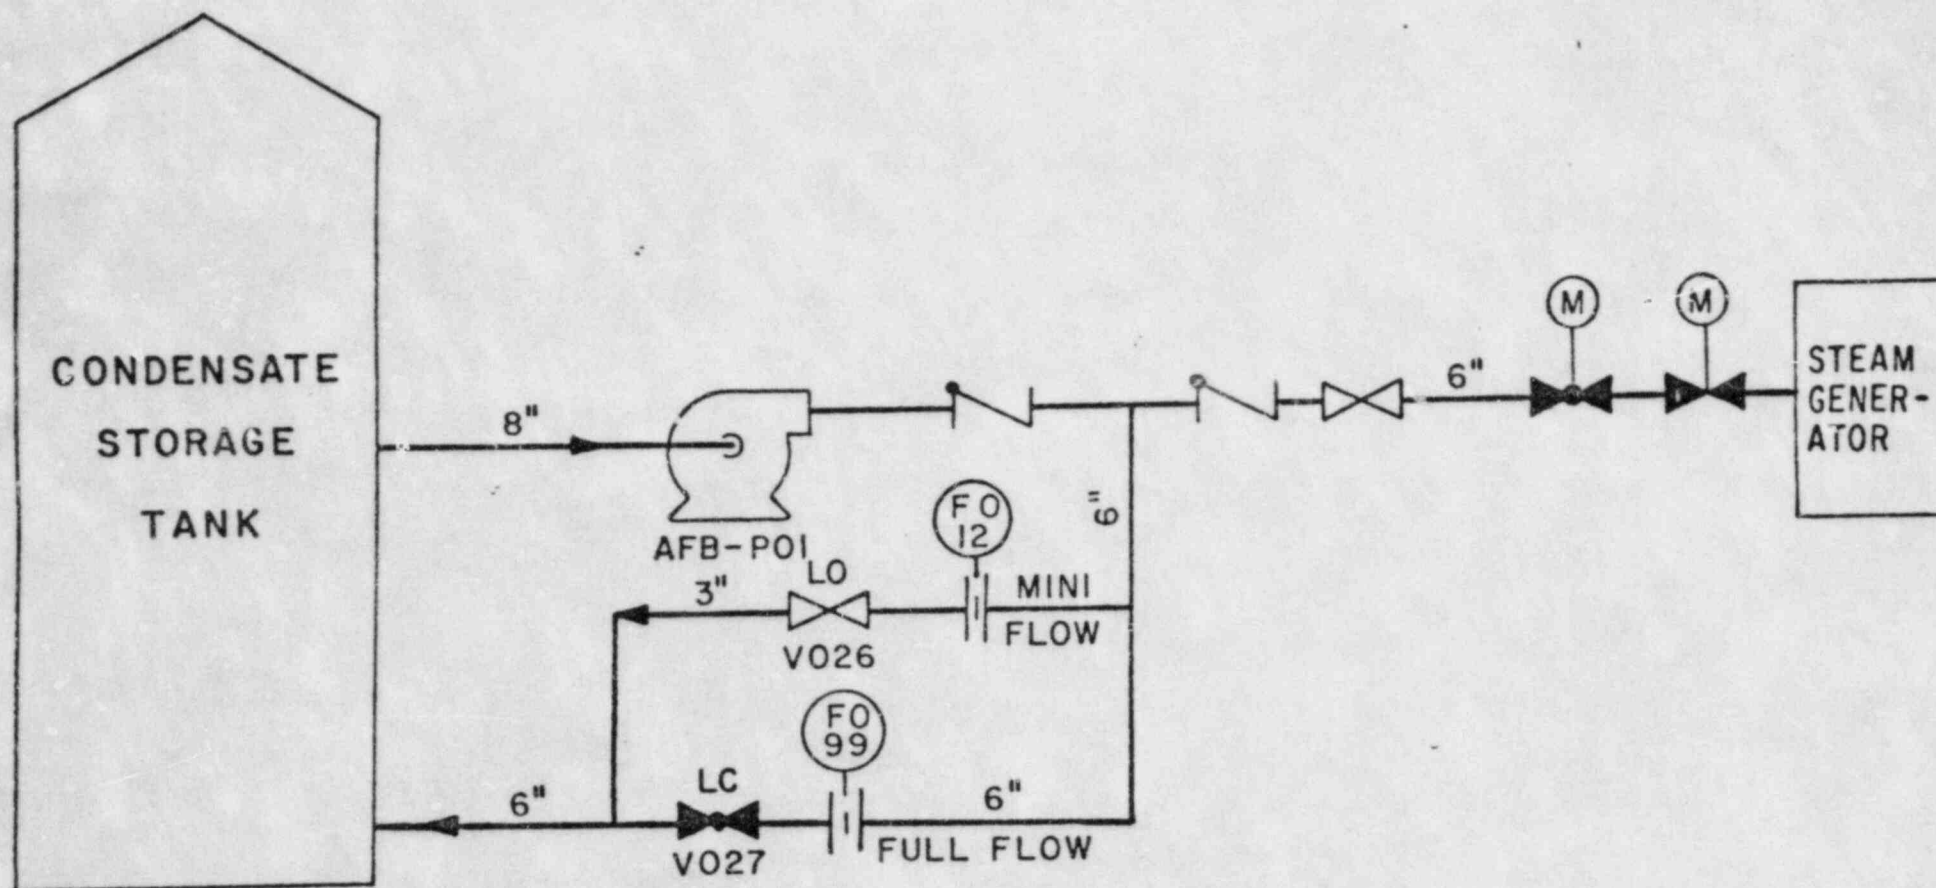
DIAGRAM OF RECIRCULATION TEST  
FOR THE  
AUXILIARY FEEDWATER PUMP

During field testing of Auxiliary Feedwater Pump (1AFB-P01) the yoke sleeve on the Train B Recirculation Valve (1AFB-V027) loosened and the following parts were damaged: yoke sleeve nut, two pinion shaft bearings and two keys. This globe valve is in the 6-inch line used for full-flow recirculation testing (see attached drawing), and the damage was due to the vibration of the 6-inch full-flow recirculation loop during pump full-flow test. The cause of this condition is attributed to the physical layout of the piping and the restrictive action of Flow Orifice 99. During normal operation, since this is only a test circuit, 1AFB-V027 is locked closed.

Valve 1AFB-V027 is open only during full flow test so its mode of failure would be leakage. It is possible that, during emergency plant operating conditions, this could result in an insufficient supply of water to the Steam Generator, thus impairing the safety function of the Auxiliary Feedwater Pump.

- A. The monthly surveillance testing of the Auxiliary Feedwater Pumps required by the Station Technical Specifications will be performed using the existing 3-inch mini-flow lines. Full flow recirculating testing of the Auxiliary Feedwater System is not required by the Technical Specifications.
- B. Recirculation Valves (V018 & V027) in both Trains A and B of the Auxiliary Feedwater Pumps in Units 1, 2, and 3 will be deleted and spectacle flanges will be inserted in place of these valves to permanently block flow in the 6-inch recirculation loop. DCPs 1SM, 2SM, and 3SM-AF-062 Revision 1 have been issued to implement this change.
- C. SAR Change Notice No. 1165 and Design Criteria Manual revision request No. 869 have been initiated to document this change.
