SUSQUEHANNA STEAM ELECTRIC STATION - UNIT 2  
INTERIM REPORT OF A DEFICIENCY CONCERNING  
ISOLATION OF THE UNIT 2 NITROGEN MAKEUP SYSTEM  
E. 100508 FILE 821-10  
PLA-1902

Interim Report

Isolation of the Unit 2 Nitrogen Makeup System

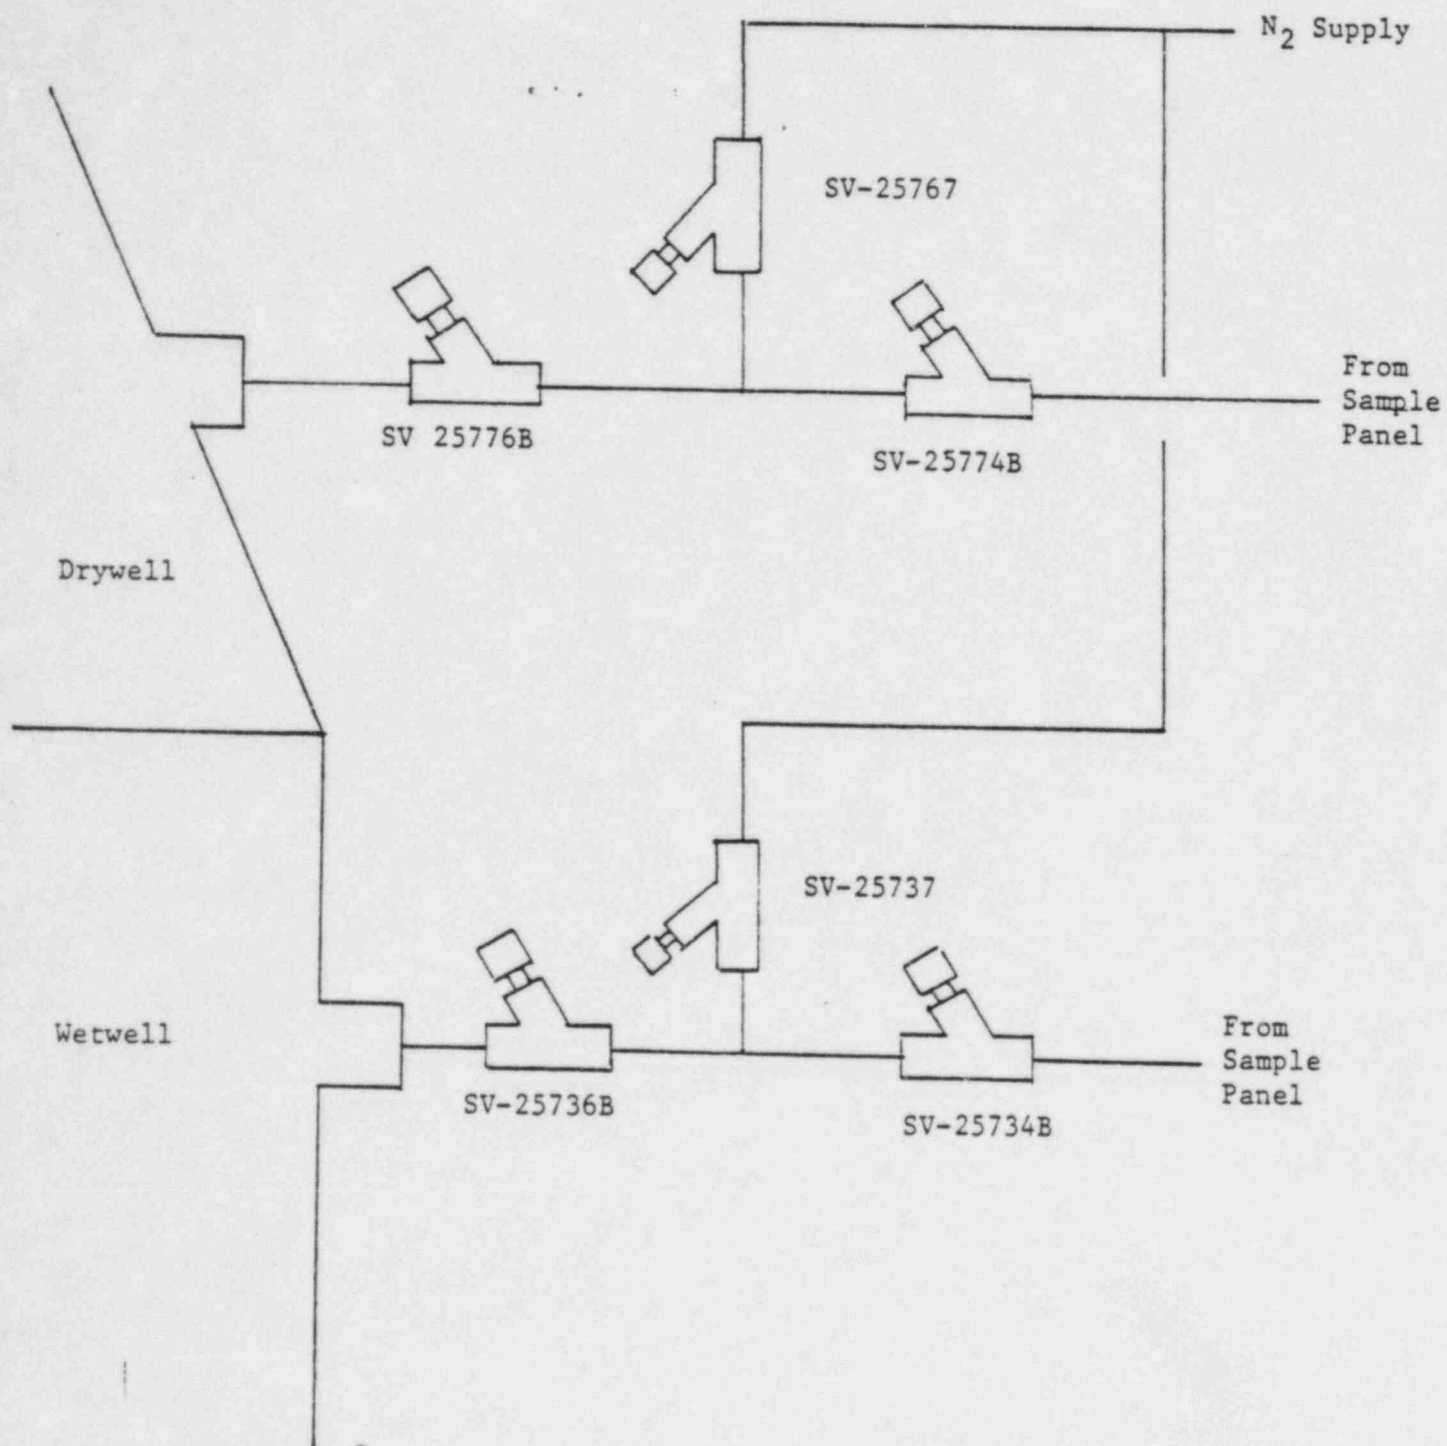
Unit 2 Nitrogen Makeup System Isolation Valves

It has been determined that the primary containment isolation system Division II relay (K83) provides a closure signal to the drywell nitrogen supply outboard isolation valve (SV-25767) and the containment atmosphere control sample inboard isolation valve (SV-25776B). The drywell nitrogen supply line taps into the containment atmosphere sample line between the inboard valve (SV-25776B) and the outboard valve (SV-25774B) (see attachment). With the nitrogen makeup system in service, coincident with a loss of coolant accident, the K83 relay could fail in such a manner as to maintain SV-25776B and SV-25767 open. This configuration could create a direct path from primary containment to the outside environment through the non-safety related nitrogen makeup system should it fail. A similar scenario is applicable to the suppression chamber nitrogen supply isolation valve (SV-25737) and the containment atmosphere control return inboard isolation valve (SV-25736B).

The deficiency resulted from a previous change of the power supply to the inboard isolation valves from Division I to Division II in order to prevent a loss of Division I power from closing the valves and preventing the operation of the Division II containment atmosphere sample system.

The nitrogen makeup system is isolated from the drywell by two 1" energize to open (fail closed) process solenoid valves. The same arrangement exists for the suppression chamber. During normal plant operation the makeup system is used intermittently.

A permanent design modification is to be implemented under PMR 83-536. Although different piping schemes are currently being evaluated, each scheme provides for a minimum of 2 redundant isolation valves in each of the nitrogen makeup lines to the containment. One valve will be powered from and isolated by the Division I power supply. The second valve will be powered from and isolated by the Division II power supply.
