SUBJECT: Supplement to Repair to the Jet Pump
Instrumentation Penetrations

PHILADELPHIA ELECTRIC COMPANY
PEACH BOTTOM ATOMIC POWER STATION
UNIT 3

JULY 23, 1984 REVISIONS TO ATTACHMENT C
SAFETY EVALUATION FOR THE OPERATION OF
PEACH BOTTOM ATOMIC POWER STATION
UNIT 3

SAFETY EVALUATION FOR THE
OPERATION OF PEACH BOTTOM
ATOMIC POWER STATION UNIT 3

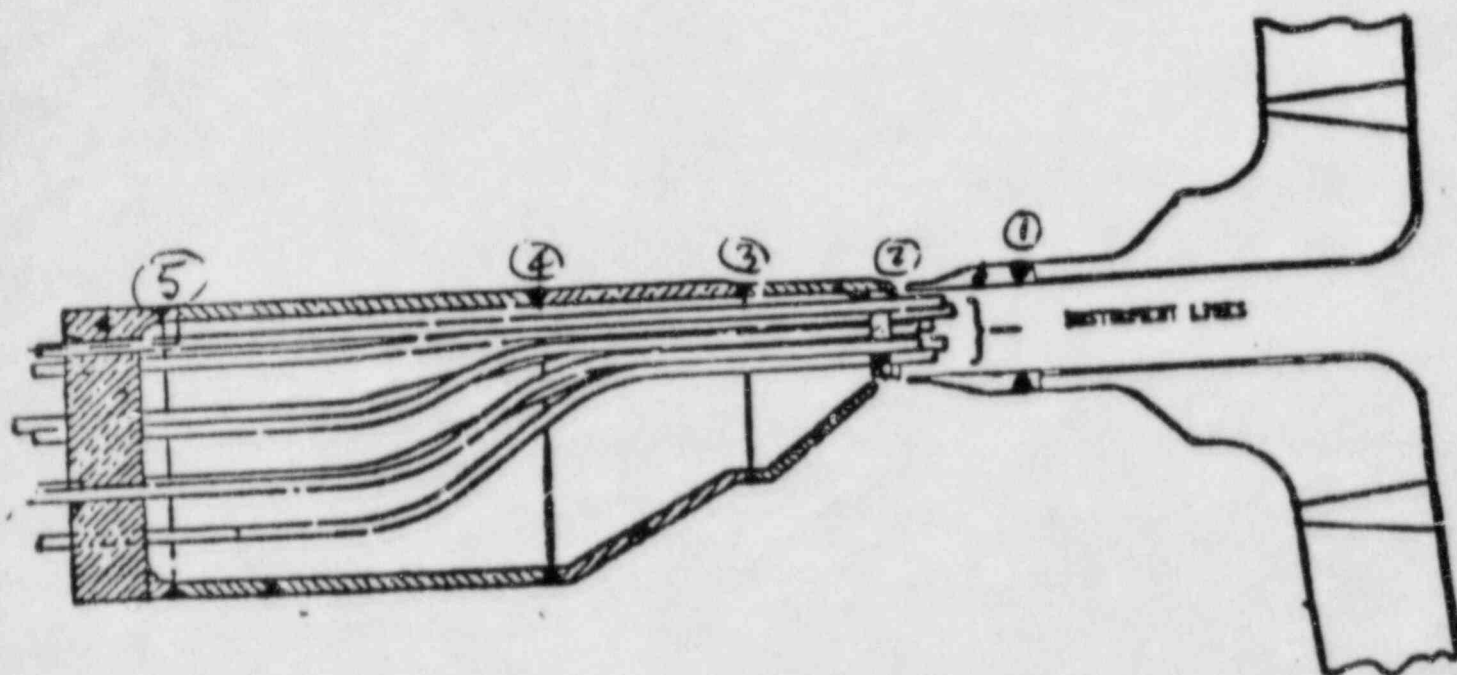
FIGURE 1

Philadelphia Electric Company performed inspections of the Peach Bottom Unit 3 jet pump instrumentation penetrations in response to I.E. Information Notice 84-41 and NRC Generic Letter 84-11. As part of this program, both liquid penetrant and ultrasonic examinations were performed on the five welds associated with each jet pump instrumentation penetration. Circumferential crack-like indications were found on weld No. 2 on each of the two jet pump instrumentation penetrations (see Figure No. 1). In addition to the crack-like indications, the "B" loop No. 2 weld also showed three pin-hole leaks.

The "A" loop circumferential indication was in the 12 o'clock position on the safe-end side of the No. 2 weld. The "B" loop circumferential indication with three pin-hole leaks was in the 12 o'clock position on the reducer side of the No. 2 weld. The pipe material of the eccentric reducer and the safe end at both locations are ASTM A182-F304 and ASTM A336-F8, respectively. Both components are 4" nominal, forged Schedule 80 TP-304 Stainless Steel. The minimal wall thickness of these piping components is 0.337".

JET PUMP INSTRUMENTATION
SEAL AND SAFE END

General Electric Company recommended applying a 0.125" thick by 1.5" wide full circumferential overlay on each weld to assure leak-free operation for a minimum of 18 months of full power operation.
