LOUISIANA POWER AND LIGHT COMPANY
WATERFORD STEAM ELECTRIC STATION
UNIT NO. 3
NPIS WALL HAIRLINE CRACKS EVALUATION

APRIL 1984

EBASCO SERVICES INCORPORATED
2 WORLD TRADE CENTER
NEW YORK, N.Y. 10048

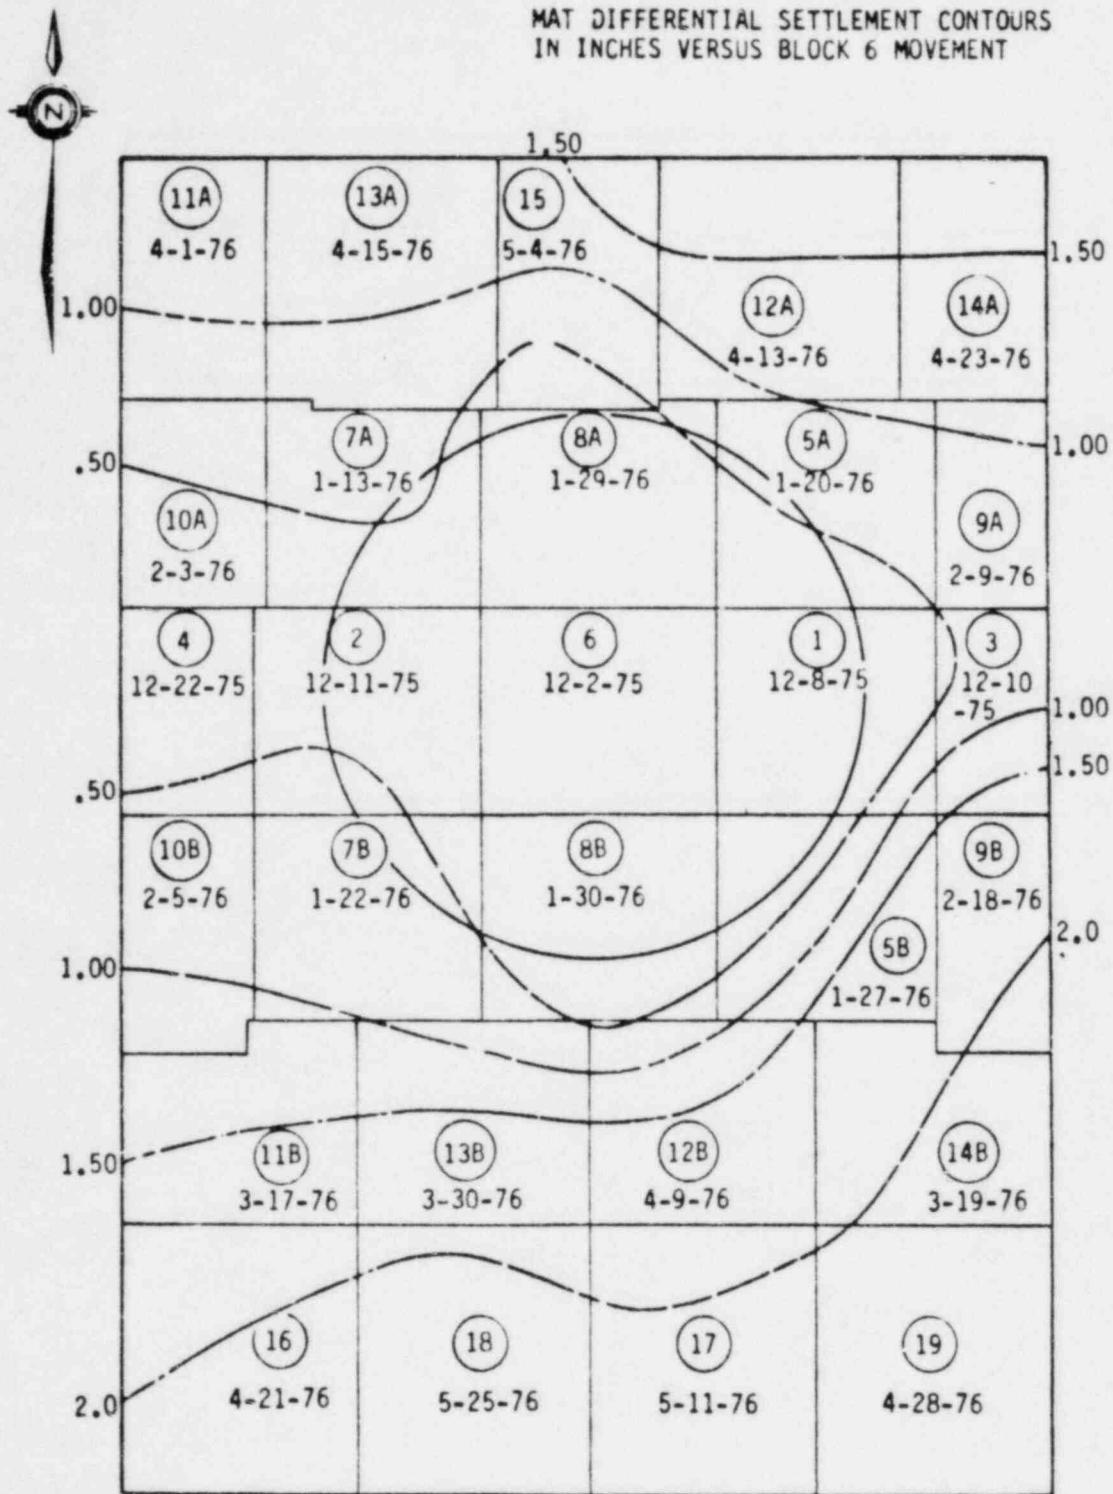
The entire common foundation mat was constructed following a checker board sequence consisting of 28 block placements, over a period of six (6) months. Figure 1 shows the sequence of basemat block placement with dates.

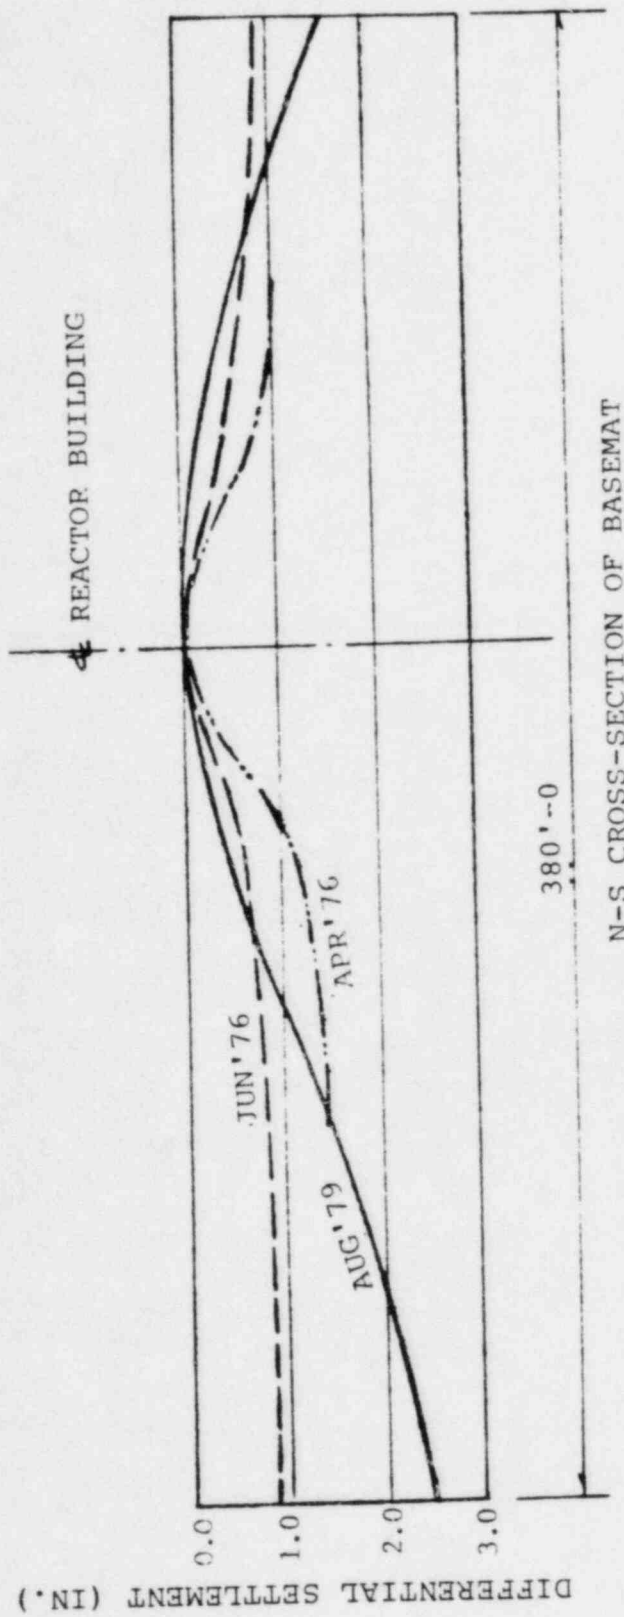
The convex shape was observed both in E-W and N-S direction, with the curvature being made pronounced in N-S direction. Figure 2 shows a generalized curvature of basemat in N-S direction at 3 key construction stages.

In April 1976, just prior to construction of Reactor Building shield wall the maximum curvature of the basemat in N-S direction was such that the center was 1 inch to 1 1/4 inches higher than the extreme edges of the mat. (At this time portions of the base mat, ie, block Nos. 15, 16, 17, 18 and 19 were not placed).

In June 1976, after the completion of Reactor Building shield wall and the remaining mat concrete, there was a slight reduction in the maximum curvature beneath the shield wall area, and resulted in a decrease of over-all differential settlement.

With additional loads added by NPIS concrete and recharging of water table, the settlement process continued, however, the mat maintained its general convex shape with only minor curvature readjustment. The mat settlement process stabilized with completion of NPIS concrete and ground water table restored to normal condition in mid 1979. Since then, no further significant net or differential settlement has occurred.

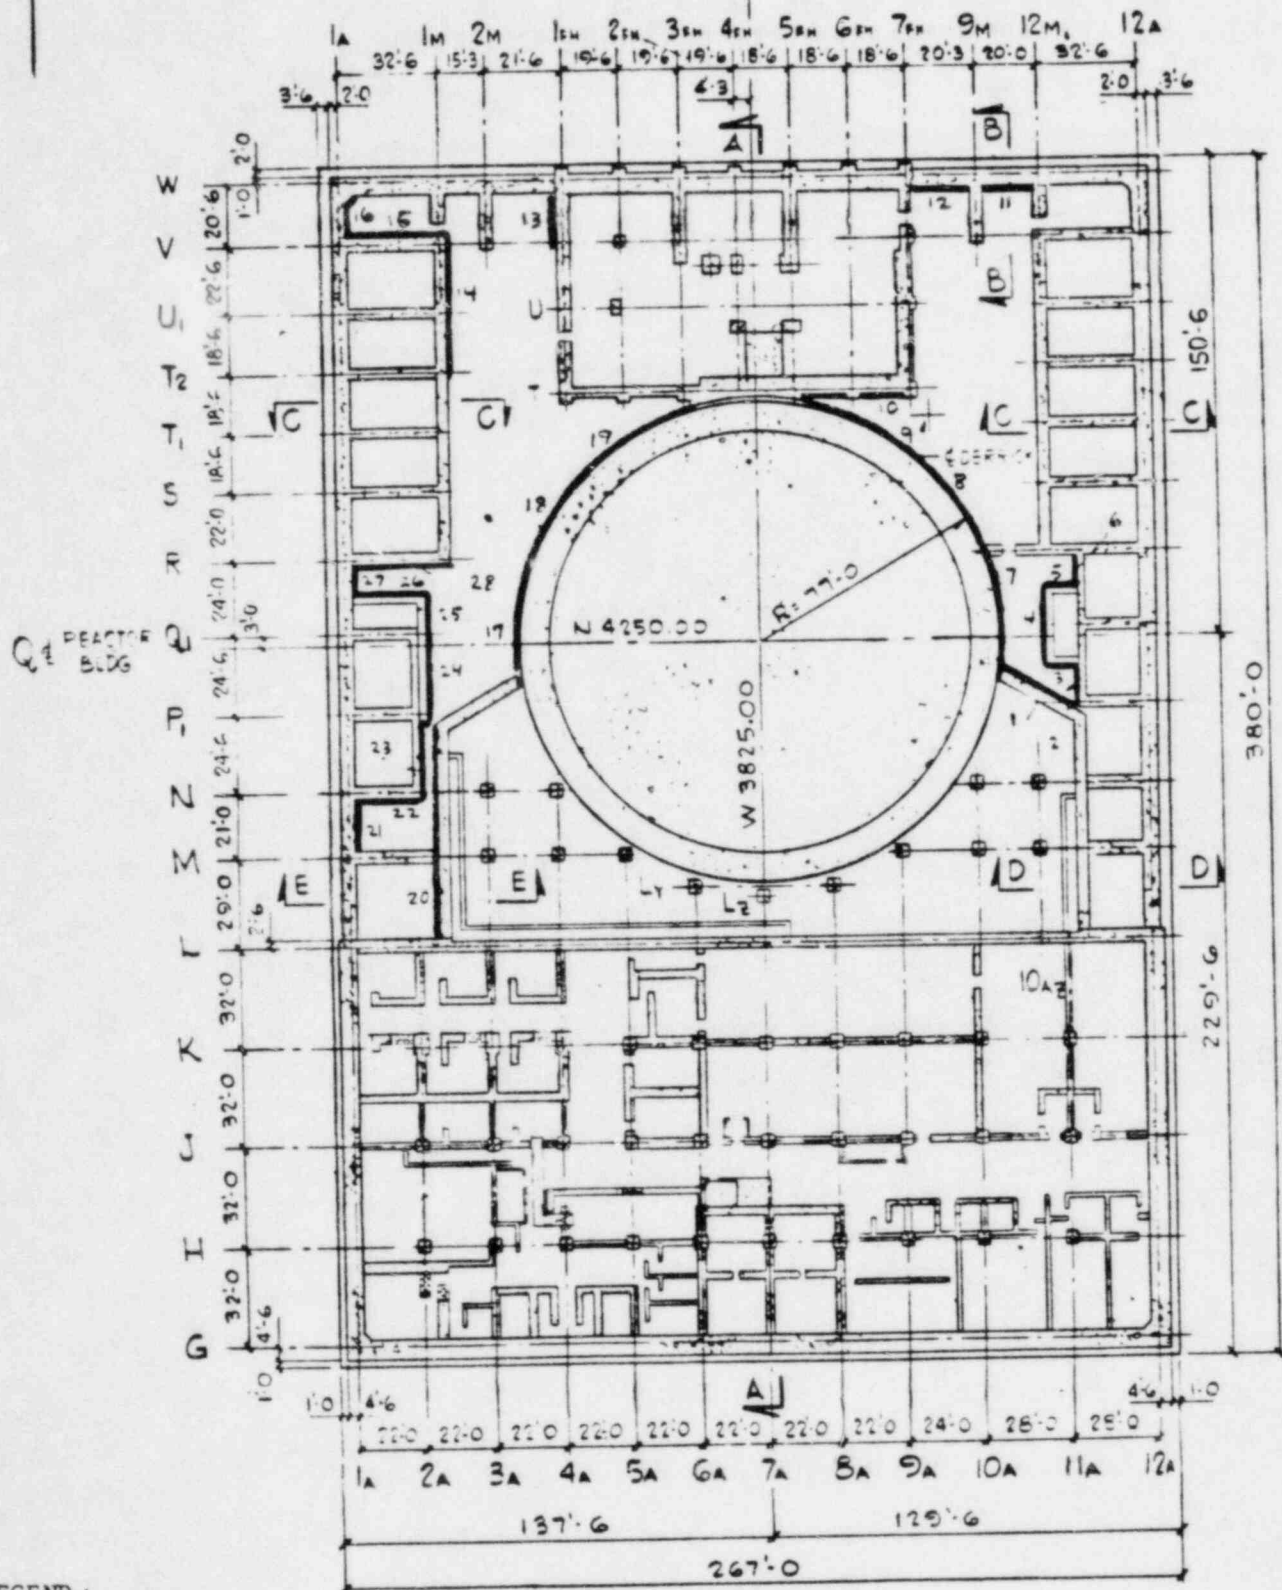
Figure 3

A detailed mapping of the wall hairline cracks of the NPIS was performed during the week of April 2, 1984, in accordance with a prescribed mapping procedure (Appendix A). The mapping was conducted for all accessible and exposed walls at the interface with and up to 10 ft above the top of the basemat El-35.0 ft. The results of wall hairline crack maps are presented in Appendix B. A plan of the mapped walls is presented in Figure 3. For photographs of cracks, see Appendix "D".

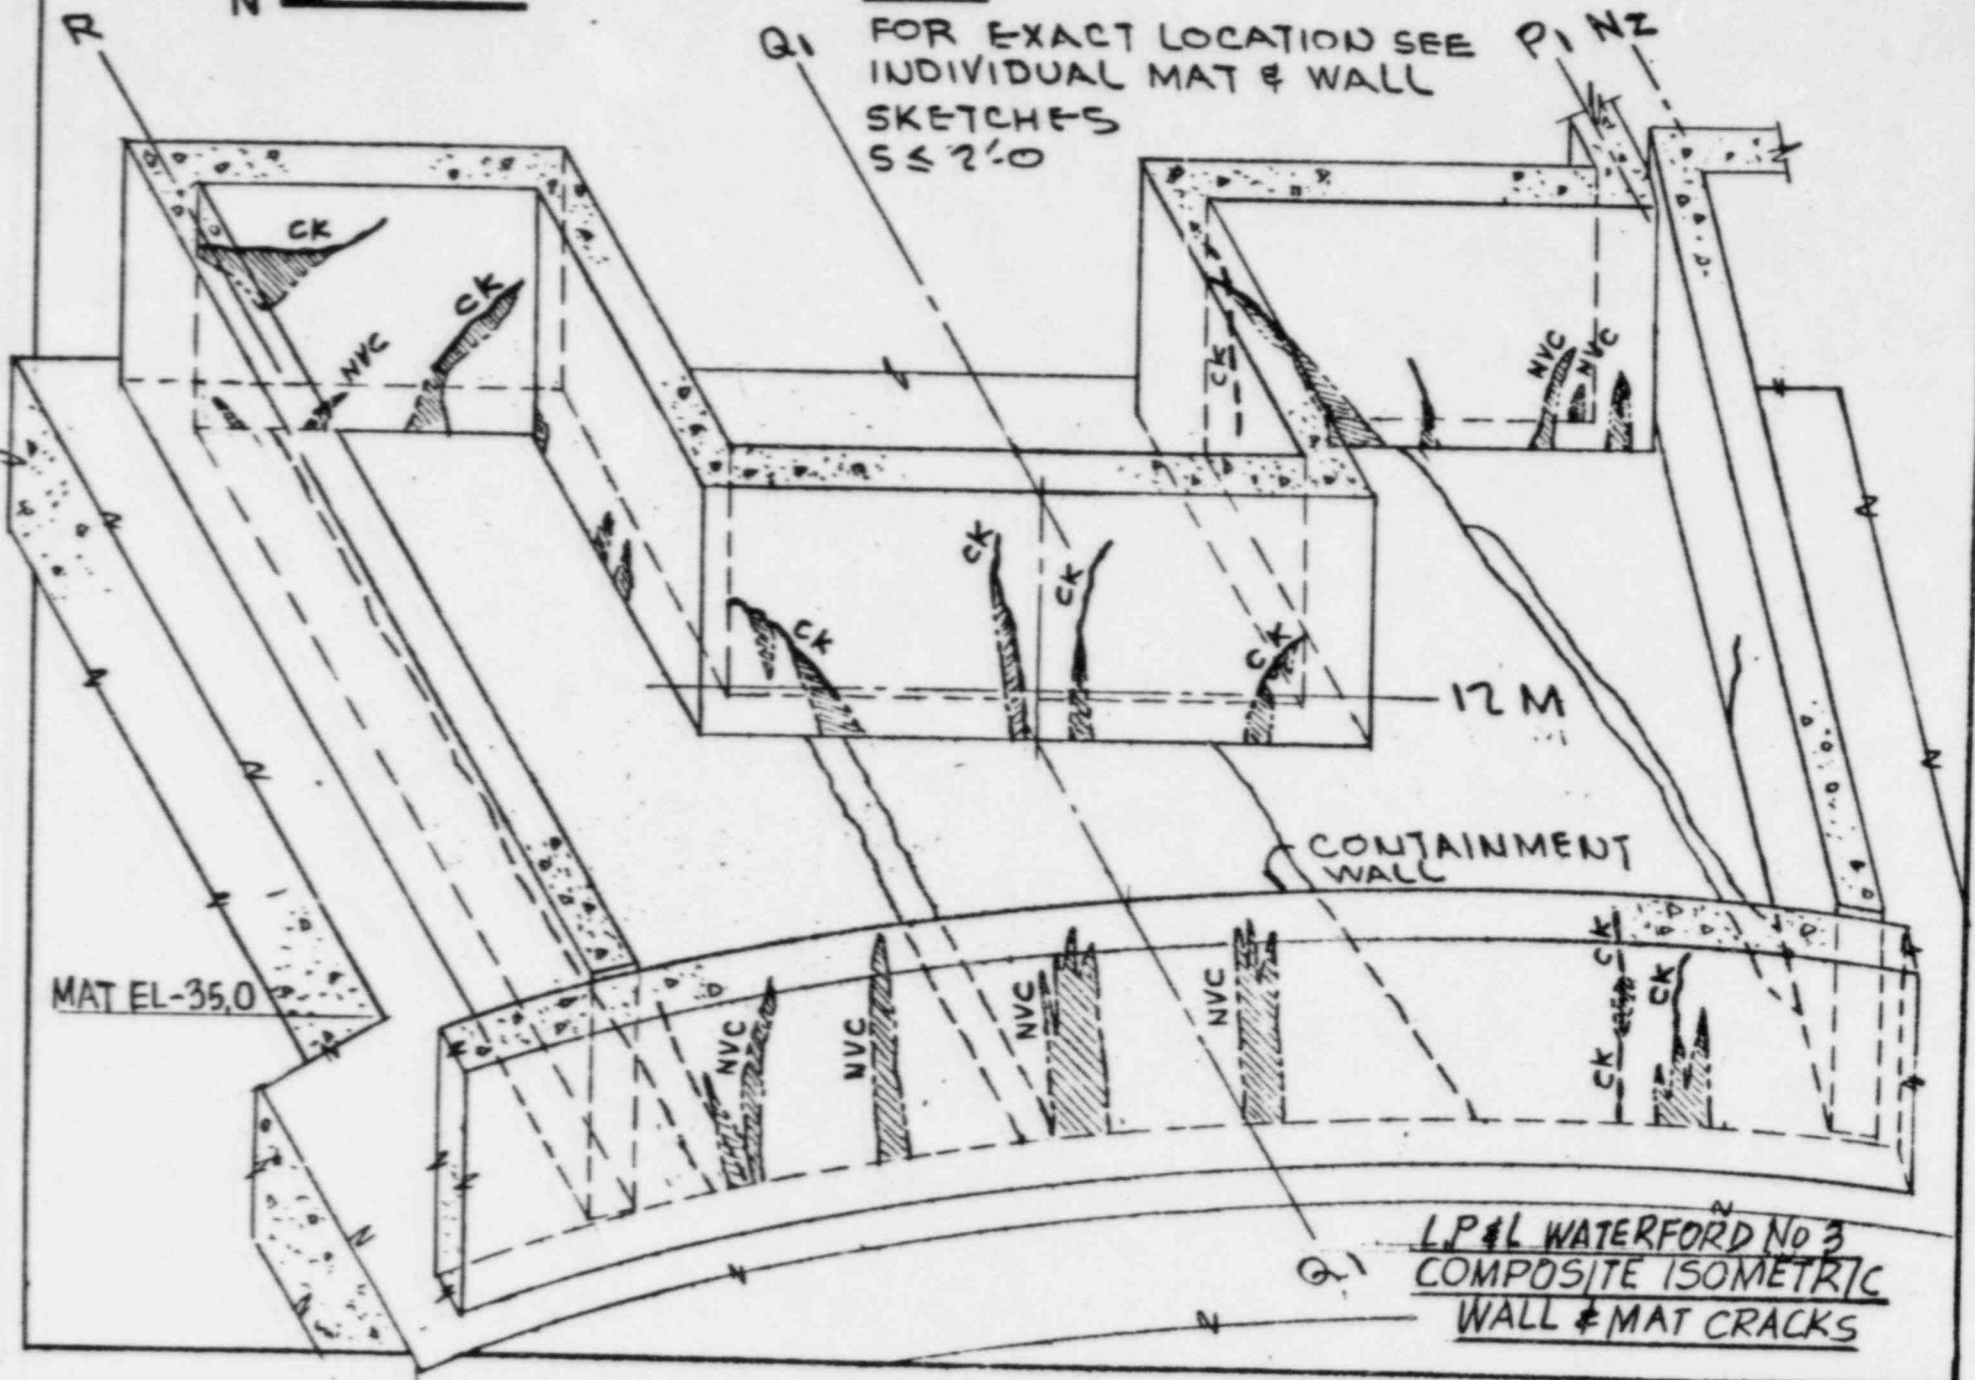
BY: A. NACCARELLA SHEET 2 OF 5
CHKD BY: G. WU DATE: 4/3/84

1. Hairline cracks at the interface are not generally found to be inter-connected or even closely inter-related (spacing less than two feet).
2. Only three localized areas were found with floor and wall cracks in close proximity:
 - a) Reactor Building ring wall, north-east quadrant (sheet 1, Appendix C)
 - b) East Wet Cooling Tower walls (Sh 2, Appendix C)
 - c) West Wet Cooling Tower walls (Sh 4&5, Appendix C)

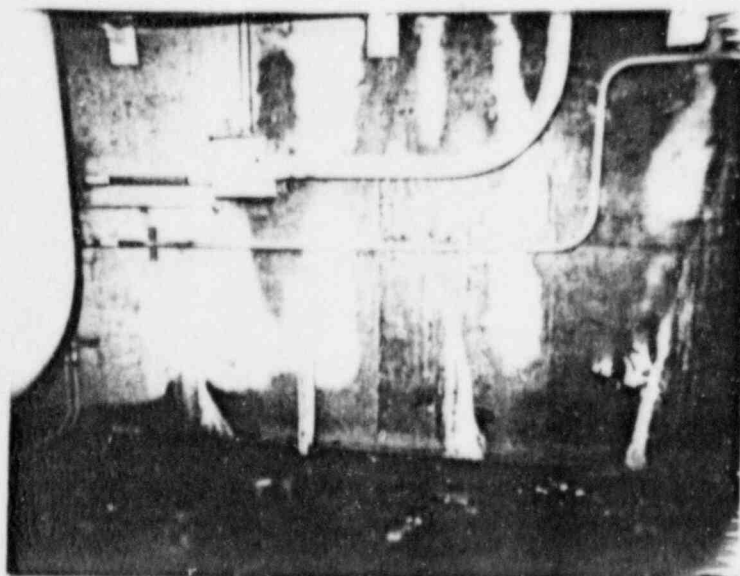
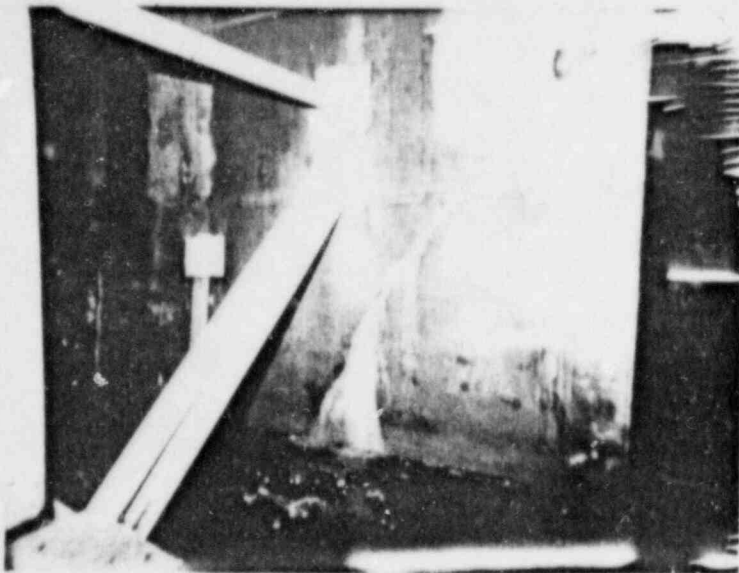
4

Leachate accumulations on the Wet Cooling Tower walls was apparently caused by seepage of water from the cooling tower basins (water level at - 9.0 ft).

EAST WET COOLING TOWER WALLS

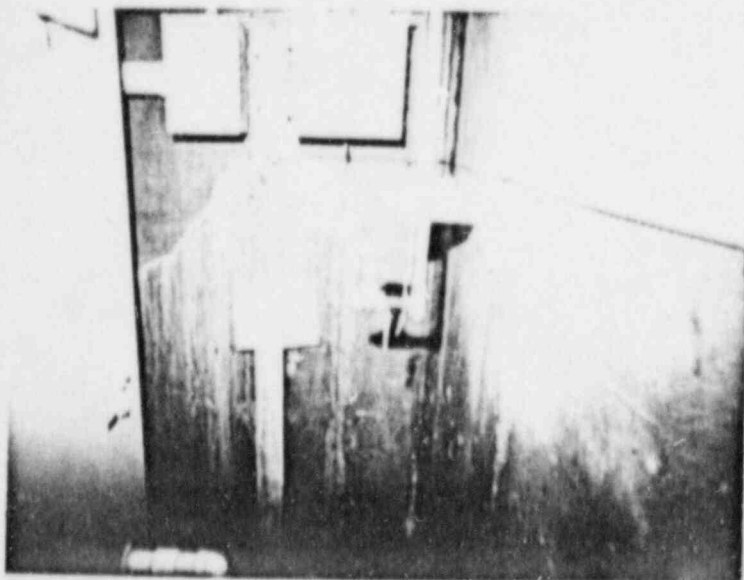
6

EAST WET COOLING TOWER WALLS

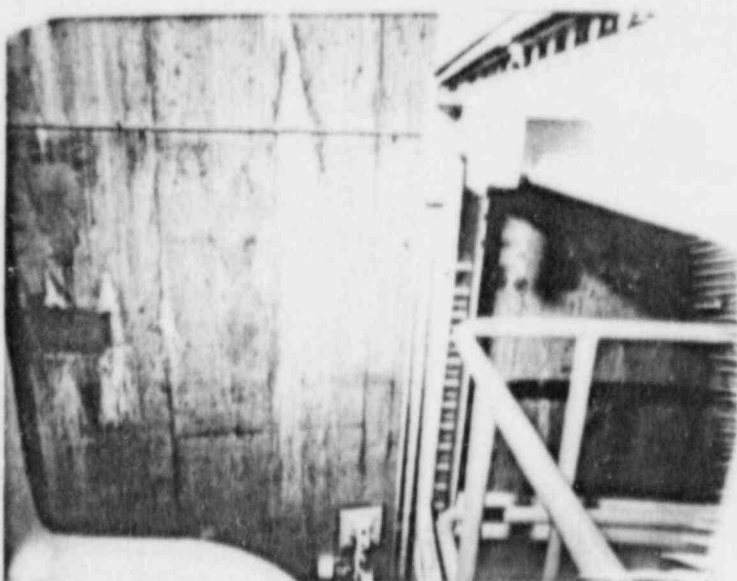
9

Leachate accumulations on the ring wall were caused by long term ponding of rain and construction water at the top of ring wall. Seepage of water was also facilitated by open pipe sleeves (El-18.0 ft) which were interconnected with the embedded structural steel system used as temporary support during construction.

REACTOR BUILDING RING WALL
(NORTH EAST QUADRANT)

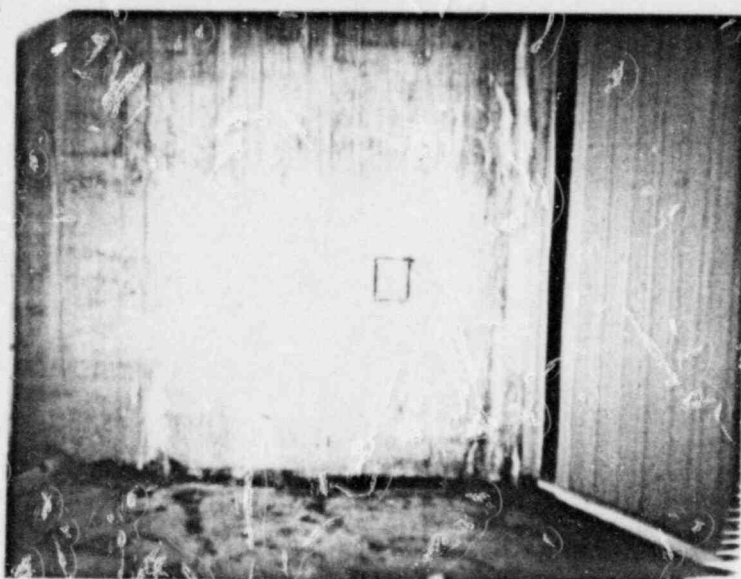
19

REACTOR BUILDING RING WALL
(NORTH WEST QUADRANT)

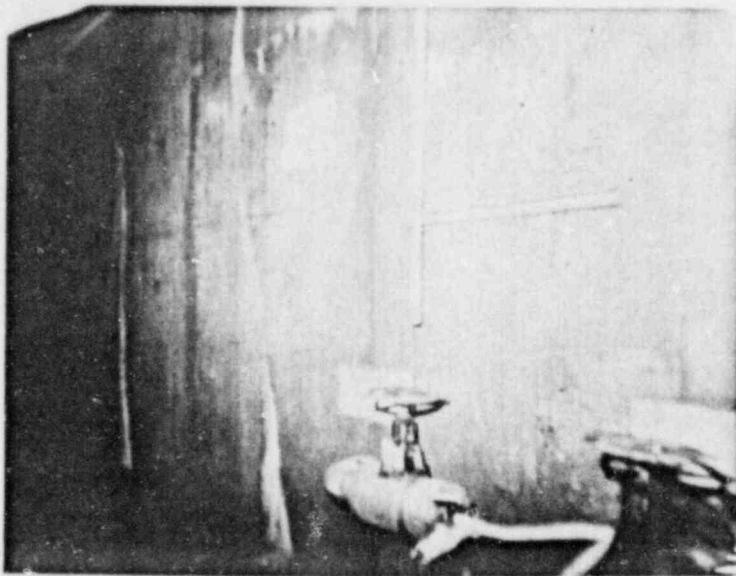
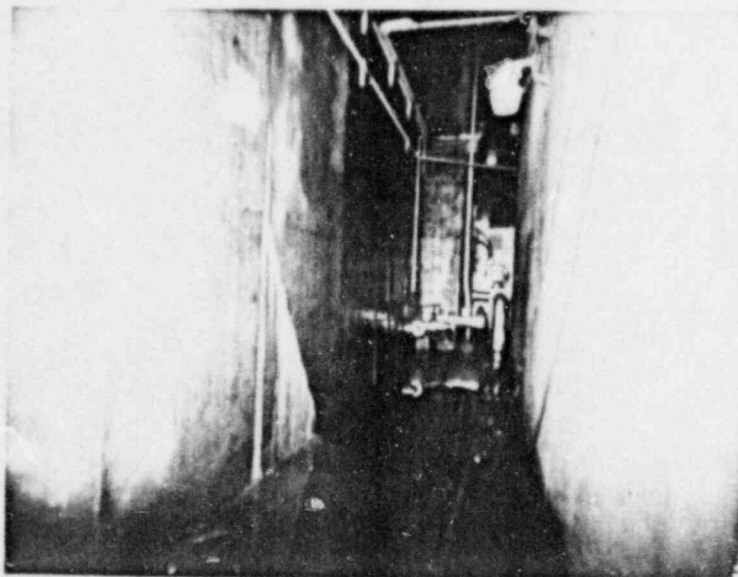
23

WEST WET COOLING TOWER WALL
