Iowa Electric Light and Power Company

Subject: Duane Arnold Energy Center  
Docket No: 50-331  
Op. License DPR-49  
Licensee Event Report #92-003

FACILITY NAME (1)										DOCKET NUMBER (2)										PAGE (3)																																							
Duane Arnold Energy Center										05000331										0016																																							
TITLE (4) Fire Barrier Degraded as a Result of an Unsealed Penetration following a Design Modification																																																											
EVENT DATE (5)										LER NUMBER (6)										REPORT DATE (7)										OTHER FACILITIES INVOLVED (8)																													
MONTH			DAY			YEAR				SEQUENTIAL NUMBER			REVISION NUMBER			MONTH			DAY			YEAR				FACILITY NAMES										DOCKET NUMBER (5)																							
																										None										05000331																							
02			11			1929				003						03			12			1929														05000331																							
OPERATING MODE (9) N										THIS REPORT IS SUBMITTED PURSUANT TO THE REQUIREMENTS OF 10 CFR 5. (Check one or more of the following) (11)

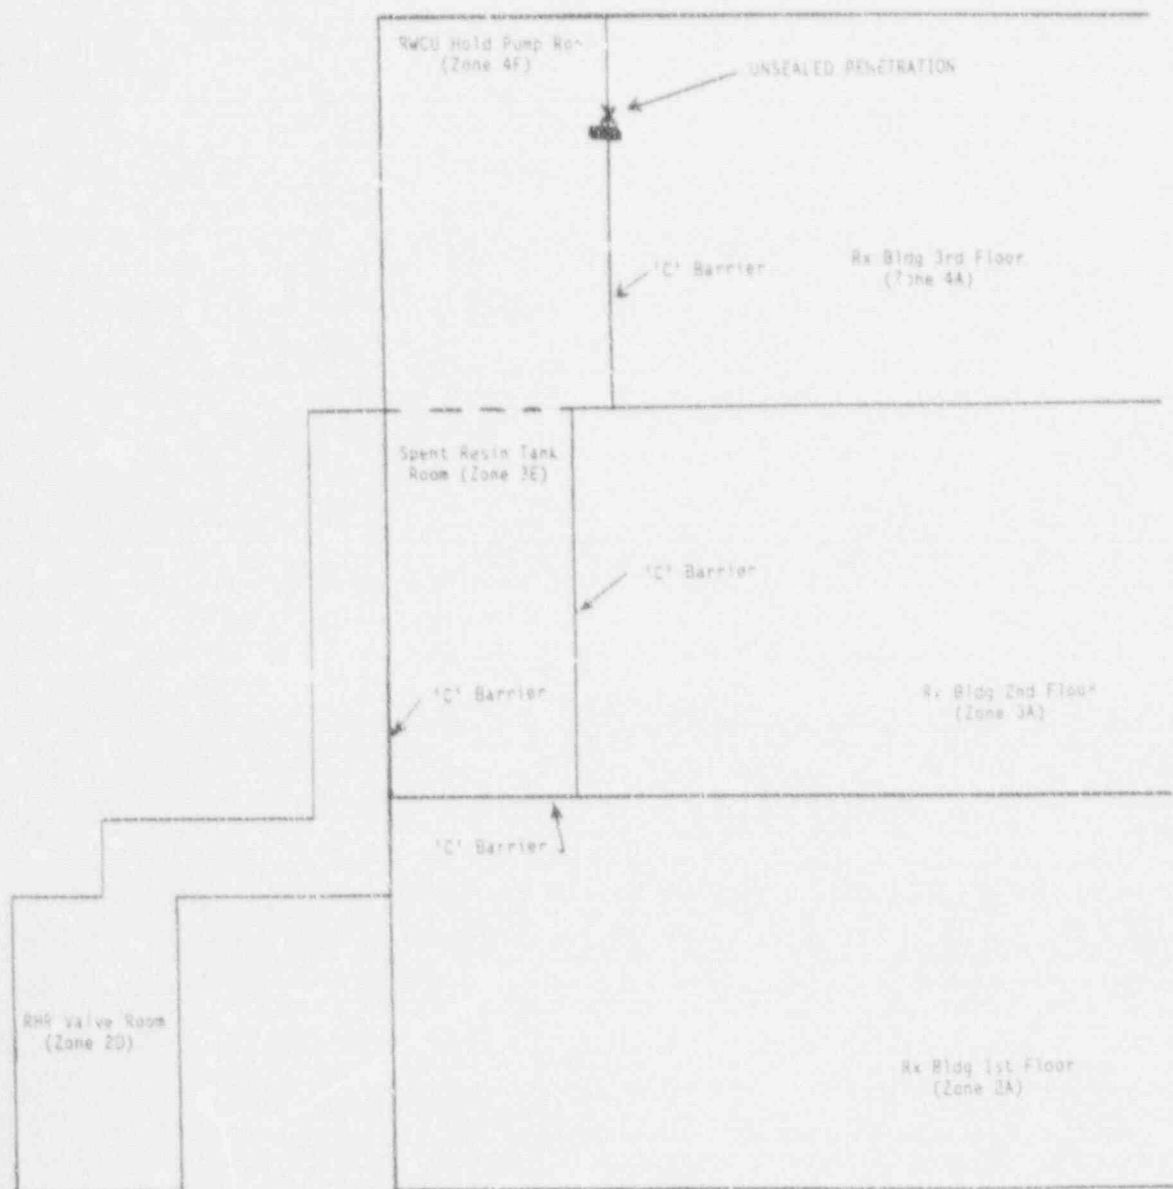
RELATIVE POSITIONS OF APPLICABLE FIRE ZONES AND BARRIERS  
(diagram does not represent actual room sizes or locations)

On 2/11/92, during performance of the fire barrier penetration seal inspection surveillance test, a fire barrier cable penetration was found unsealed. The penetration is rectangular in shape, approximately 4 inches tall by 6 inches wide cut through the concrete block wall which separates the open area of the third floor of the reactor building (fire zone 4A) from the Reactor Water Cleanup (RWCU) hold pump room (fire zone 4F). It is positioned directly above a ladder type steel tray penetration such that it increases the size of the original tray penetration. The tray penetration is located approximately 15 feet above the floor and is approximately 18 inches wide and 4 inches tall. Several electrical cables and one 1/2 inch conduit are run through the open penetration.

The barrier in question, which the DAEC classifies as a type "C" (see note 1) fire barrier, is used to meet 10 CFR 50 Appendix R separation requirements for safe shutdown equipment. When "C" barriers are used to meet Appendix R requirements, more than one "C" barrier must be intact between the safe shutdown equipment fire zones. The fire zones which did not meet the separation requirement due to the inoperable "C" barrier caused by the unsealed fire penetration are zones 4A (reactor building third floor) and 3A (reactor building second floor), zones 4A and 2D (Residual Heat Removal (RHR) valve room), and zones 4A and 2A (first floor reactor building). The two fire zones (4F-RWCU hold pump room and 3E-spent resin tank room) which a fire must pass through to get from zone 4A to any of the above mentioned zones do not contain safe shutdown equipment. (see attached diagram)
