In the Matter of  
Louisiana Power & Light Company  
(Waterford Steam Electric Station, Unit 3)  
Docket No. 50-382

SUBJECT: Waterford 3 SES  
Docket No. 50-382  
Additional Information on NPIS Basemat Cracks

LOUISIANA POWER AND LIGHT COMPANY  
WATERFORD STEAM ELECTRIC STATION  
UNIT NO.3  
NPIS WALL HAIRLINE CRACKS EVALUATION

Subject: Waterford III SES  
Analysis of Cracks and Water Seepage in Foundation  
Review of Wall Cracking

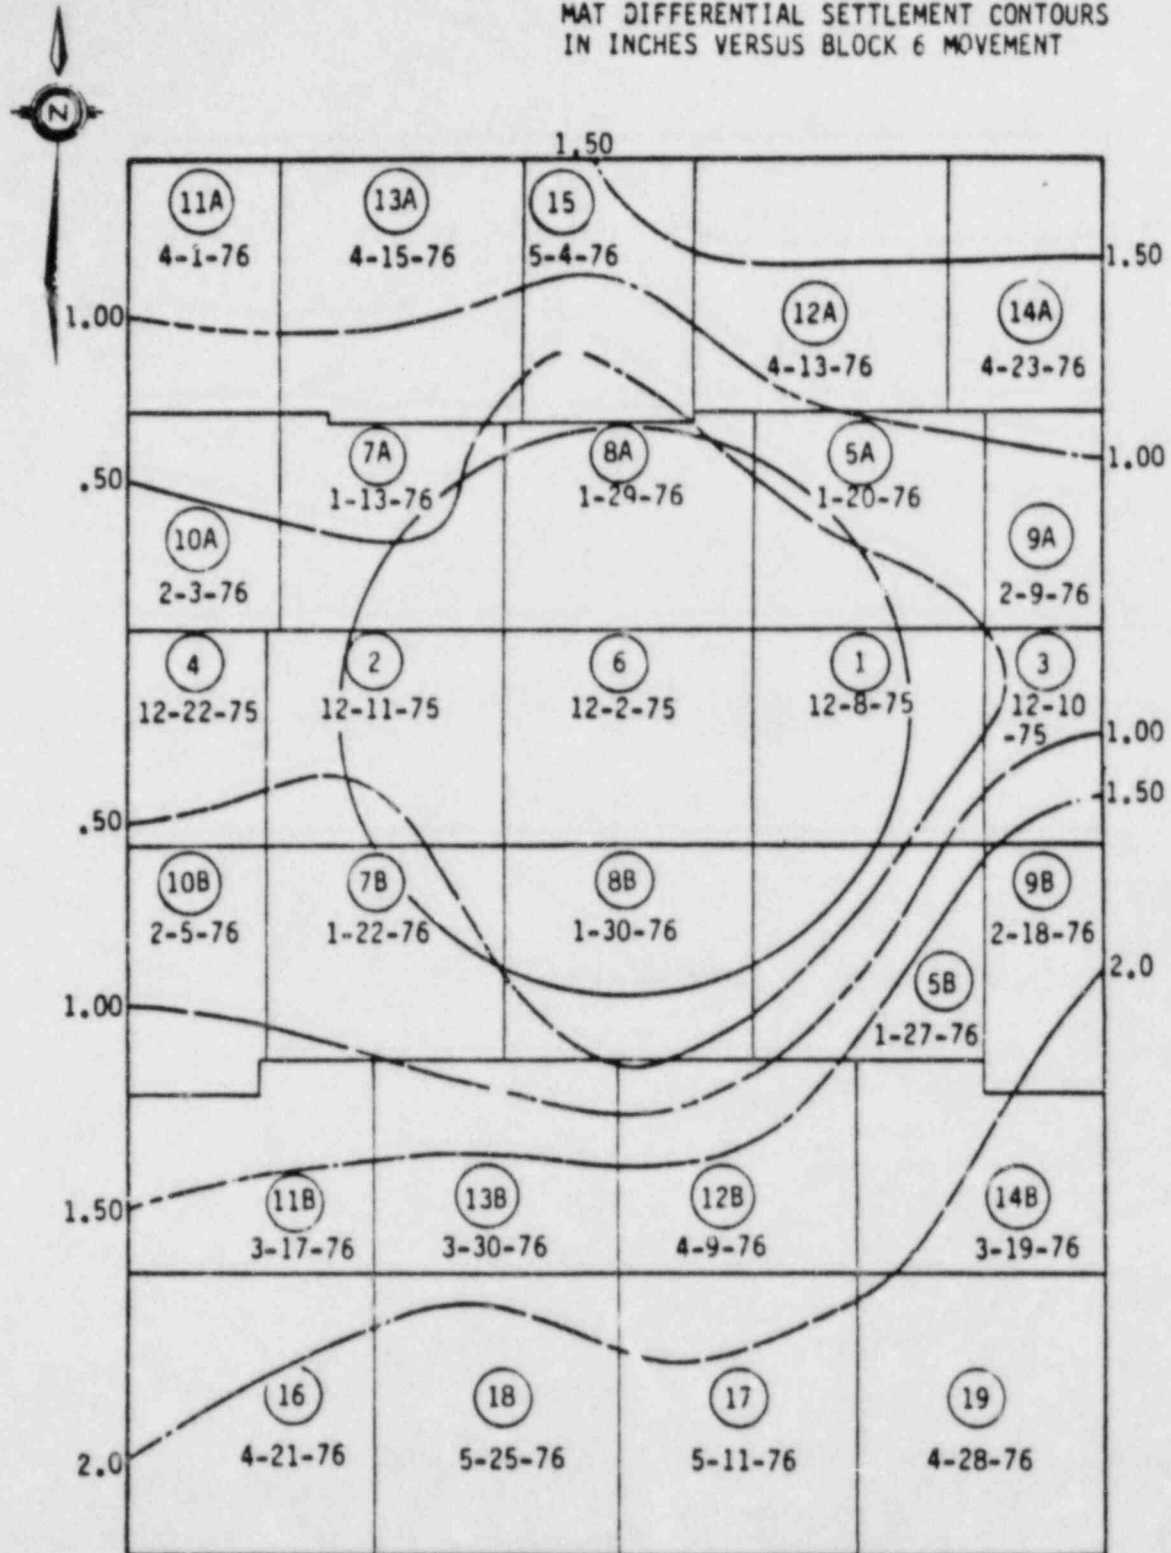
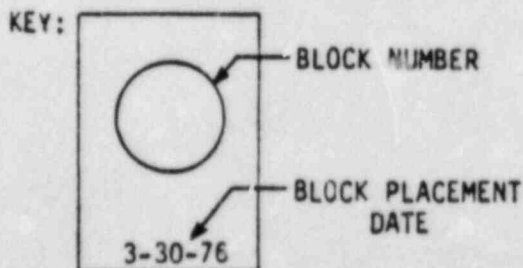
The entire common foundation mat was constructed following a checker board sequence consisting of 28 block placements, over a period of six (6) months. Figure 1 shows the sequence of basemat block placement with dates.

WATERFORD SES UNIT NO. 3  
BASEMAT PLACEMENT SEQUENCE AND  
DIFFERENTIAL SETTLEMENT CONTOURS

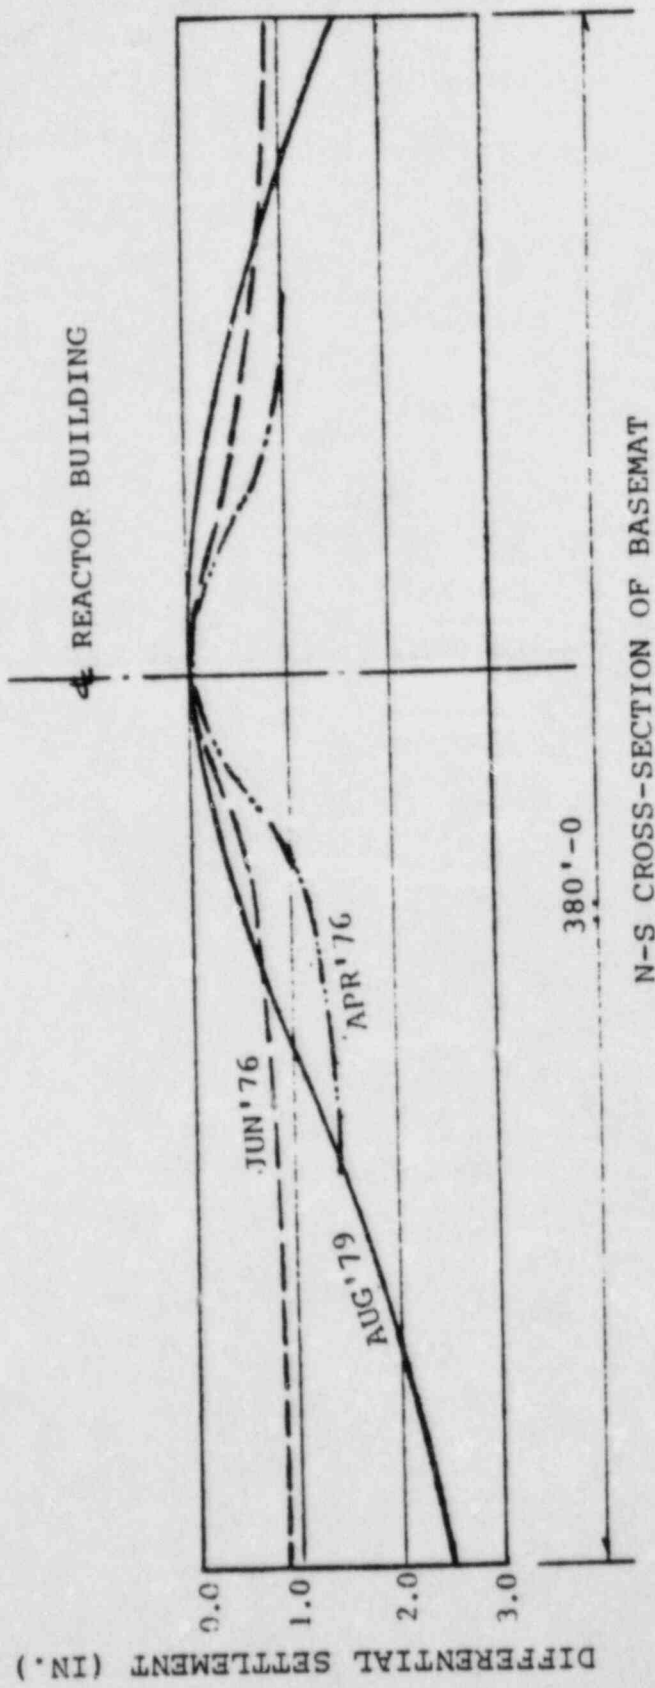
The convex shape was observed both in E-W and N-S direction, with the curvature being more pronounced in N-S direction. Figure 2 shows a generalized curvature of basemat in N-S direction at 3 key construction stages.

NOTE: VERTICAL EXAGGERATION = 300

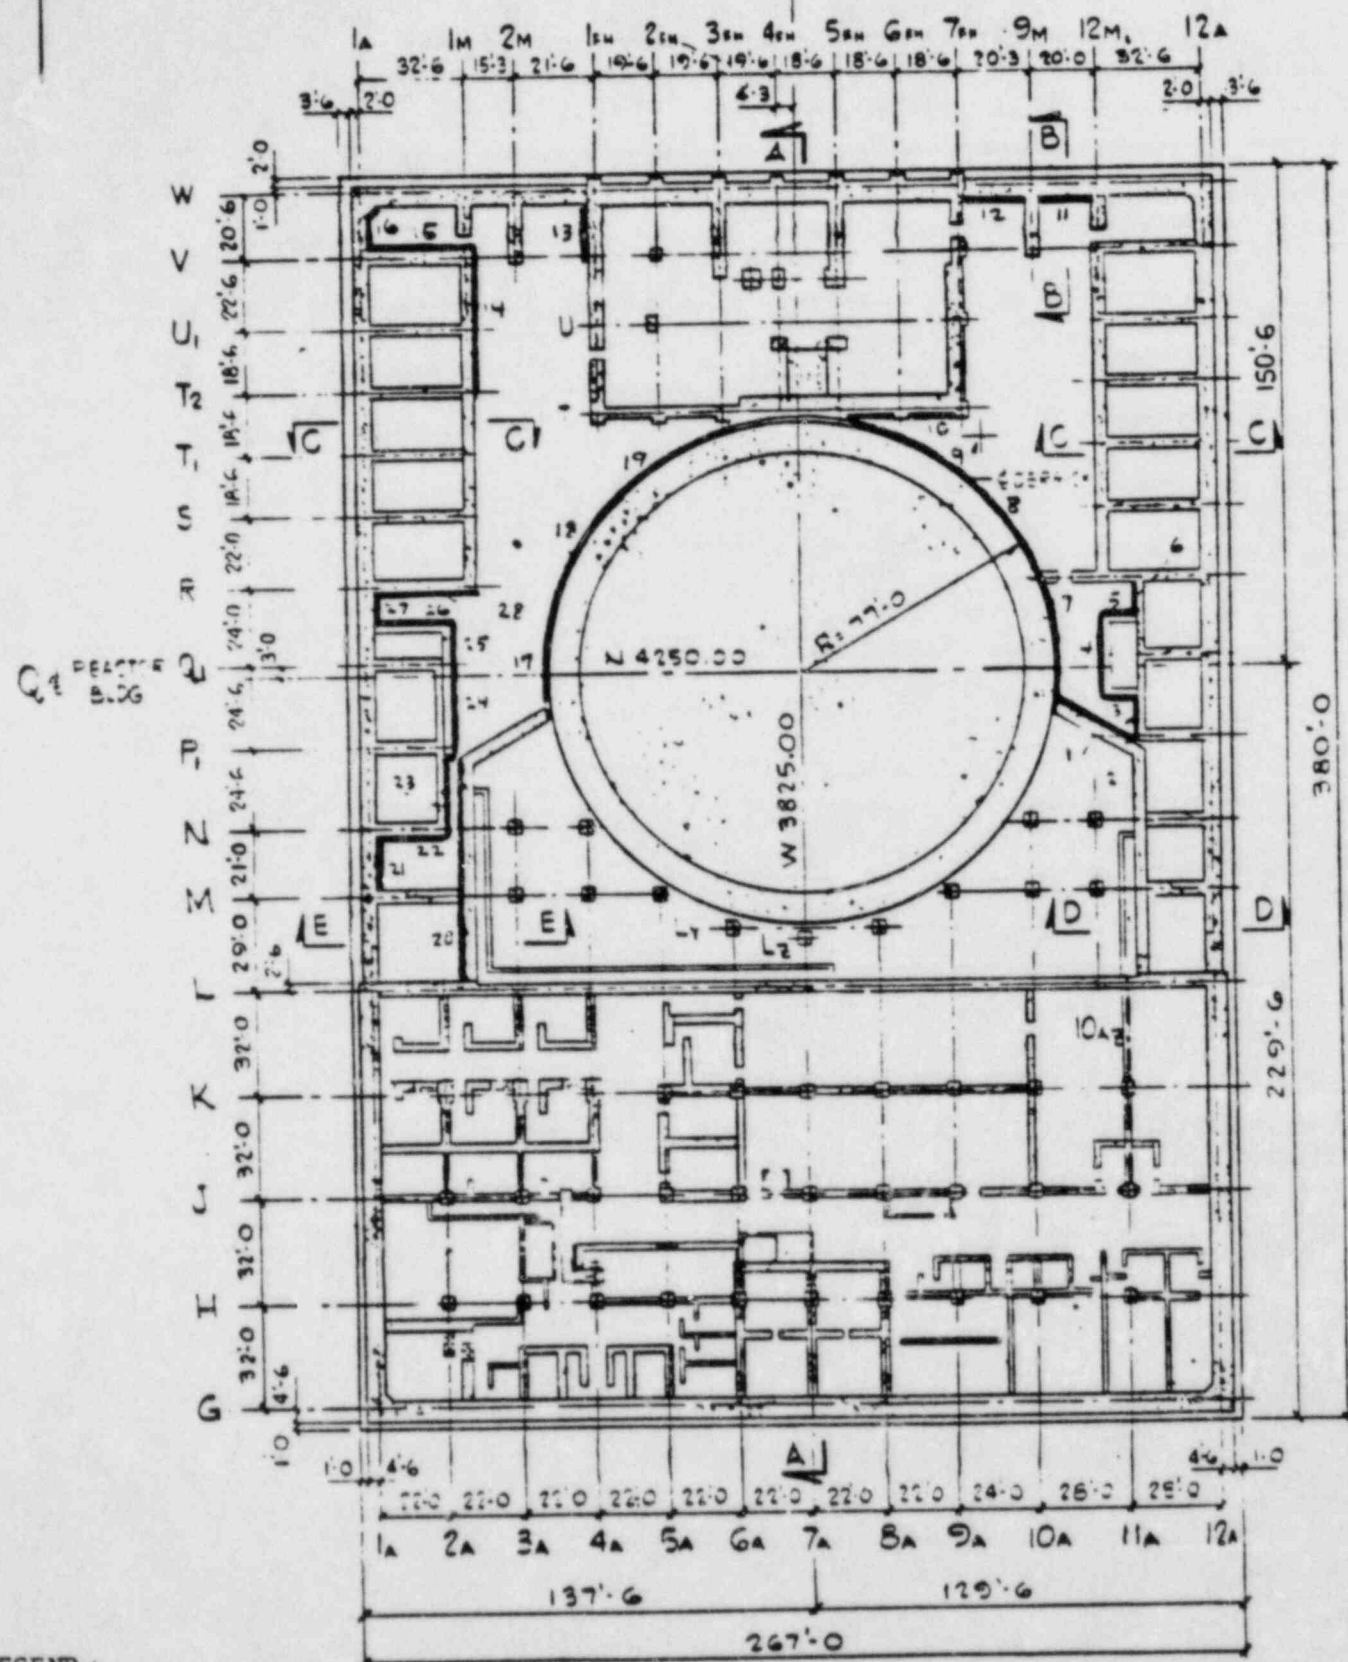
A detailed mapping of the wall hairline cracks of the NPIS was performed during the week of April 2, 1984, in accordance with a prescribed mapping procedure (Appendix A). The mapping was conducted for all accessible and exposed walls at the interface with and up to 10 ft above the top of the basemat El-35.0 ft. The results of wall hairline crack maps are presented in Appendix B. A plan of the mapped walls is presented in Figure 3. For photographs of cracks, see Appendix "D".

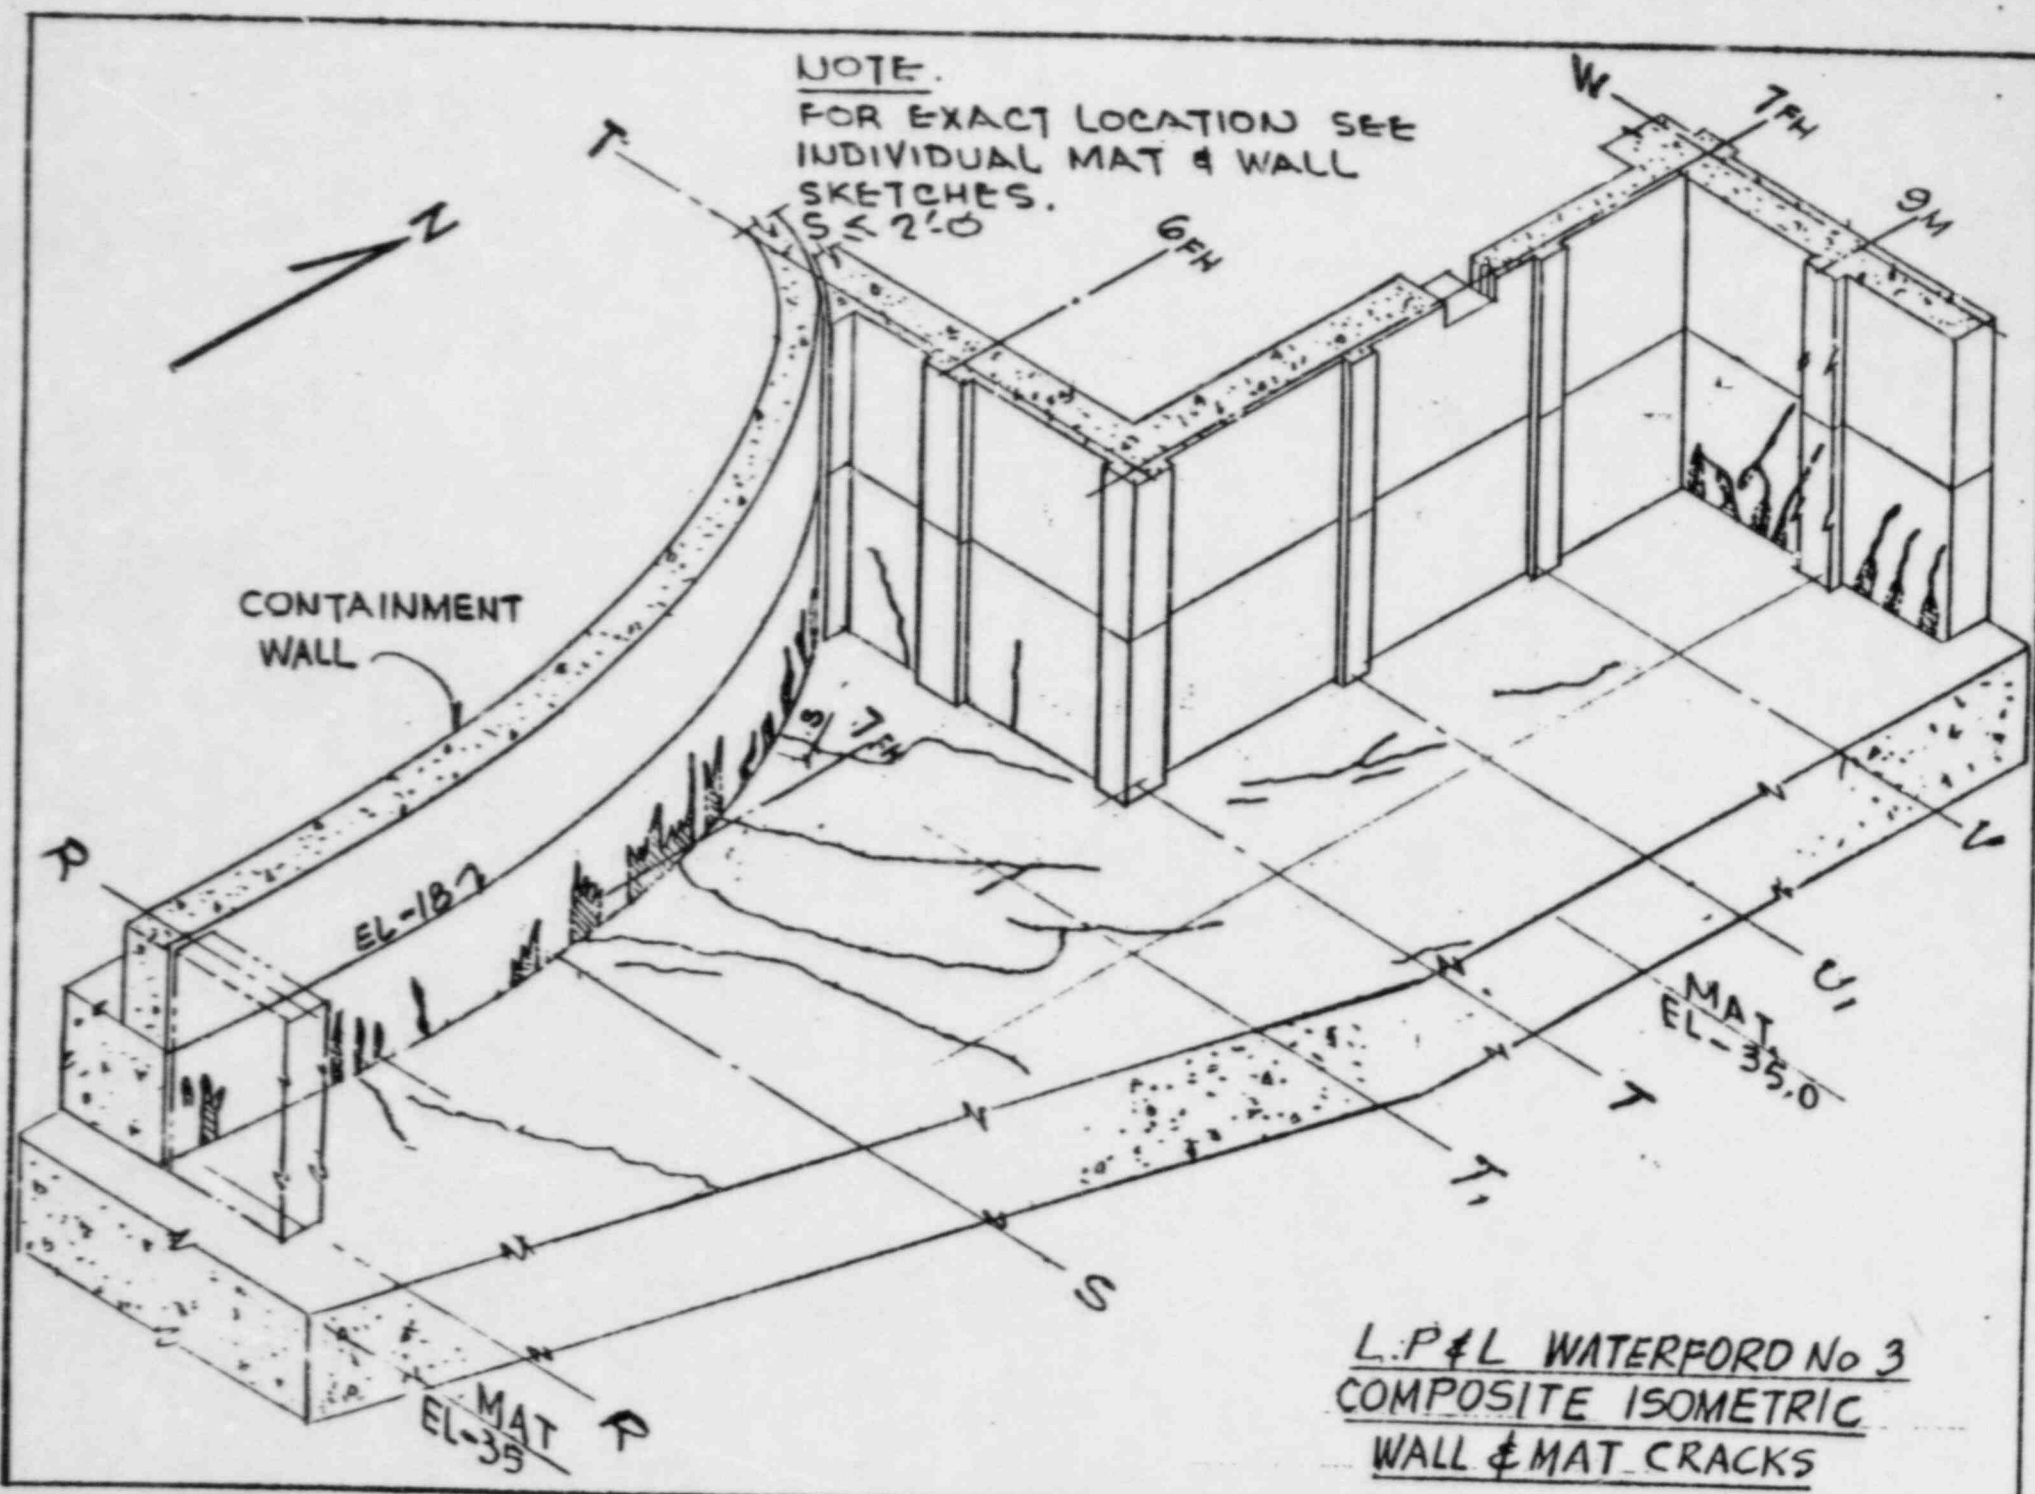
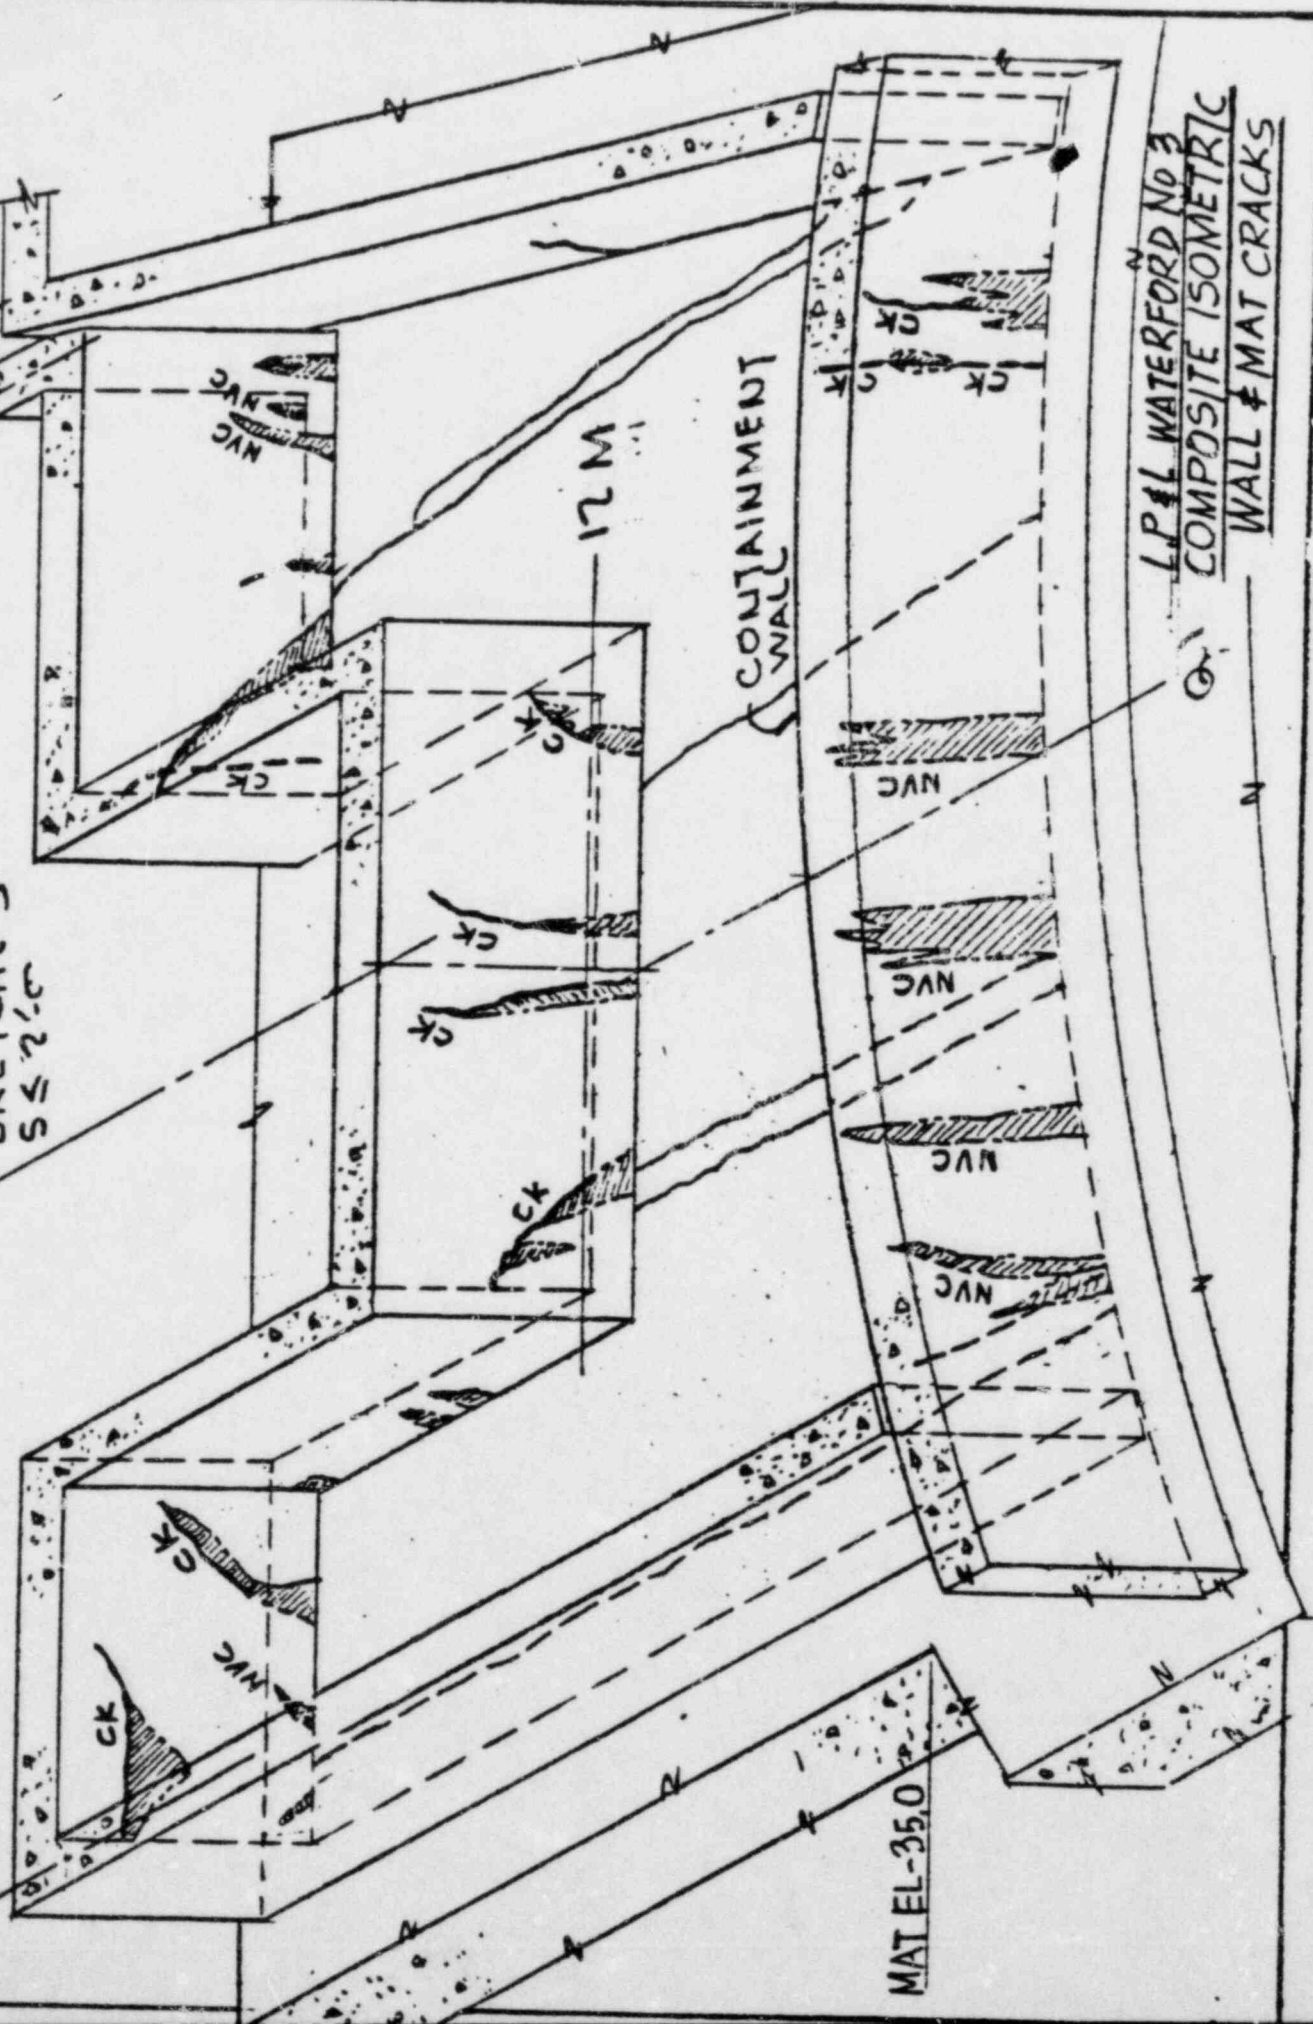
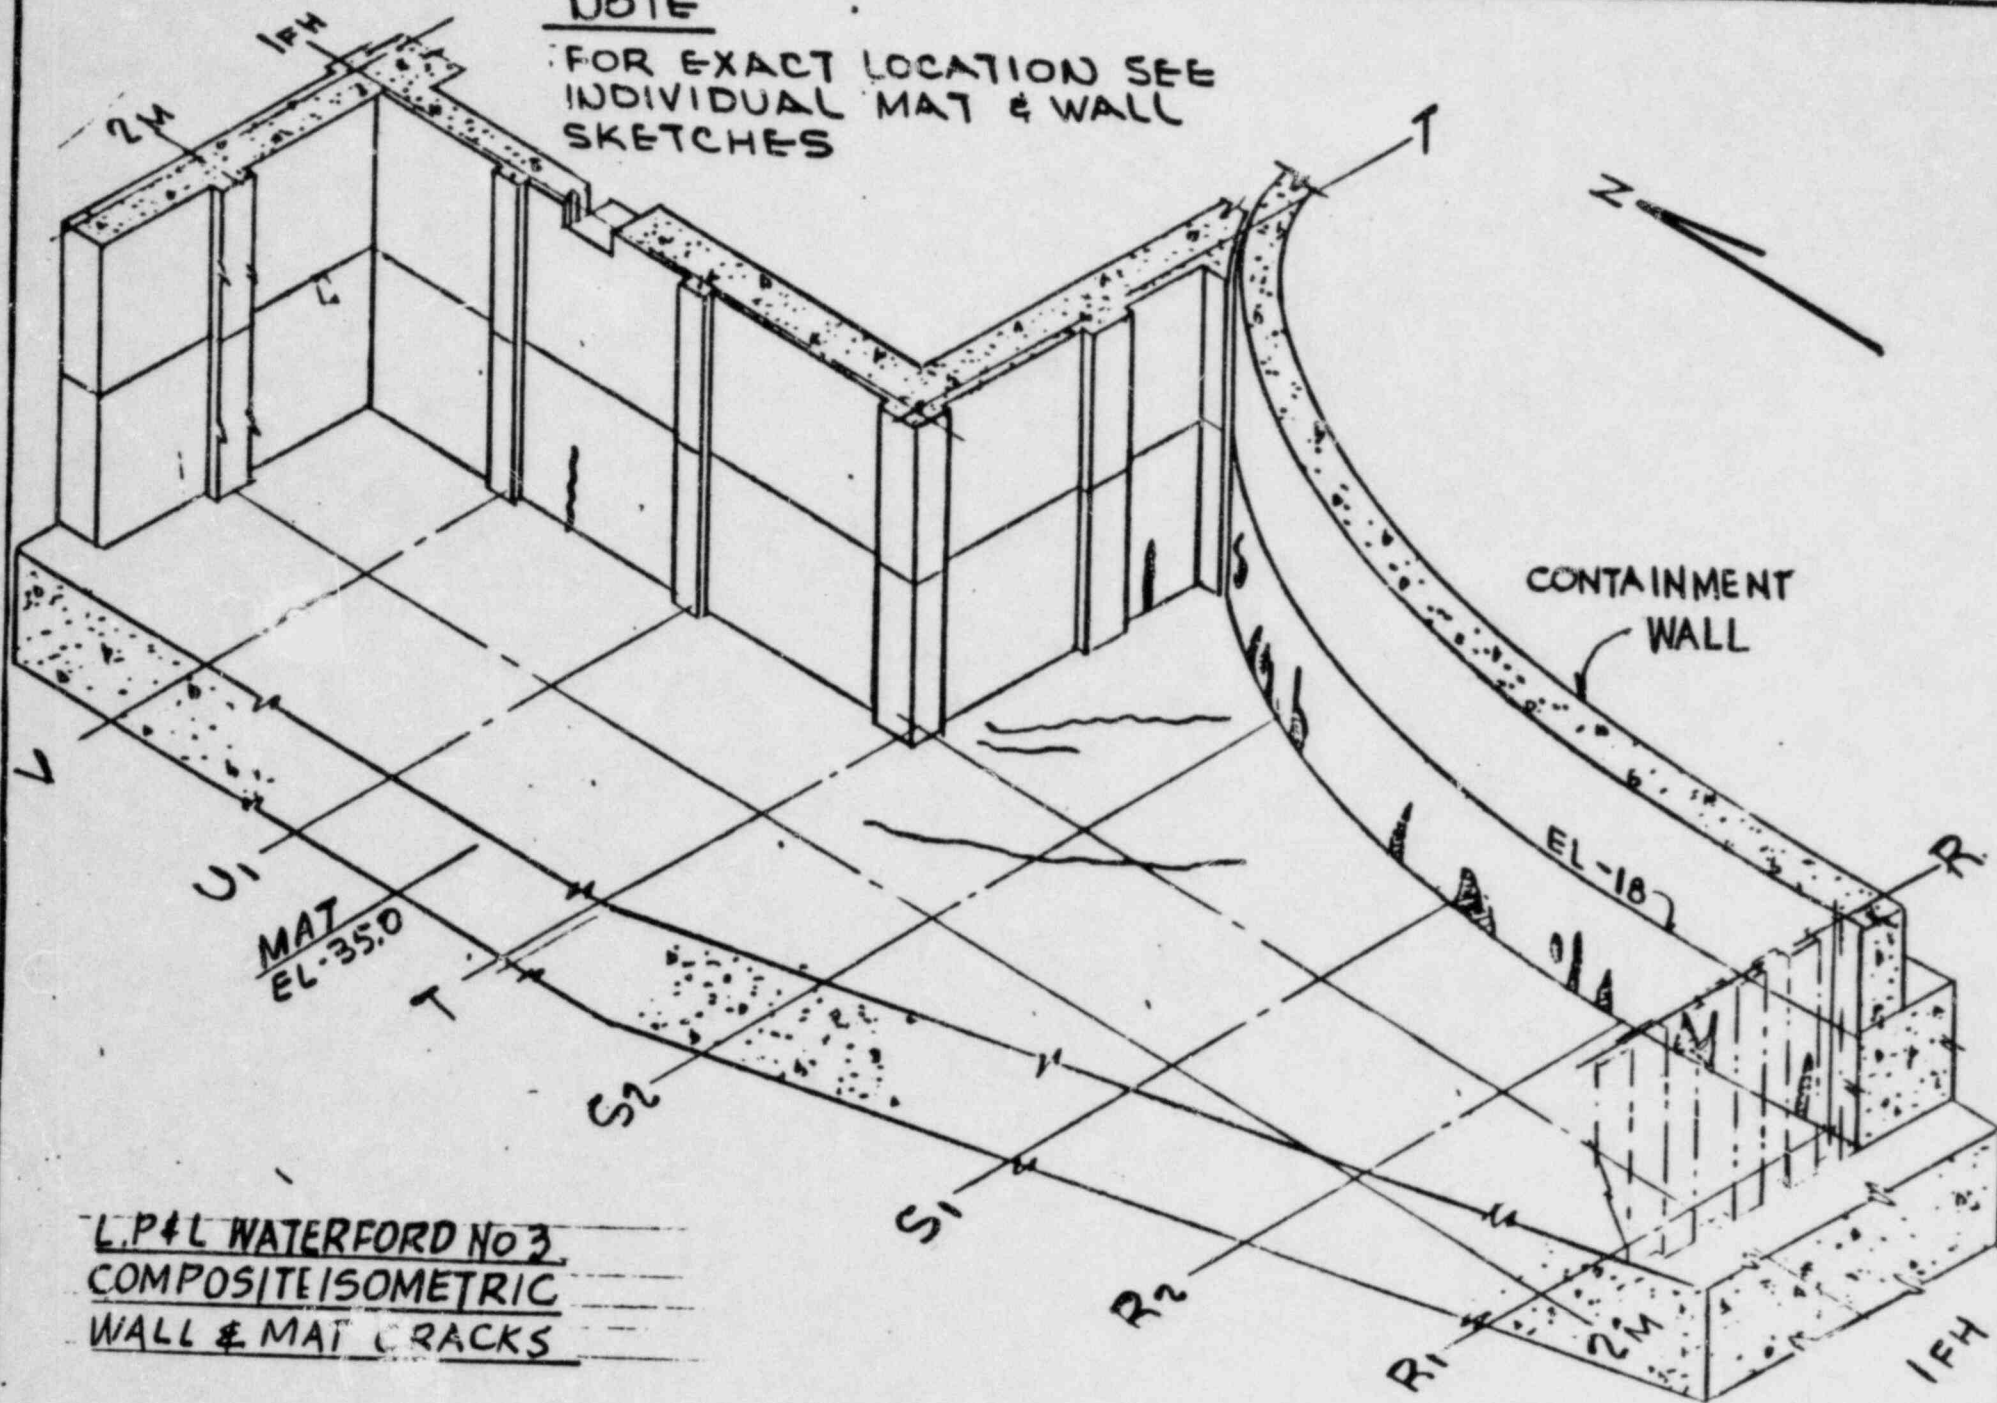
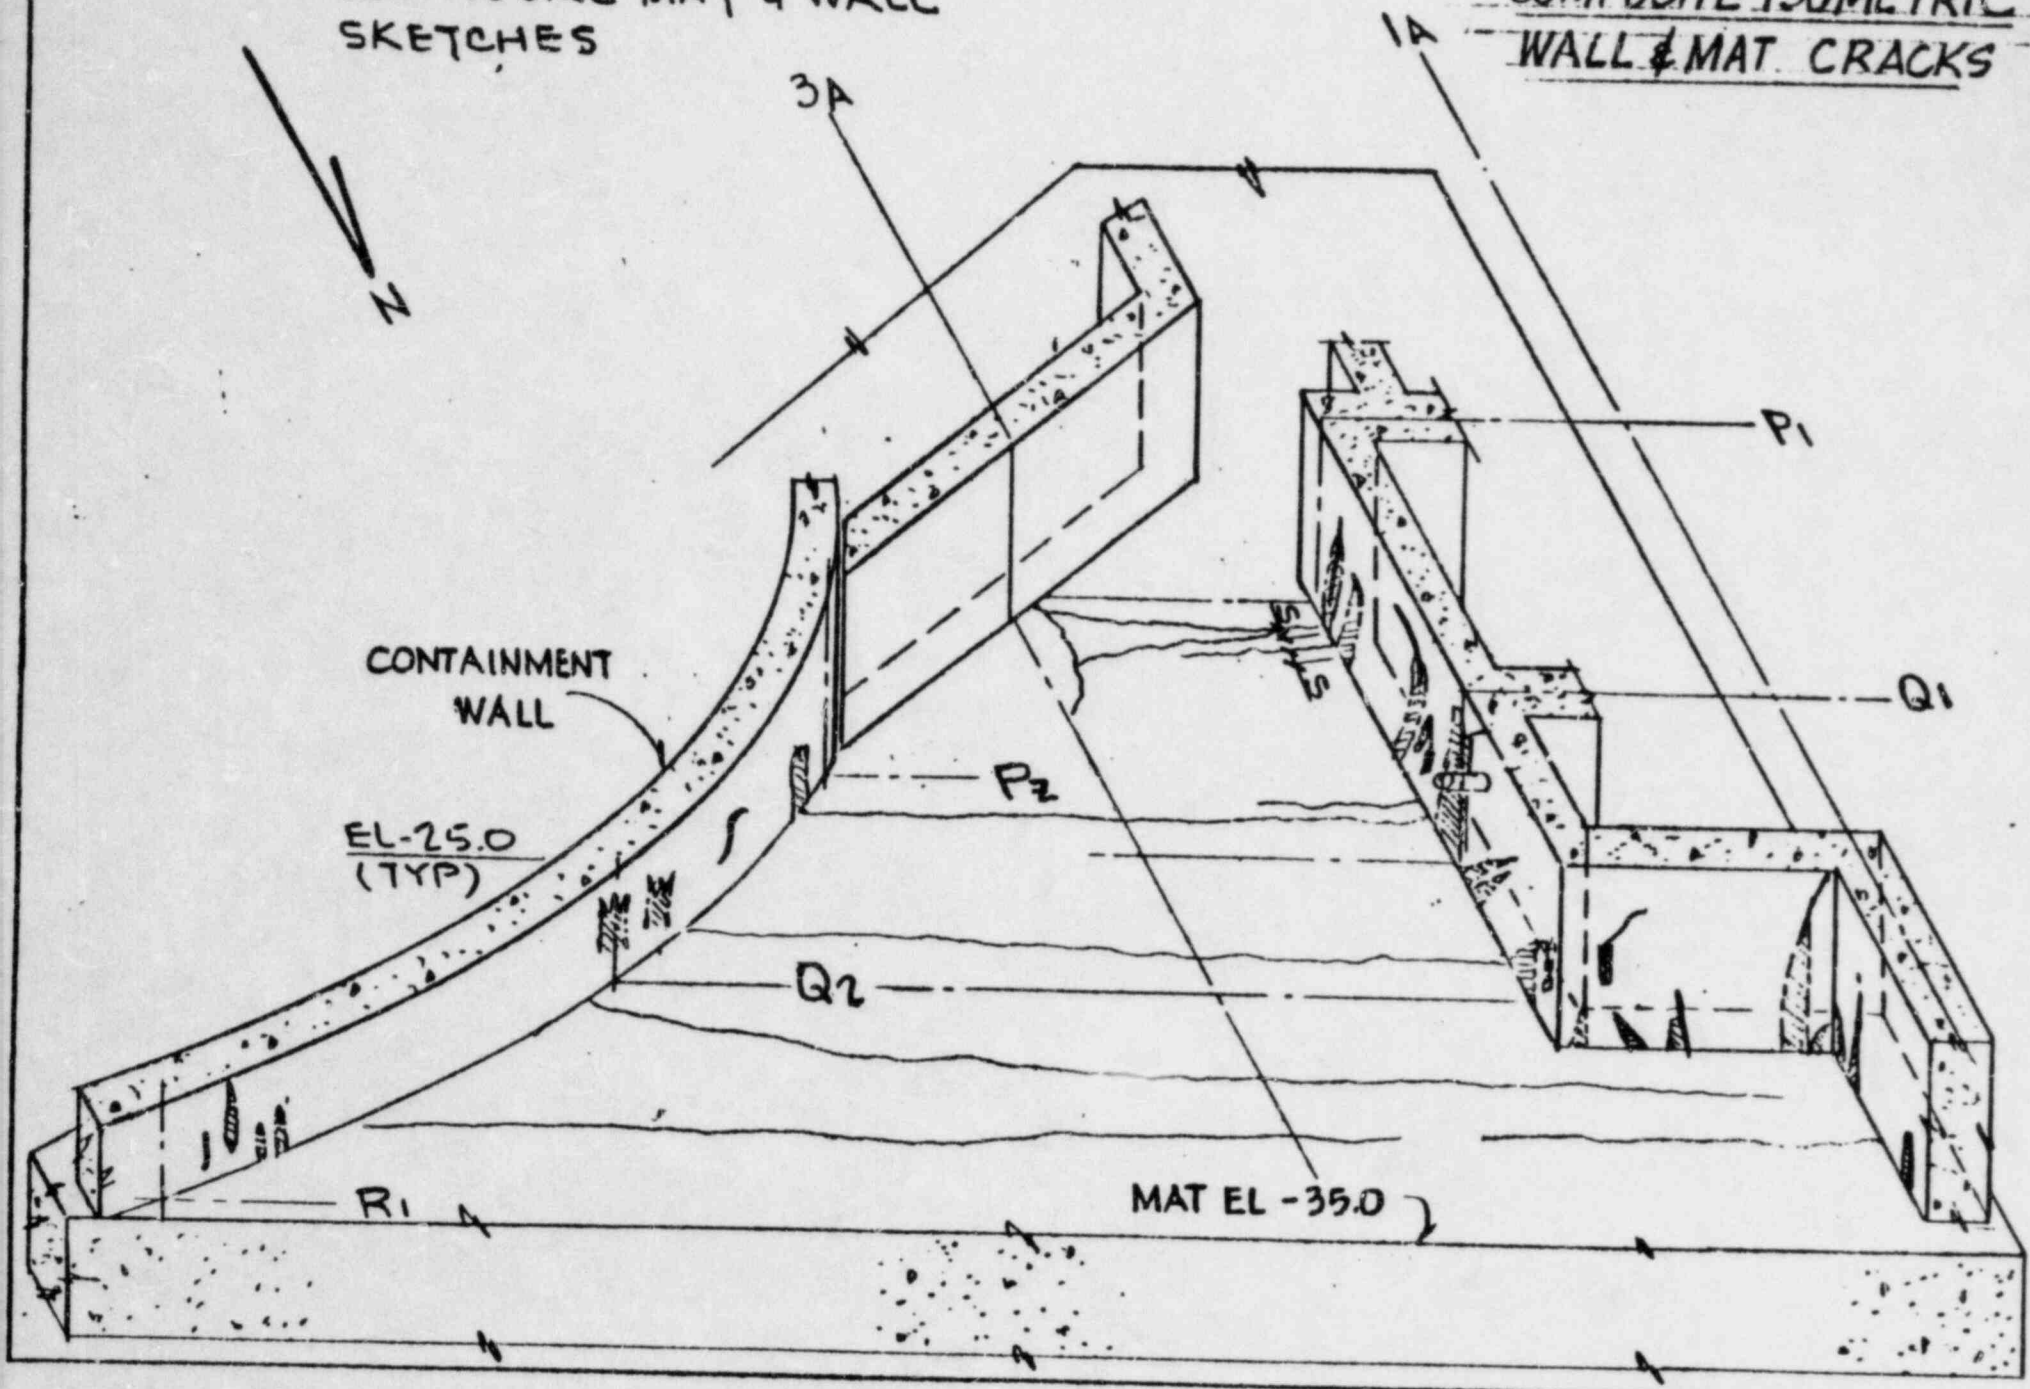
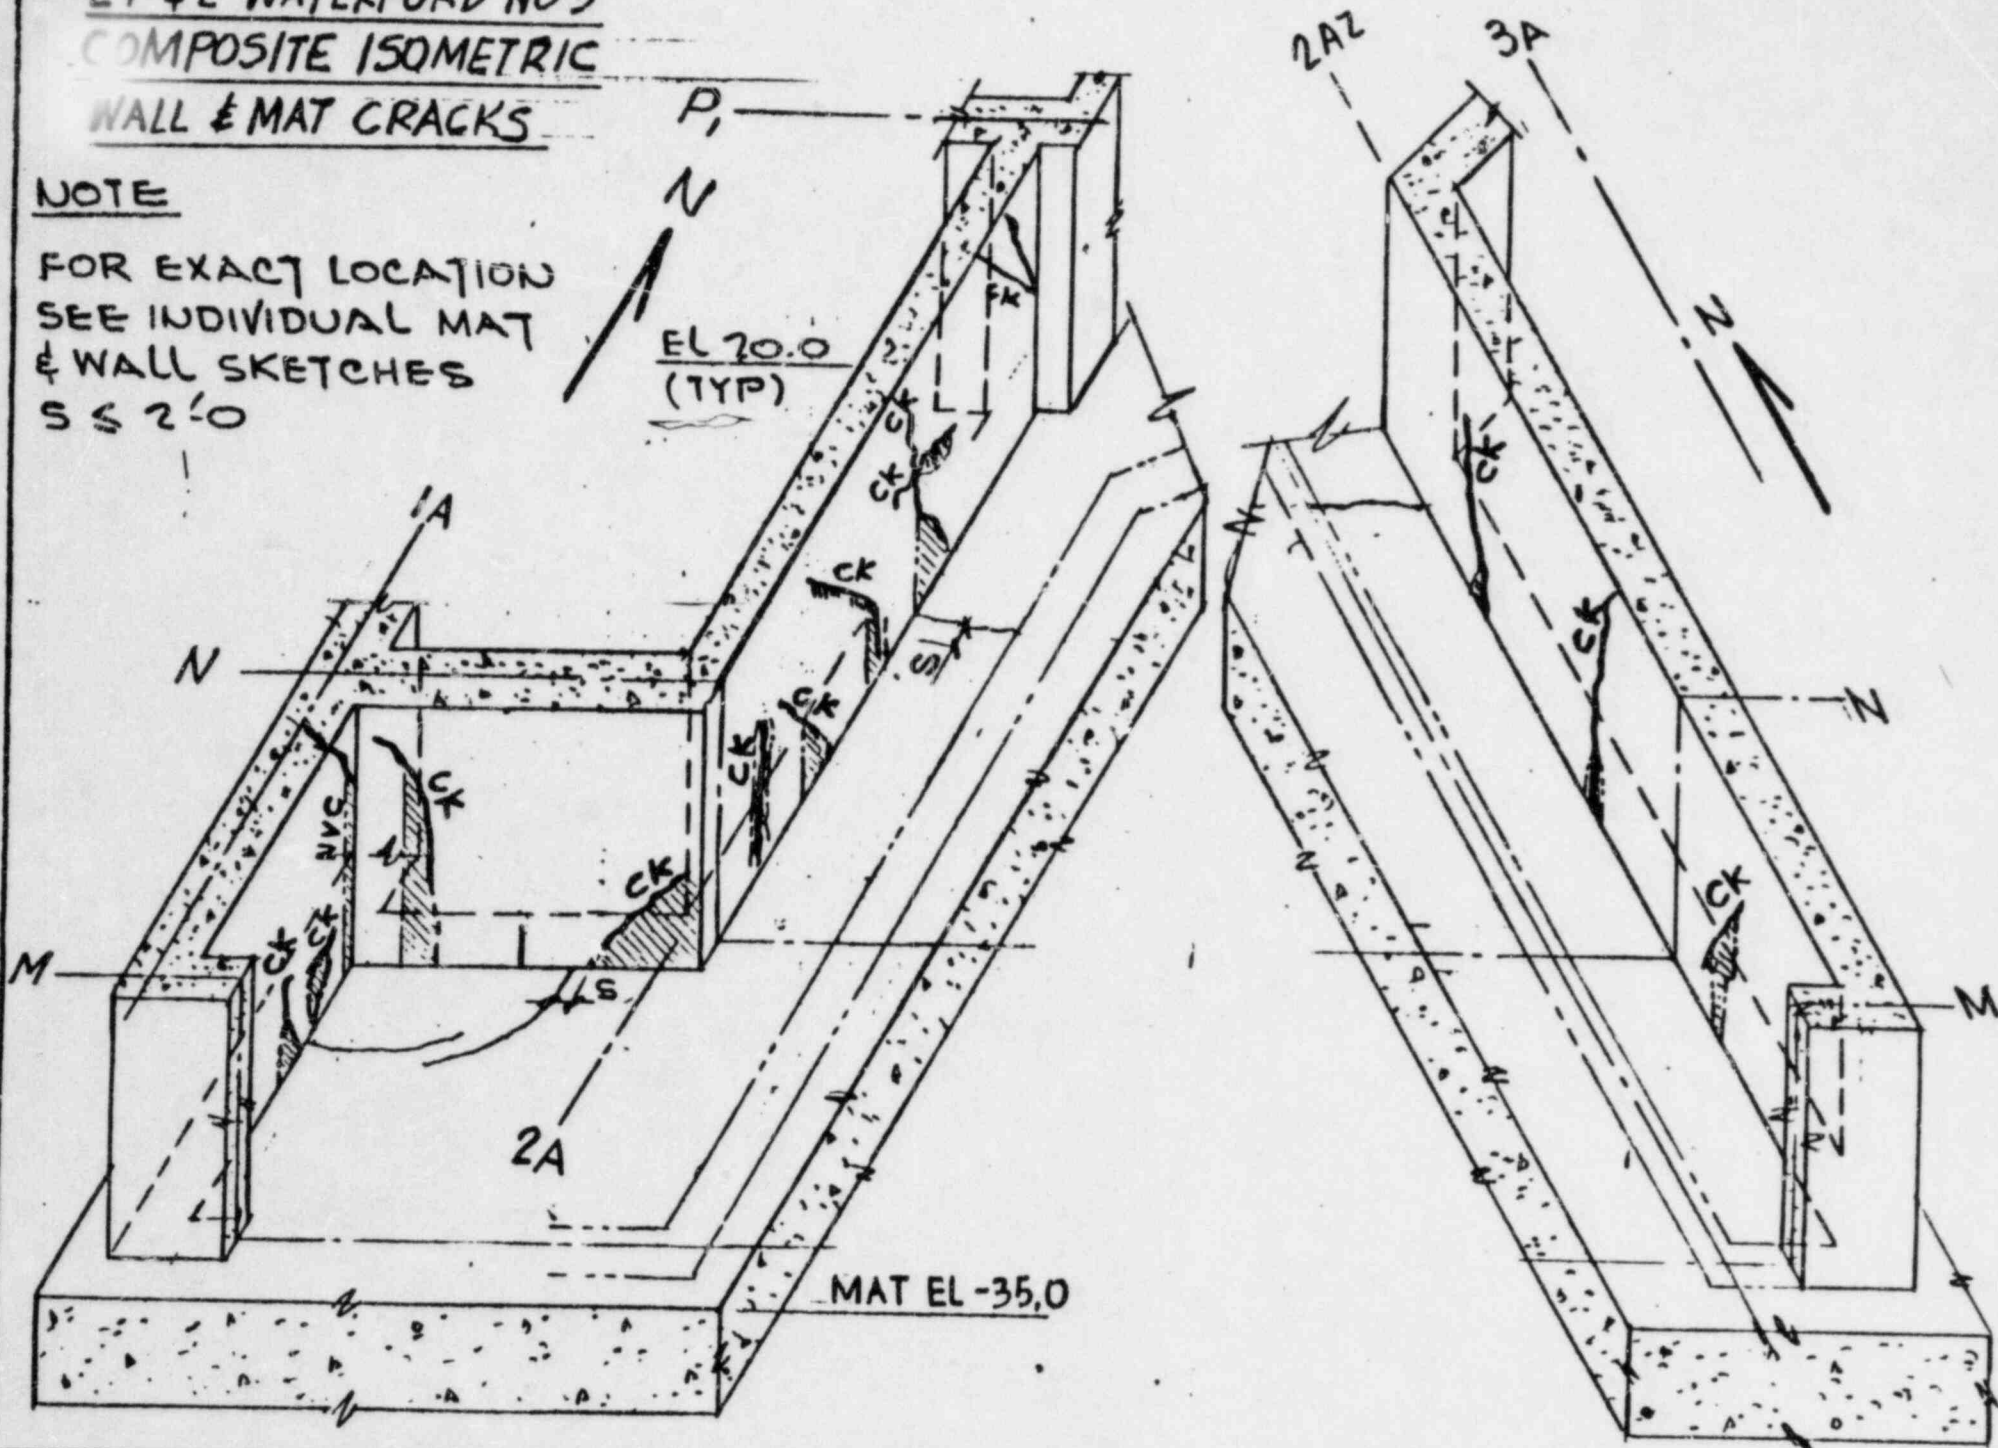
COMPOSITE ISOMETRIC WALL AND MAT CRACK MAPS

Composite isometric maps (Appendix C) have been prepared to show the relative location and orientation of all identified cracks at the basemat/wall interface.

1. Hairline cracks at the interface are not generally found to be inter-connected or even closely inter-related (spacing less than two feet).
2. Only three localized areas were found with floor and wall cracks in close proximity:
  - a) Reactor Building ring wall, north-east quadrant (sheet 1, Appendix C)
  - b) East Wet Cooling Tower walls (Sh 2, Appendix C)
  - c) West Wet Cooling Tower walls (Sh 4&5, Appendix C)

Many leachate deposits on the walls extend further down the wall than the crack due to the originating moisture migrating down the wall. In assessing the inter-relationship, a conservative assumption has been made that hairline cracks are present in all leachate areas.

Based on the above, it is concluded that a structural inter-relationship cannot be established between cracks on surfaces of walls and basemat.

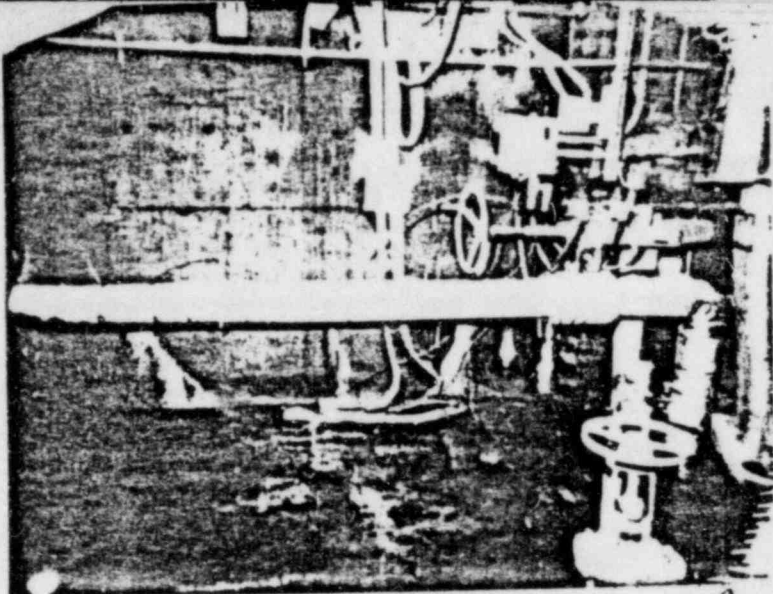
2

Number on each Photograph  
Corresponds to Wall Map  
Sheet, Appendix B

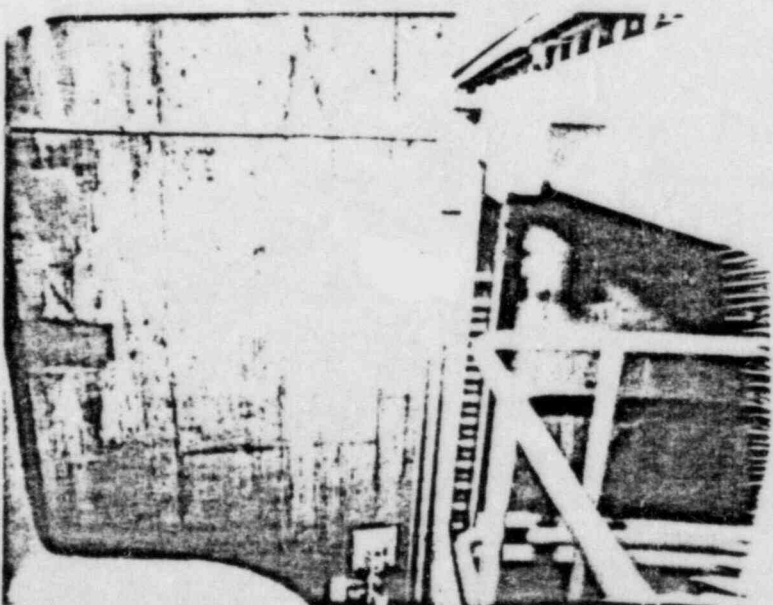
9

Leachate accumulations on the ring wall were caused by long term ponding of rain and construction water at the top of ring wall. Seepage of water was also facilitated by open pipe sleeves (El-18.0 ft) which were interconnected with the embedded structural steel system used as temporary support during construction.

REACTOR BUILDING RING WALL.  
(NORTH EAST QUADRANT)

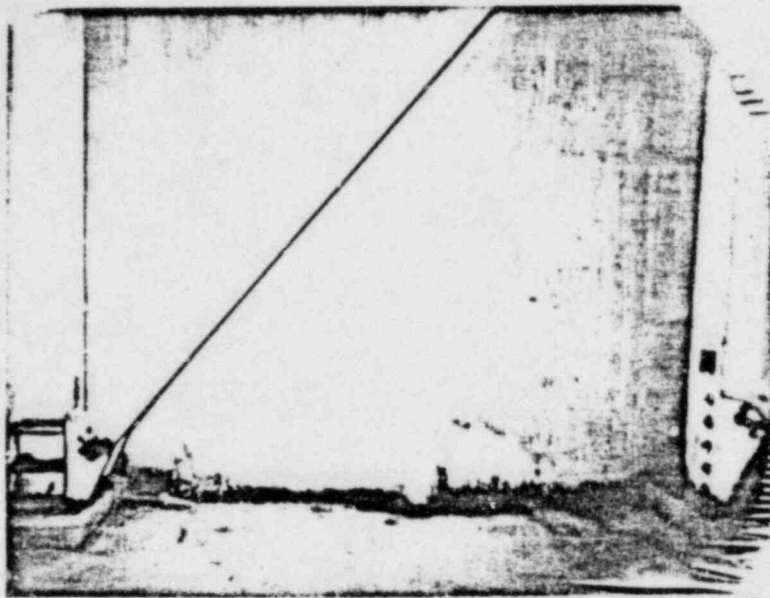
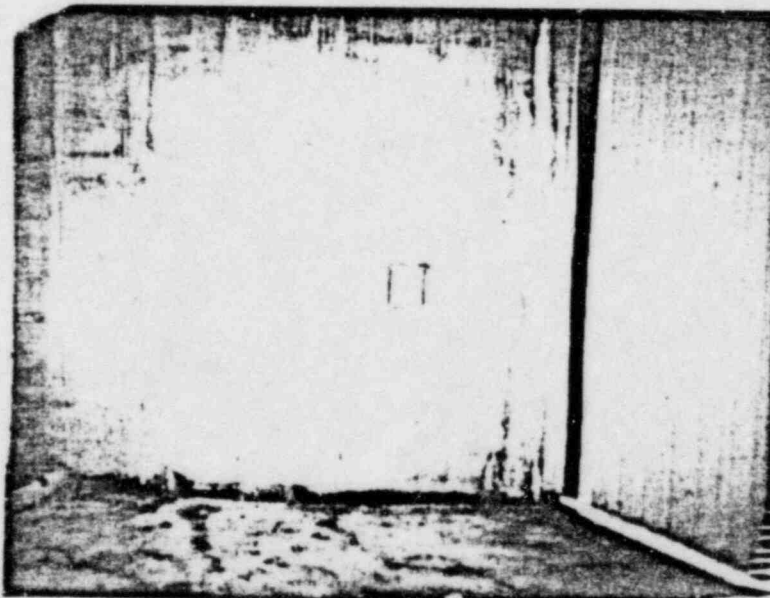
19

REACTOR BUILDING RING WALL.  
(NORTH WEST QUADRANT)

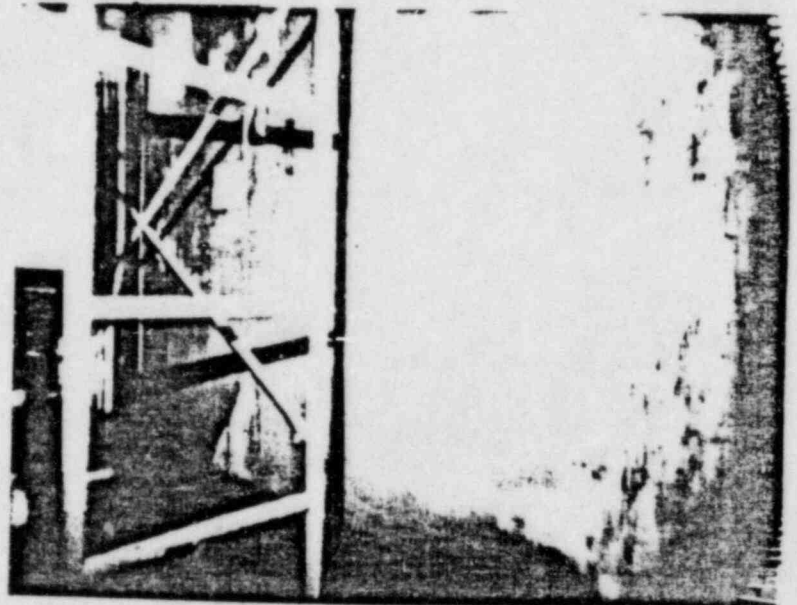
212

WEST WET COOLING TOWER WALL.
