LIMERICK GENERATING STATION

SUBJECT: Licensee Event Report
Limerick Generating Station - Unit 1

Reference:	Docket No. 50-352
Report Number:	1-91-009
Revision Number:	00
Event Date:	April 12, 1991
Report Date:	May 13, 1991
Facility:	Limerick Generating Station P.O. Box A, Sanatoga, PA 19464

LICENSEE EVENT REPORT (LER)

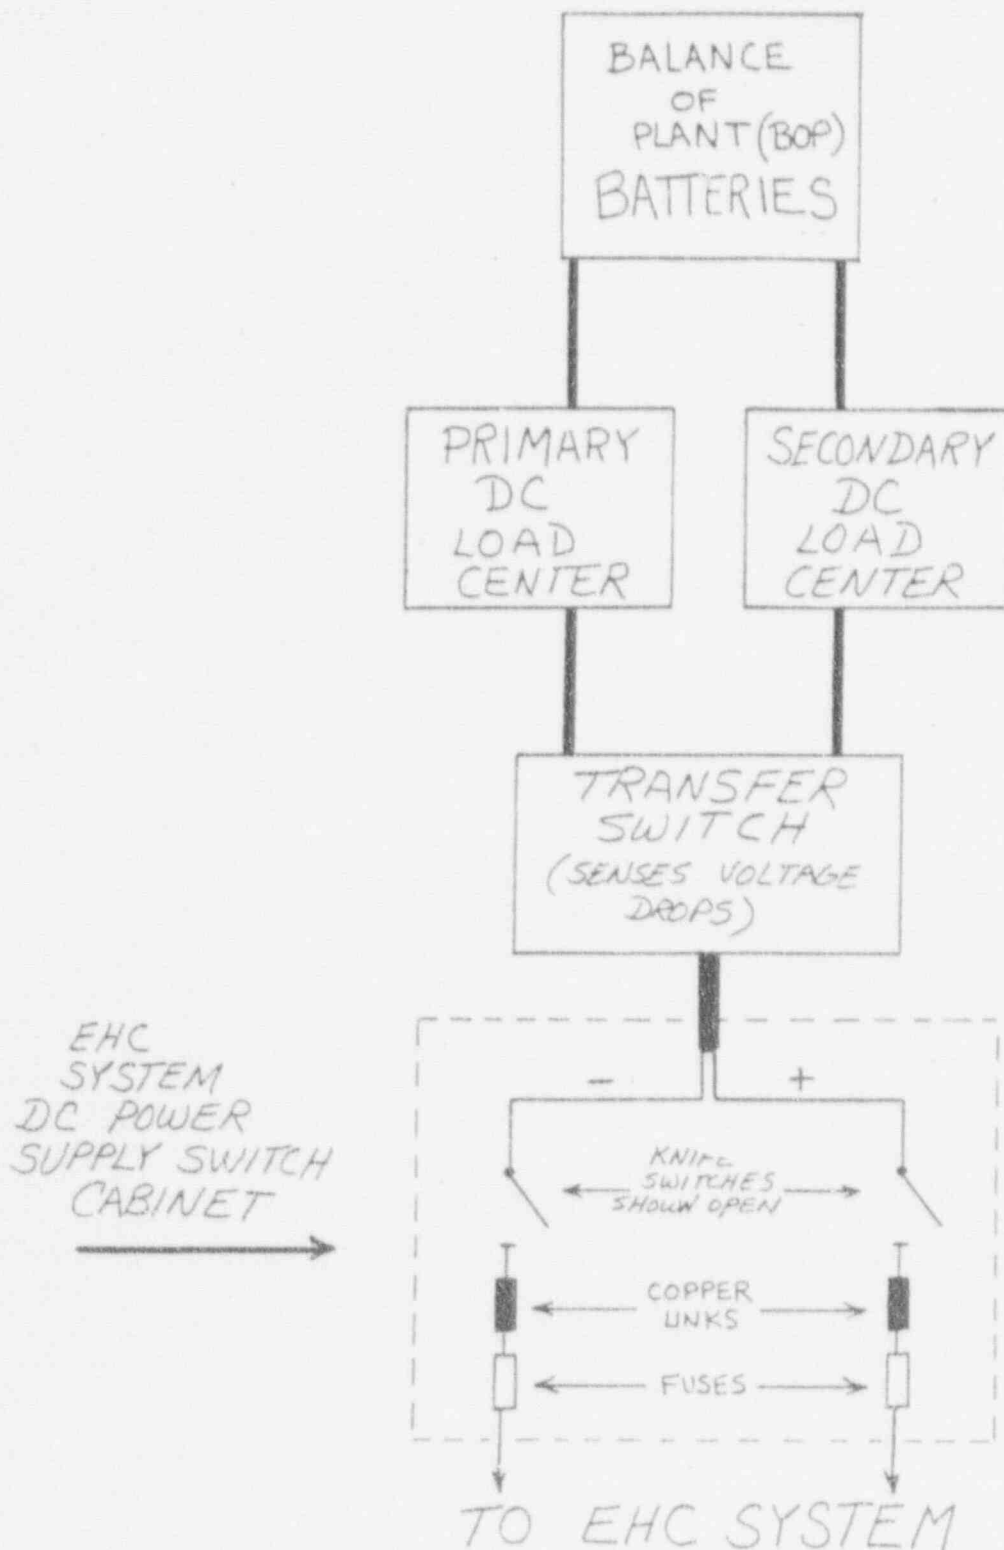
DIAGRAM 1

The cause of the loss of the 125 volt DC electrical power supply to the EHC system, which initiated the Main Turbine trip, was due to a loosely fitting copper link found in the General Electric (GE) Company supplied DC power supply cabinet (See Diagram 1). The copper links were installed during original construction of the Unit 1 EHC system. The EHC system 125 volt DC electrical power supply lines have the capability to be double fused. There was no need or requirement to double fuse these DC power lines, and hence, copper links were installed in place of the secondary fuses. Troubleshooting by the EHC System Engineer (SE) following the Unit 1 SCRAM actuation revealed that one of the copper links was loose, and showed signs of pitting, which is indicative of arcing in the circuit. Additionally, loss of the DC power supply to the EHC system through this loose copper link was repeatable during troubleshooting activities when vibration was initiated in the area of the switch cabinet. Loss of 125 volt DC power to the EHC system will initiate a Main Turbine trip signal if the undervoltage condition is present for 0.2 seconds or longer per design. During troubleshooting, the EHC SE determined that the actual undervoltage condition existed for 0.5 seconds. Therefore, the Main Turbine trip initiated as designed on the loss of 125 volt DC power to the EHC system. This event is the first occurrence of a loose copper link or fuse and it has been concluded to be an isolated occurrence.

1. The four (4) copper links installed in the 125 volt DC electrical power supply switch cabinets for the Unit 1 and Unit 2 EHC systems were removed and replaced by lugged hardwire connectors to ensure reliability of both EHC systems.
