PEACH BOTTOM ATOMIC POWER STATION

SUBJECT: Licensee Event Report
Peach Bottom Atomic Power Station - Units 2 and 3

This LER concerns Primary Containment Isolation System isolation due to a failure of the No. 2 Startup Emergency Feed cable and a Unit 2 & 3 shutdown for cable replacement.

Reference:	Docket Nos. 50-277 50-278
Report Number:	2-91-009
Revision Number:	00
Event Date:	4/20/91
Report Date:	5/20/91
Facility:	Peach Bottom Atomic Power Station RD 1, Box 208, Delta, PA 17314

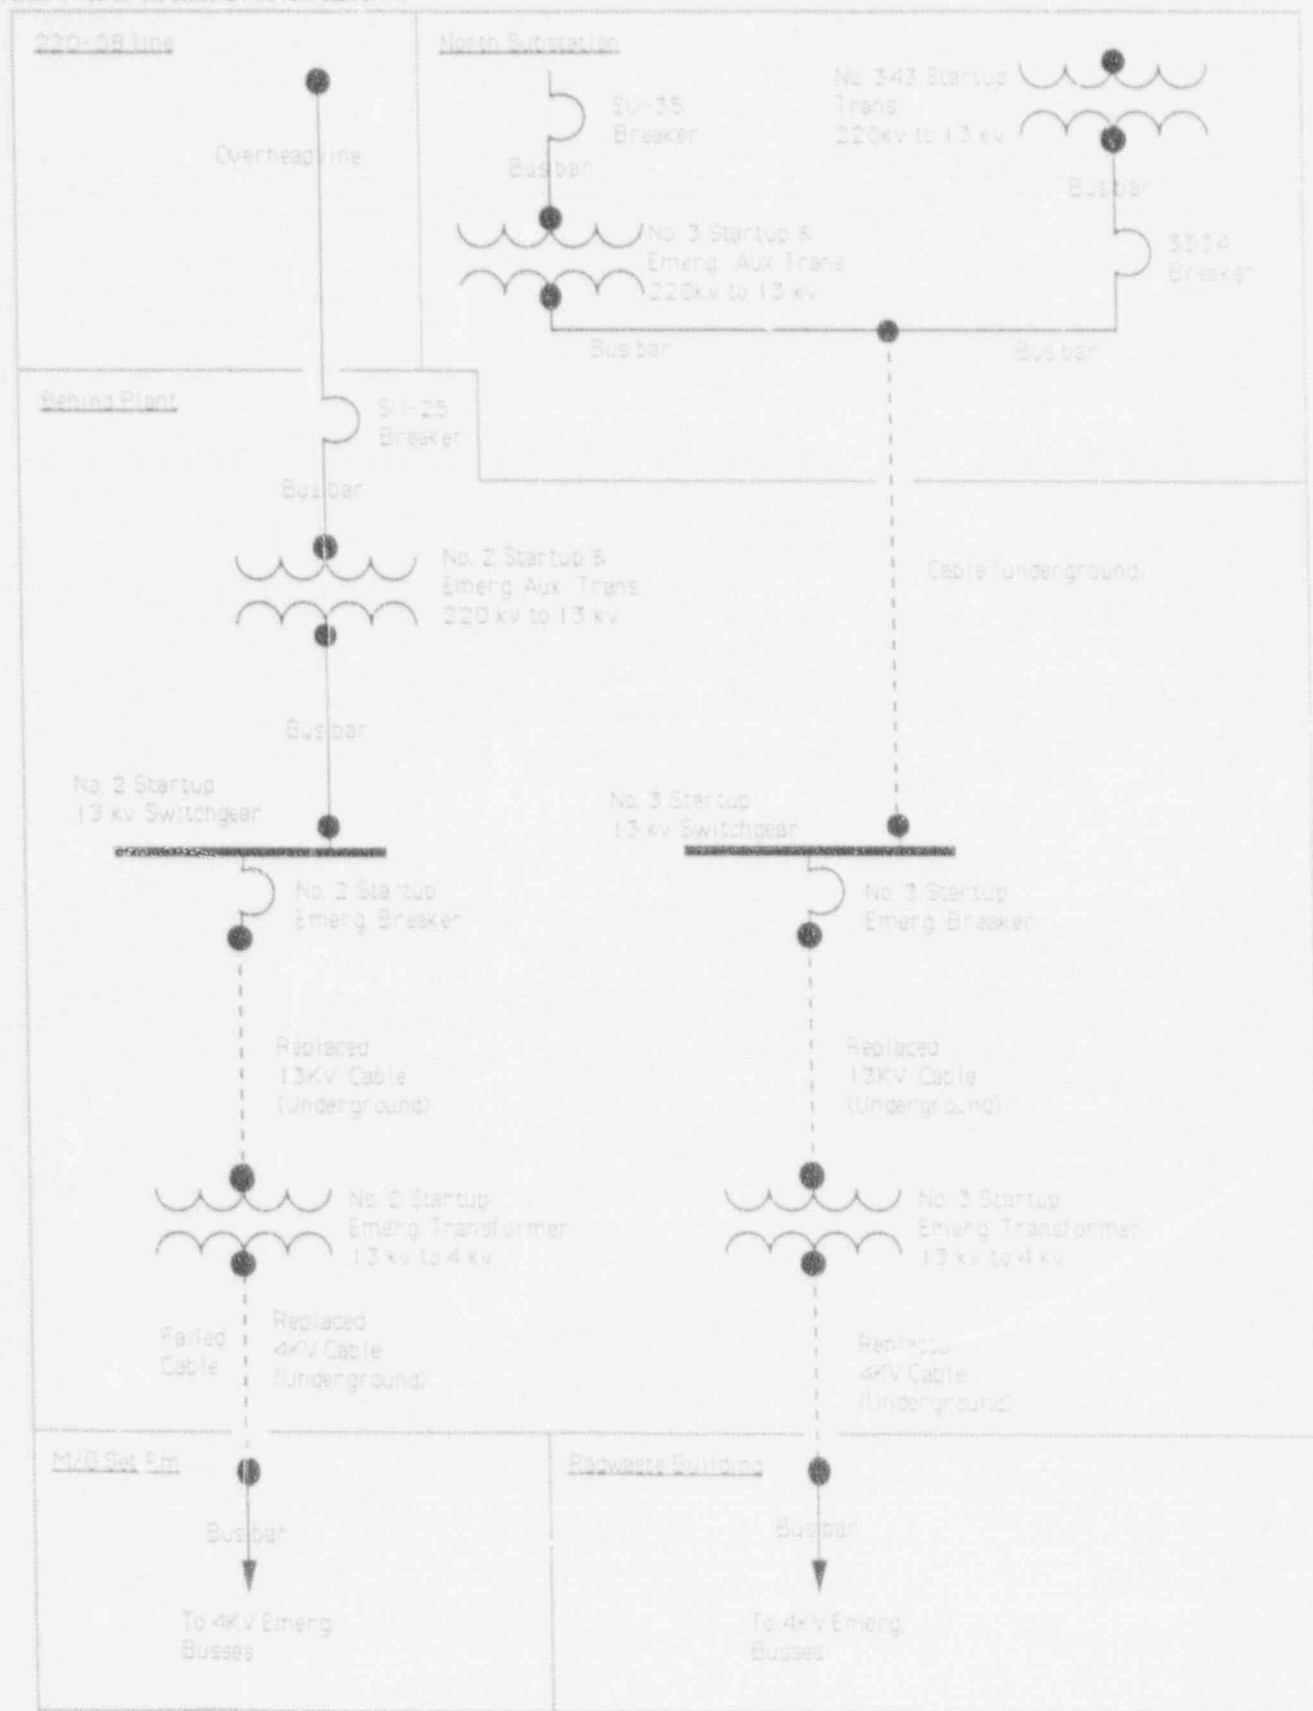
No. 2 Startup Emergency Feed cables (See Attached Drawing) were inspected which identified that one of the twenty-seven cables on the secondary side of the No. 2 Startup Emergency Transformer was damaged and one cable had indication of degradation. The decision was made to repair the one damaged cable with a splice and abandon the degraded cable in place as an interim repair. It was planned to pull new cables at the first opportunity. The repaired cable was tested satisfactorily and the Unit 2 Emergency Startup Feed was returned to service at 0250 hours on 4/26/91.

The No. 2 4KV cables were inspected and accelerated insulation degradation was identified which is known as "Treeing". "Treeing" results when normally occurring voids and impurities from the manufacturing process degrades the cable insulation when energized at low current conditions and exposed to a damp environment.

The event was initiated when the No. 2 Startup Emergency Feed cable failure caused the opening of the No. 2 Startup Emergency Breaker. The accelerated insulation degradation identified is known as "Treeing". "Treeing" results when normally occurring voids and impurities from the manufacturing process degrades the cable insulation when energized at low current conditions and exposed to a damp environment.

A review of other plant cable configurations have indicated that the Startup Emergency Feeds are the only cables requiring replacement at this time. Startup Emergency Feed cables on both units from the Startup Emergency Breaker down to the 4 KV Emergency Busses have been replaced with a new cable.

System isolations were reset on both units immediately following the event. The 13 KV and 4 KV cables on both sources from the Startup Emergency Breaker down to the 4 KV Emergency Busses have been replaced with a new type cable. The manufacturing process and the cable additives have been improved which significantly reduces the new cables vulnerability to "Treeing". The new cables and connections have been tested as specified by Engineering. The 4 KV Emergency Busses have been returned to their normal Startup Emergency Feeds.
