LIMERICK GENERATING STATION

J. DOERING, JR.
PLANT MANAGER
LIMERICK GENERATING STATIONDocket Nos. 50-352
50-353
License Nos. NPF-39
NPF-85U.S. Nuclear Regulatory Commission
Attn: Document Control Desk
Washington, DC 20555SUBJECT: Licensee Event Report
Limerick Generating Station - Units 1 and 2

Reference: Docket Nos. 50-352
50-353
Report Number: 1-91-010
Revision Number: 00
Event Date: April 18, 1991
Report Date: May 20, 1991
Facility: Limerick Generating Station
P.O. Box A, Sanatoga, PA 19464

FACILITY NAME (1) Limerick Generating Station, Unit 1										DOCKET NUMBER (2) 0 5 0 0 0 3 5 2 1 OF 0 5										PAGE (3) 1 OF 0 5									
TITLE (4) This LER reports the inadvertent isolation of the Refuel Floor Secondary Containment & initiation of the 'B' Standby Gas Treatment system due to a suspected tubing or valve leak.																													
EVENT DATE (5)			LER NUMBER (6)				REPORT DATE (7)			OTHER FACILITIES INVOLVED (8)																			
MONTH	DAY	YEAR	YEAR	SEQUENTIAL NUMBER	REVISION NUMBER	MONTH	DAY	YEAR	FACILITY NAMES					DOCKET NUMBER(S)															
									Unit 2					0 5 0 0 0 3 5 3															
0	4	1	8	9	1	9	1	0	1	0	0	0	5	2	0	9	1	0 5 0 0 0 1 1 1											
OPE

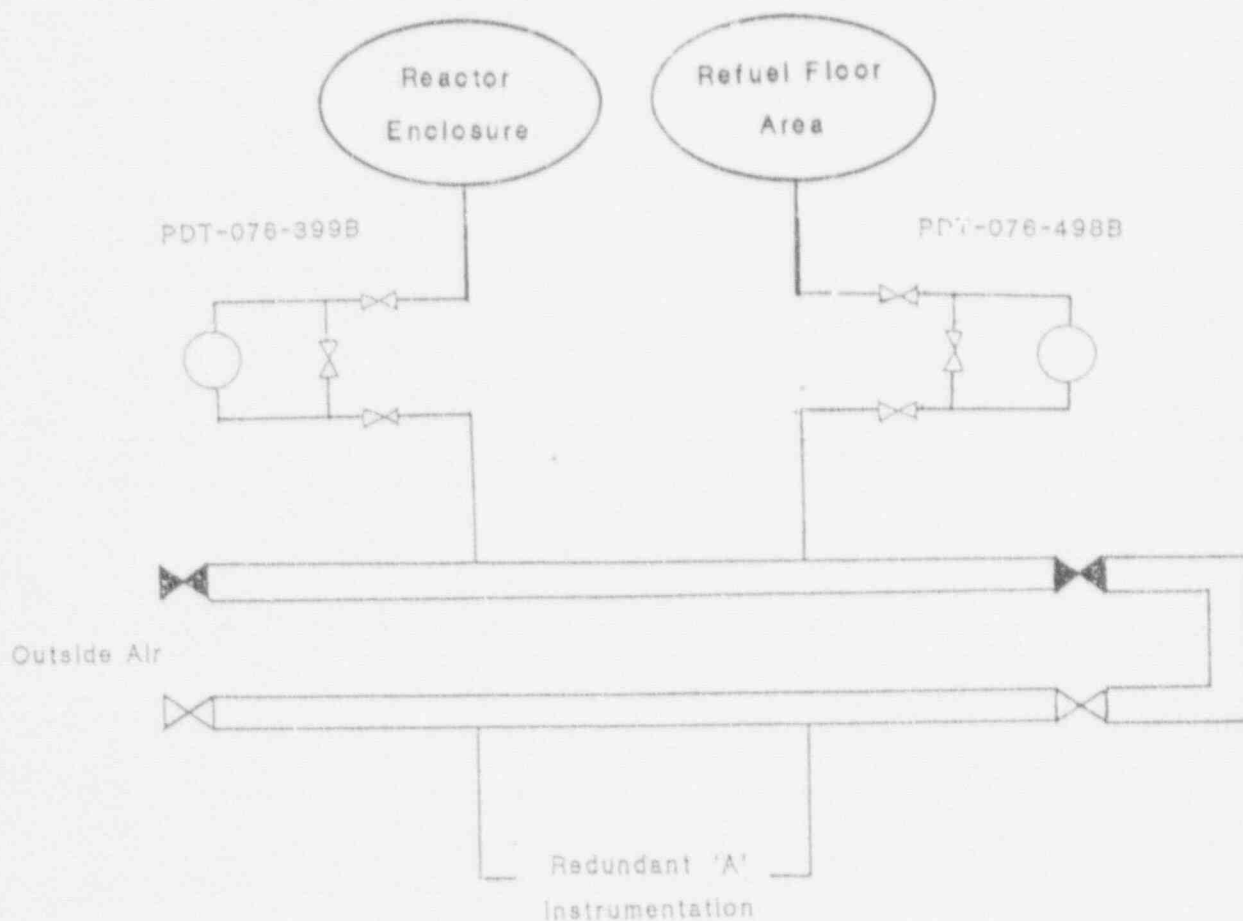
Figure 1

The cause of this event was the generation of a false low negative differential pressure signal as a result of a suspected small leak in the isolated outside air sensing line, or the manifold equalizing valve for PDT-076-399B allowing indicated negative differential pressure to approach zero.

Since the 'B' outside air sensing line header was isolated in accordance with ST-2-076-401-1 (see Figure 1), a small leak in the instrument tube fittings could, over time, allow the 'B' outside air sensing line header pressure to vent and equalize such that the differential pressure across the transmitter approached zero. This is due to PDT-076-399B being physically located in the Unit 1 Reactor Enclosure. Therefore, the negative differential pressure decayed and reached -0.1 inches wg causing the 'B' isolation signal to be generated. The same scenario would occur if the manifold equalizing valve for PDT-076-399B had a small leak.

As a result of plant conditions, a leak check of tubing and valves could not be initially performed by I&C personnel. However, on May 16, 1991, I&C personnel were able to perform a leak check of tubing and valves and then performed procedure ST-2-076-401-1 while observing the output of PDT-076-399B for a slowly degrading differential pressure condition. No leaks were identified and the pressure transient could not be reproduced. Further investigation is required to confirm the cause of this event and to identify and repair any leaking fittings. Upon completion of this investigation a supplement will be provided to clearly define causes and present any additional corrective actions as necessary.
