J. T. Beckham, Jr.
Vice President - Nuclear
Hatch Project

PLANT HATCH - UNIT 2
NRC DOCKET 50-366
OPERATING LICENSE NPF-5
IGSCC FLAW EVALUATIONS AND WELD OVERLAY DESIGN
UNIT 2 SPRING 1991 MAINTENANCE/REFUELING OUTAGE

FEEDWATER WELD FLAW EVALUATION AND REPAIR

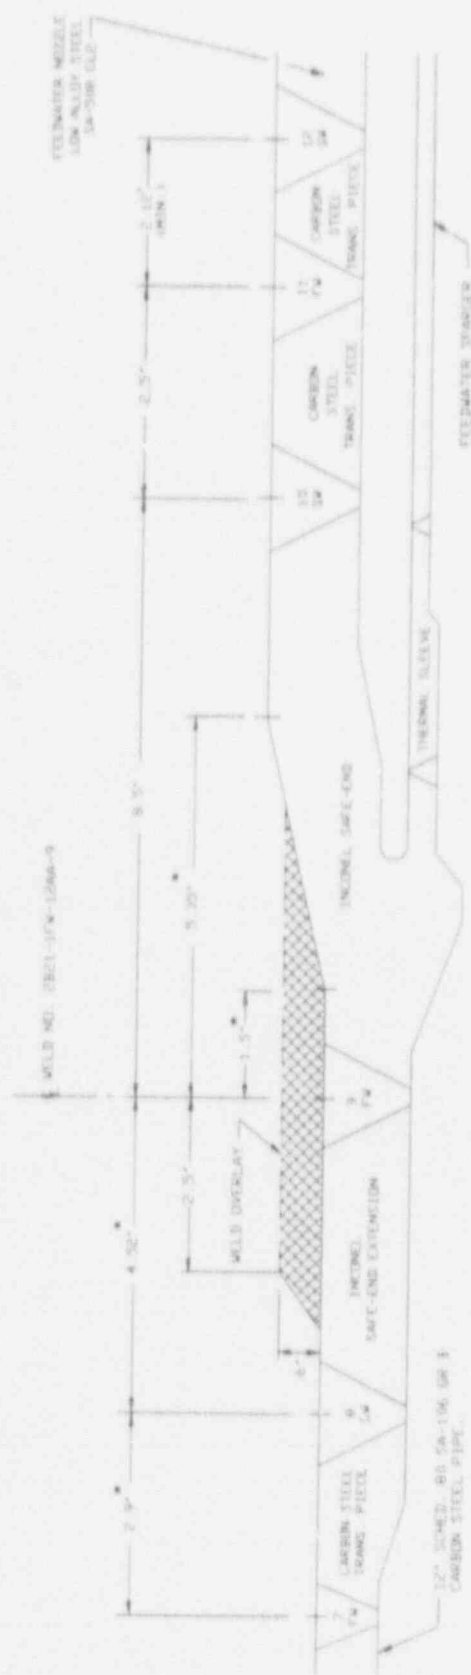
FIGURE 1

Of the twelve welds examined, feedwater weld 2B21-1FW-12AA-9 (see Figure 1) was determined to have reportable and unacceptable indications. The subject weld material is Inconel 182 and joins an Inconel 600 safe-end extension to an Inconel 600 safe-end. This weldment contains three identified flaws that are axially oriented.

These indications originate near or in the root of the weld and terminate in the weld material on the safe-end extension side. Quantification as to whether the crack originated in the base material near the root of the weld or in the root of the weld is not readily obtainable, since the precise location of the root is ultrasonically indeterminate in the area of the indications.

Using a combination of EPRI NDE Center qualified sizing techniques, the indications were evaluated and sized. The indications are all contained in approximately 2 inches of the circumference (25" to 27" CW from TDC) and have a thru-wall dimension of approximately 50% to 75%, with a length of less than 0.5".

SIA prepared flaw evaluations and a weld overlay repair design. As discussed above, this weld contains three identified flaws which are axially oriented. The flaws were evaluated as if they resulted from IGSCC, since we believe this conservatively bounds weld flaw behavior due to other possible causes, such as thermal fatigue or fabrication defects.

These flaws did not present a significant structural concern, even if through the original component wall, since they are axially oriented. However, repair was considered to be necessary based upon ASME Section XI and guidance in NUREG-0313, Revision 2. NUREG-0313 Paragraph 4.4.2 notes that a component with axial flaws will generally benefit from weld overlay. Further, because of the observed depth of the flaws (75% max), GPC elected to make a standard weld overlay repair.

Figure 2 of the SIA report (Enclosure 2) represents the repair design utilized for this location. The design basis for this design is the NUREG-0313 Rev. 2 "Standard Weld Overlay" which is based upon an assumed 360 degree "thru-wall" circumferential flaw. This assumption is very conservative for the observed flaws.

2. The weld material is Inconel 182 and the base metal on either side is Inconel 600 material. The repair was made using ERNiCr-3 weld metal deposited by the gas tungsten arc welding (GTAW) process (the ERNiCr-3 material which was used on this repair is chemically the same as the trade name Inconel 82).

Because of the thermal sleeve junction on the inside surface and because of the flaws themselves, the welding was sequenced such that all passes began at the safe-end taper, and proceeded toward the feedwater piping end of the repair.

This sequence represents good welding practice and minimizes the risk of blow-throughs and resulting stresses in the region of the thermal sleeve junction. On the safe-end side of the repair, the weld overlay was blended into the transition region. Following repair, surface and volumetric inspections were performed with no reportable indications detected in the weld overlay, and the weldment has been reclassified as category "E" in accordance with NUREG-0313, Rev. 2.
