Report No.: SIR-91-028
Revision No. 0
Project No. GPCO-19Q
May, 1991

EVALUATION AND REPAIR OF
FLAW INDICATIONS IN THE FEEDWATER
"A" SAFE-END TO EXTENSION WELD
AT HATCH UNIT 2

Georgia Power Company

Structural Integrity Associates, Inc.

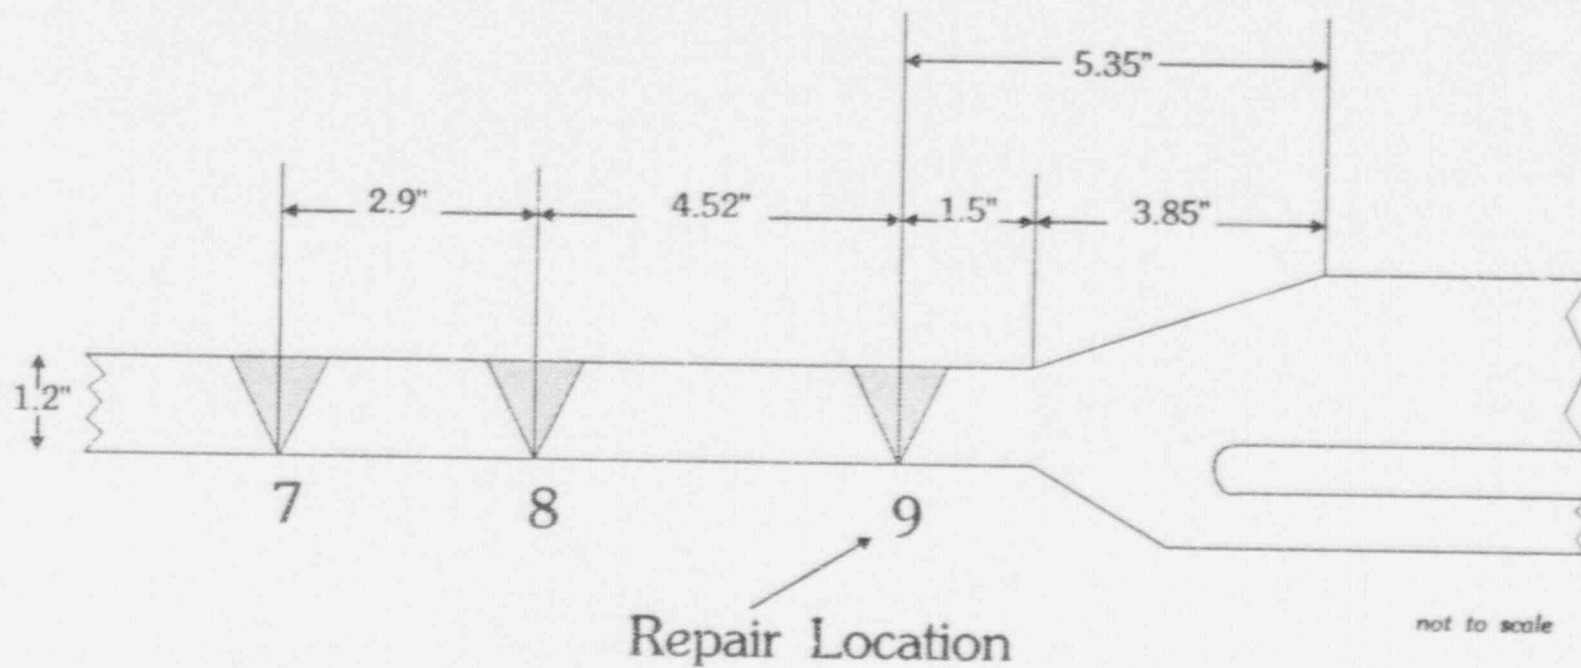
Figure 1. Geometry of Repair Location

Weld 2B21-1FW-12AA-9 contains three identified flaws which are axially oriented and essentially confined to the Inconel 182 weld material [3]. The flaws are all contained in approximately 2 inches of circumference. The girth weld material is Inconel 182 weld metal, and the base material on either side of the weld is Inconel 600.

The identified flaws are located in the safe-end to extension piece weld (weld 9 in Figure 1). This weld is remote from the feedwater nozzle, and joins two Inconel 600 components. The weld itself was fabricated with Inconel 182 material. No low alloy steel is affected by the repair. Figure 1 illustrates the geometry of the location.

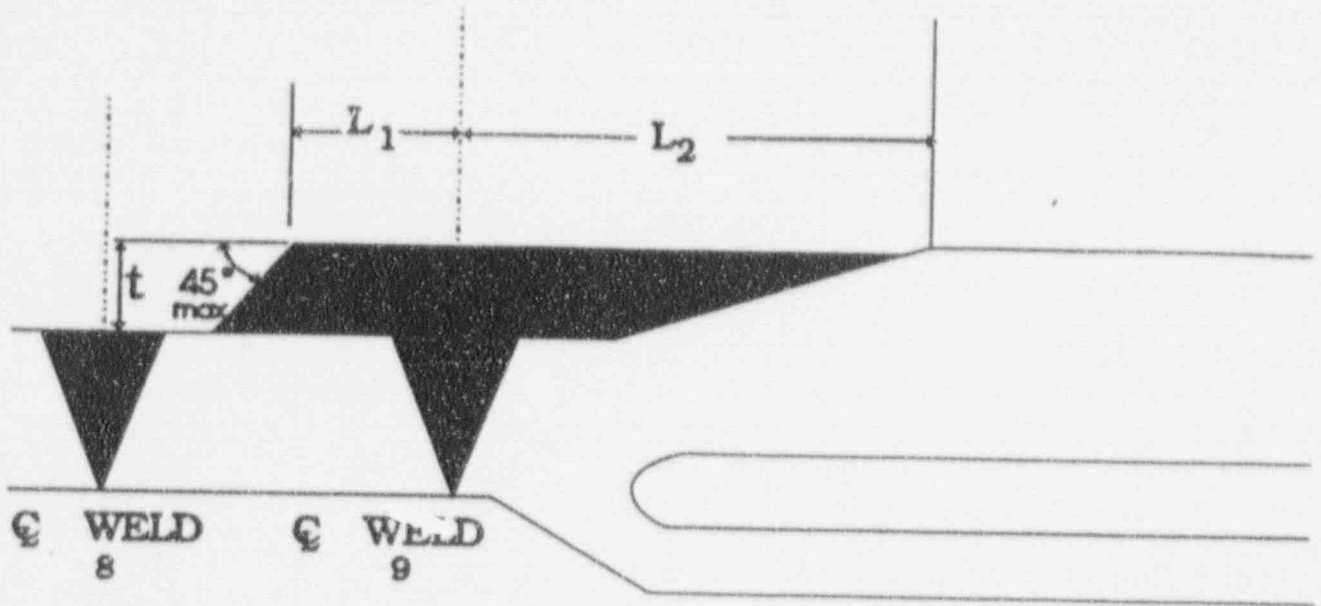
Figure 2 Weld Overlay Repair Design

The design basis for this repair is the NUREG-0313, Revision 2 "Standard Weld Overlay" which is based upon an assumed 360° through-wall circumferential flaw [1]. This assumption is very conservative for the observed flaws. The weld overlay repair design is presented in Figure 2.

The design thickness for the weld overlay repair is 0.4 inches for structural adequacy. This thickness is adequate to provide a standard weld overlay repair for a 360° through-wall circumferentially oriented flaw. In addition, allowance was included to account for the worst case assumption of continued flaw growth into the repair. The allowance was determined by assuming continued growth at the rate defined by:

The design thickness required to meet the Standard Weld Overlay requirements for this location is 0.4 inches. The allowance for continued flaw growth is 0.2 inches. This allowance may be considered to be sacrificial material to guarantee that the structural portion of the repair (0.4 inches) is not degraded in the unlikely event that the observed flaws continue to propagate into the applied weld material.

The overlay length is blended into the safe-end taper on that side of the repair as noted in Figure 2. On the pup piece side, the overlay is designed to extend to a full thickness length of at

Because of the thermal sleeve junction on the inside surface and because of the flaws themselves, the welding was sequenced such that all passes began at the safe-end taper, and proceeded toward the feedwater piping end of the repair (in other words, the welding progressed upstream relative to feedwater flow). This sequence minimized the resulting stresses in the region of the thermal sleeve junction. On the safe-end side of the repair, the weld overlay was blended into the transition region, to minimize stress concentration in the region.

Structural Integrity Associates has reviewed the as-built data [7] for the subject repair, and has determined that the design basis for the repair has been met by the repair. The required structural reinforcement thickness of 0.4 inches is met at all measured locations. The allowance for continued flaw propagation (0.2 inches) is met in the vicinity of the observed flaws in particular, and the average of all thickness measurements exceeds the design thickness of 0.6 inches (which includes both structural material of 0.4 inches and growth allowance of 0.2 inches). Two locations have reported thicknesses of slightly less than the 0.6 inches value (0.57 inches and 0.58 inches), but this is not significant and in no way invalidates the repair. These locations are remote from the observed flaw location.

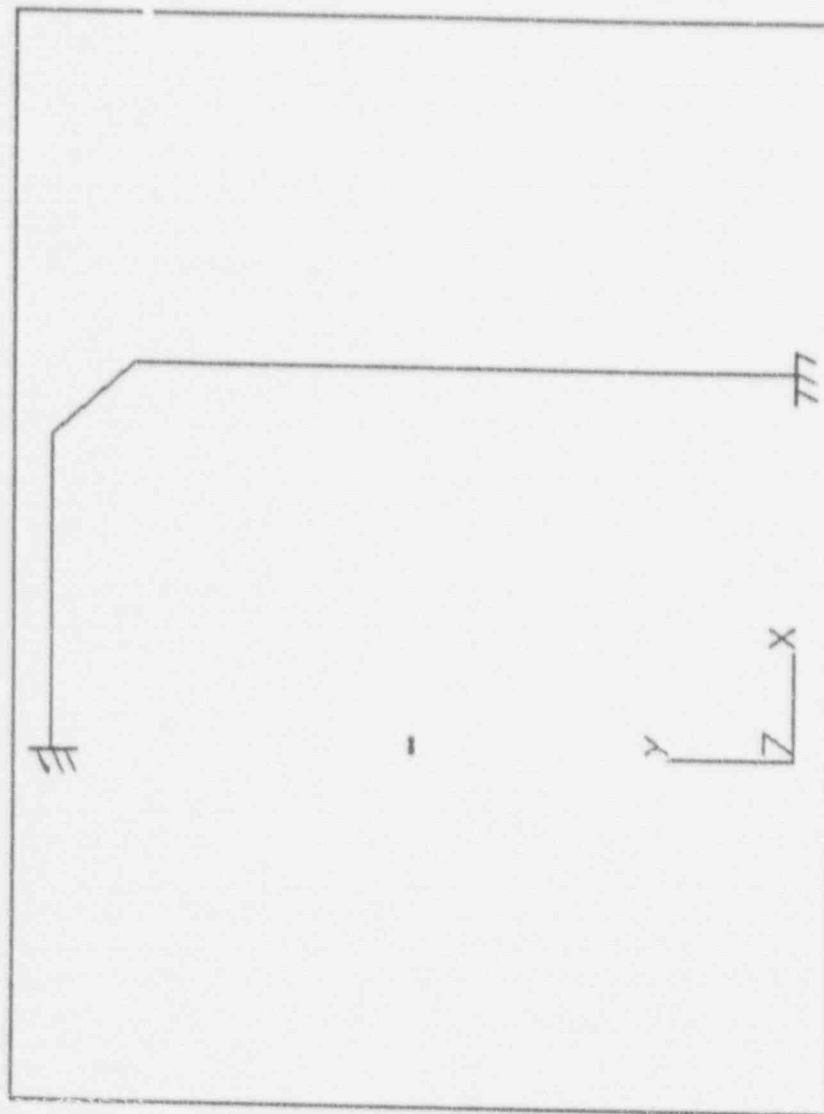
Figure 3. Finite Element Piping Model for Evaluation of Shrinkage Stresses

The reported axial shrinkage due to the repair is an average of 0.078 inches. The only welds potentially affected by this shrinkage are in-line with the repair, so any imposed stress on these welds will be axial rather than bending. (The bending stresses are dominant in the recirculation system repairs.) Most of the minor shrinkage experienced during the feedwater repair will be accommodated by flexure of the relatively flexible feedwater riser piping, so no significant stress is expected in any of the Inconel or Inconel to carbon steel welds adjacent to the repair location.

A simple finite element piping analysis of the feedwater riser and safe-end region was performed to confirm this conclusion. The finite element model is shown in Figure 3. The resulting stresses at each of the Inconel weld joints in this line are shown in Table 2. These stresses are not expected to have a significant effect on these welds.
