BELLEFONTE NUCLEAR PLANT UNITS 1 AND 2 - REVISED RESPONSE TO DEVIATIONS 50-438/83-10-01, 50-439/10-01, PORTIONS OF THE FIRE PROTECTION SYSTEMS DO NOT CONFORM TO THE DESIGN CRITERIA OF THE APPLICABLE NFPA CODE - 50-438/83-10-03, 50-439/10-03, EXTERIOR FIRE PROTECTION WATER SYSTEM WAS NOT INSTALLED UNDER A QA/QC PROGRAM - 50-438/83-10-05, 50-439/83-10-05, IMPROPER FIRE DAMPER INSTALLATION

BELLEFONTE NUCLEAR PLANTS UNITS 1 AND 2
REVISED RESPONSE TO DEVIATION 50-438/83-10-01, 50-439/83-10-01
PORTIONS OF THE FIRE PROTECTION SYSTEMS DO NOT CONFORM TO
THE DESIGN CRITERIA OF THE APPLICABLE NFPA CODE

BELLEFONTE NUCLEAR PLANT UNITS 1 AND 2
REVISED RESPONSE TO DEVIATION 50-438/83-10-03, 50-439/83-10-03
EXTERIOR FIRE PROTECTION WATER SYSTEM WAS NOT
INSTALLED UNDER A QA/QC PROGRAM

BELLEFONTE NUCLEAR PLANT UNITS 1 AND 2
REVISED RESPONSE TO DEVIATION 50-438/83-10-05, 50-439/83-10-05
IMPROPER FIRE DAMPER INSTALLATION

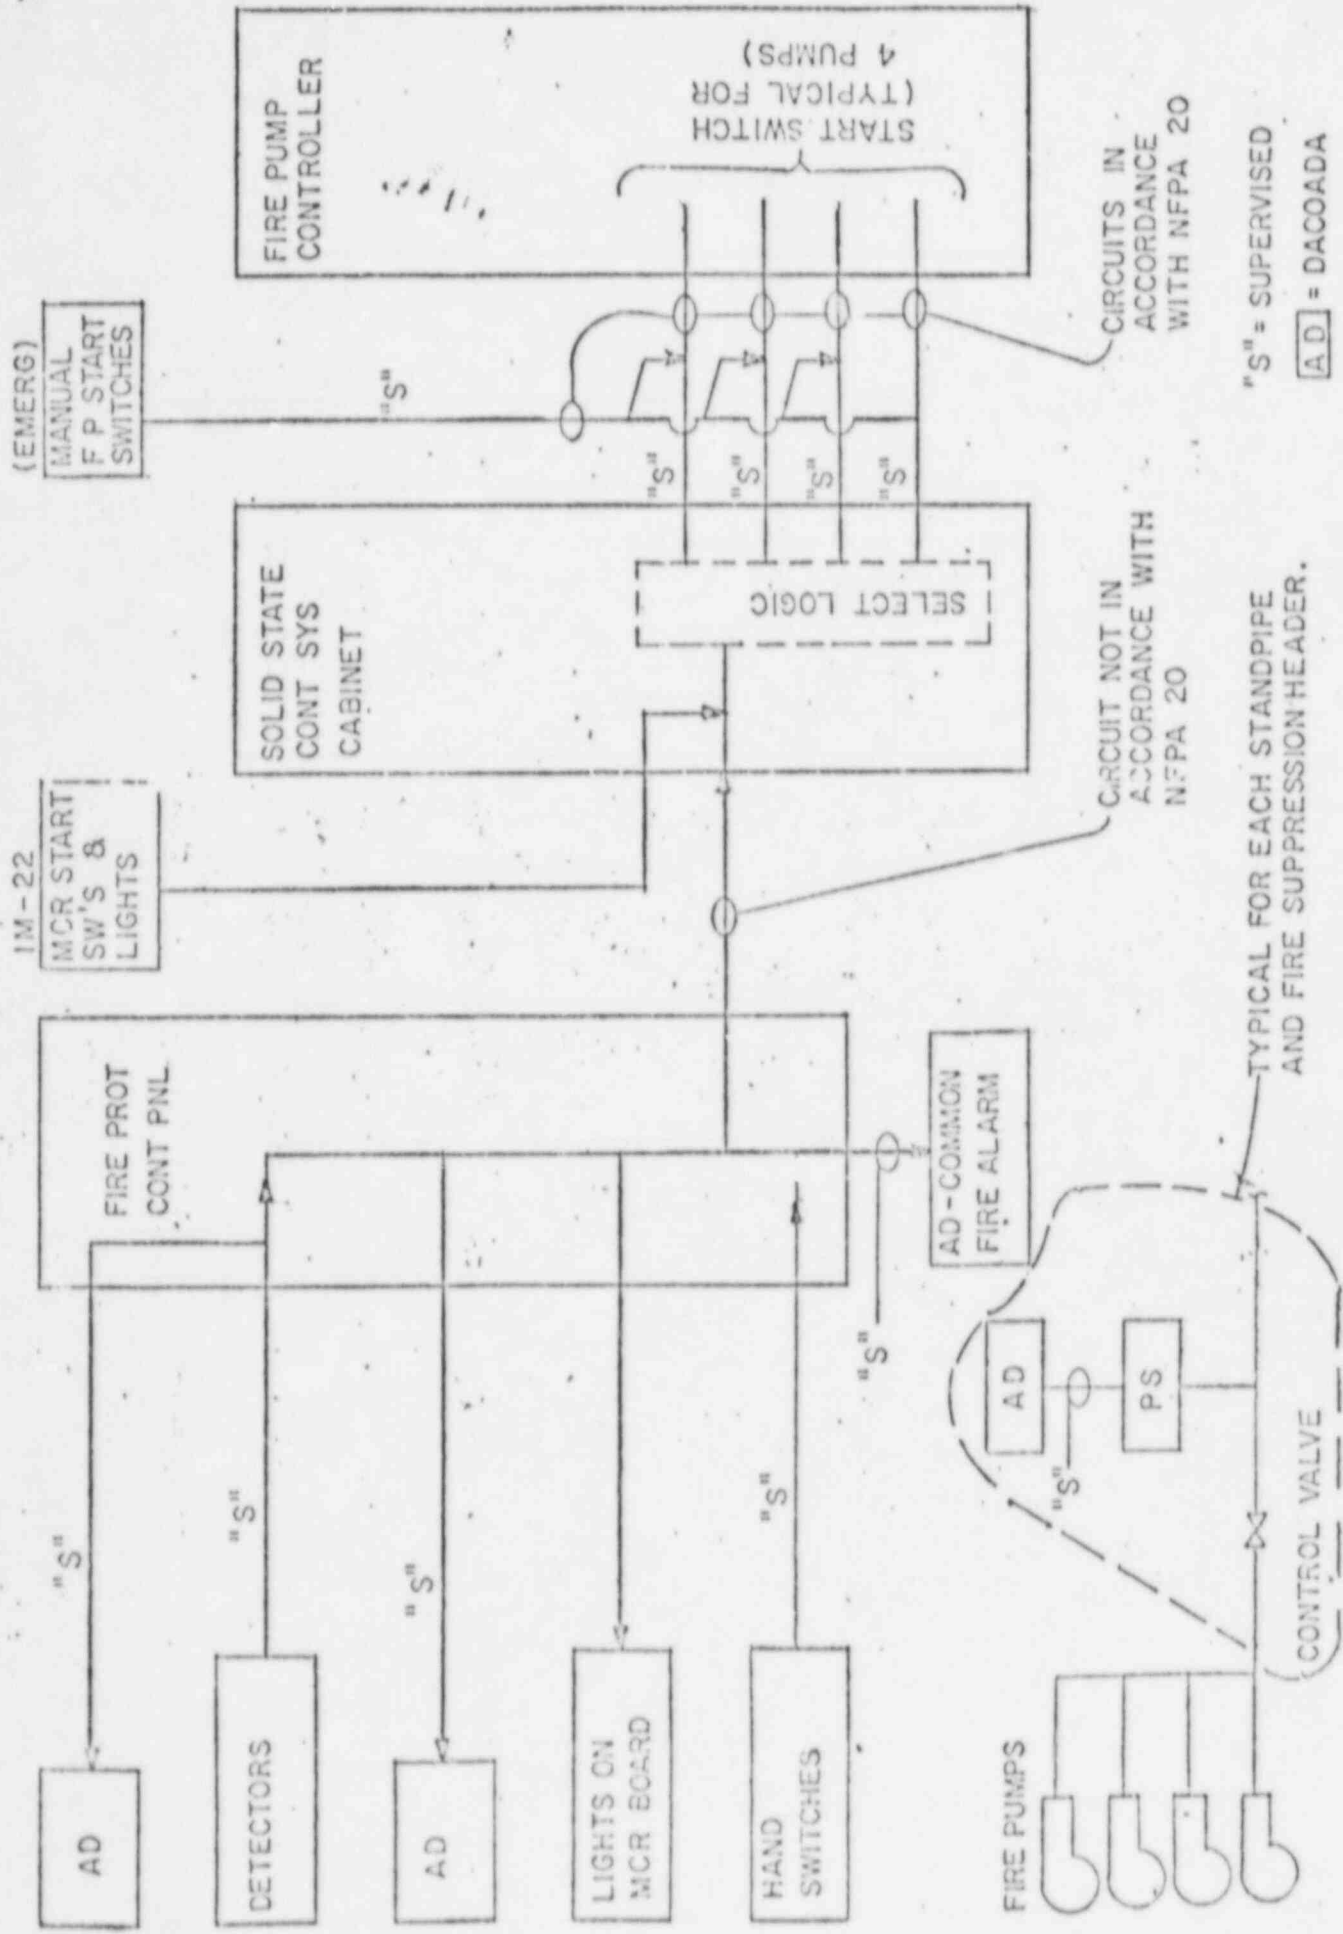
FIGURE 1

The fire pump actuation circuits are routed from two fire detection control panels in the auxiliary instrument rooms through the Solid-State Control System (SSCS) cabinets to the pump controllers. The starting circuits from the SSCS cabinets to the pump controllers are wired to normally closed contacts and are arranged such that breakage, disconnection, or loss of power to the starting circuits will cause automatic continuous operation of the fire pumps. Circuits from the fire detection panels to the SSCS cabinets are wired to normally open contact, and failure of these circuits will not cause automatic start of the fire pumps. However, if an input signal to the detection panels requiring fire pump start fails to generate a corresponding output to the SSCS, the control room operator is notified that an alarm condition exists on that panel. This is transmitted over a common alarm circuit from the detection panels to the Data Acquisition and Control, Operation Recording, Annunciation, Data Logging, Access Control, and Fire Detection System (DACODA). Appropriate manual actions will then be taken to start the fire pumps. All input signals to the detection panels are supervised. In addition, the fire pumps can be started from the main control room through the SSCS. If the SSCS should fail, the fire pumps can also be started by an emergency bypass switch located in the immediate vicinity of the SSCS cabinets. This switch is a normally closed contact and the circuit is arranged such that any breakage, disconnection, or loss of power will cause automatic continuous operation of the fire pumps. The fire pump controller is also wired so that a loss of power to the controller will cause automatic continuous operation of the fire pumps.

TVA believes that the unique arrangement of the Bellefonte Nuclear Plant's SSCS in conjunction with the level of supervision of fire detection input circuitry to the detection panels and plant operating procedures provide a level of protection that meets the intent of NFPA 20-1976, Section 9-5.2.4 (FSAR Code of Record).

The following Fire Pump Start Block Diagram (Figure 1) with accompanying explanatory notes illustrates the fire pump start circuitry inputs.

1. In event of either a detector actuation or manual fire pump start initiation, there is an alarm on DACOADA (supervised) for the individual condition and a common alarm (supervised).

2. There is a pressure-switch indication downstream of each valve (supervised) which can be compared with the alarm in item 1 to ensure pumps have started and valve has opened. (Exceptions are standpipes which do not have valves).

3. If pumps start, there will be indication on main control room board (MCR) IM-22. If not started, operator can attempt to start them from: (1) MCR (nonsupervised circuit), (2) manual fire pump start switch downstream of solid state control system (SSCS) (supervised), or (3) at the fire pump controller.

4. In summary, there are supervised circuits to alarm the operator that the pumps should be started and status (most of which is supervised) to show that they have started. If they did not start, there is both nonsupervised start circuits in MCR and supervised start circuits at the SSCS cabinet.

5. There are 20,000-gallon tanks on top of the turbine building which would gravity-feed most areas which would automatically fill from the four electric pumps.
