# NORTHEAST UTILITIES

## LICENSEE EVENT REPORT (LER)

Millstone Nuclear Power Station Unit 3

TITLE (4) Failure to Adequately Perform Overlap Testing of the Containment Depressurization Actuation Loops  
Due to Management Deficiency

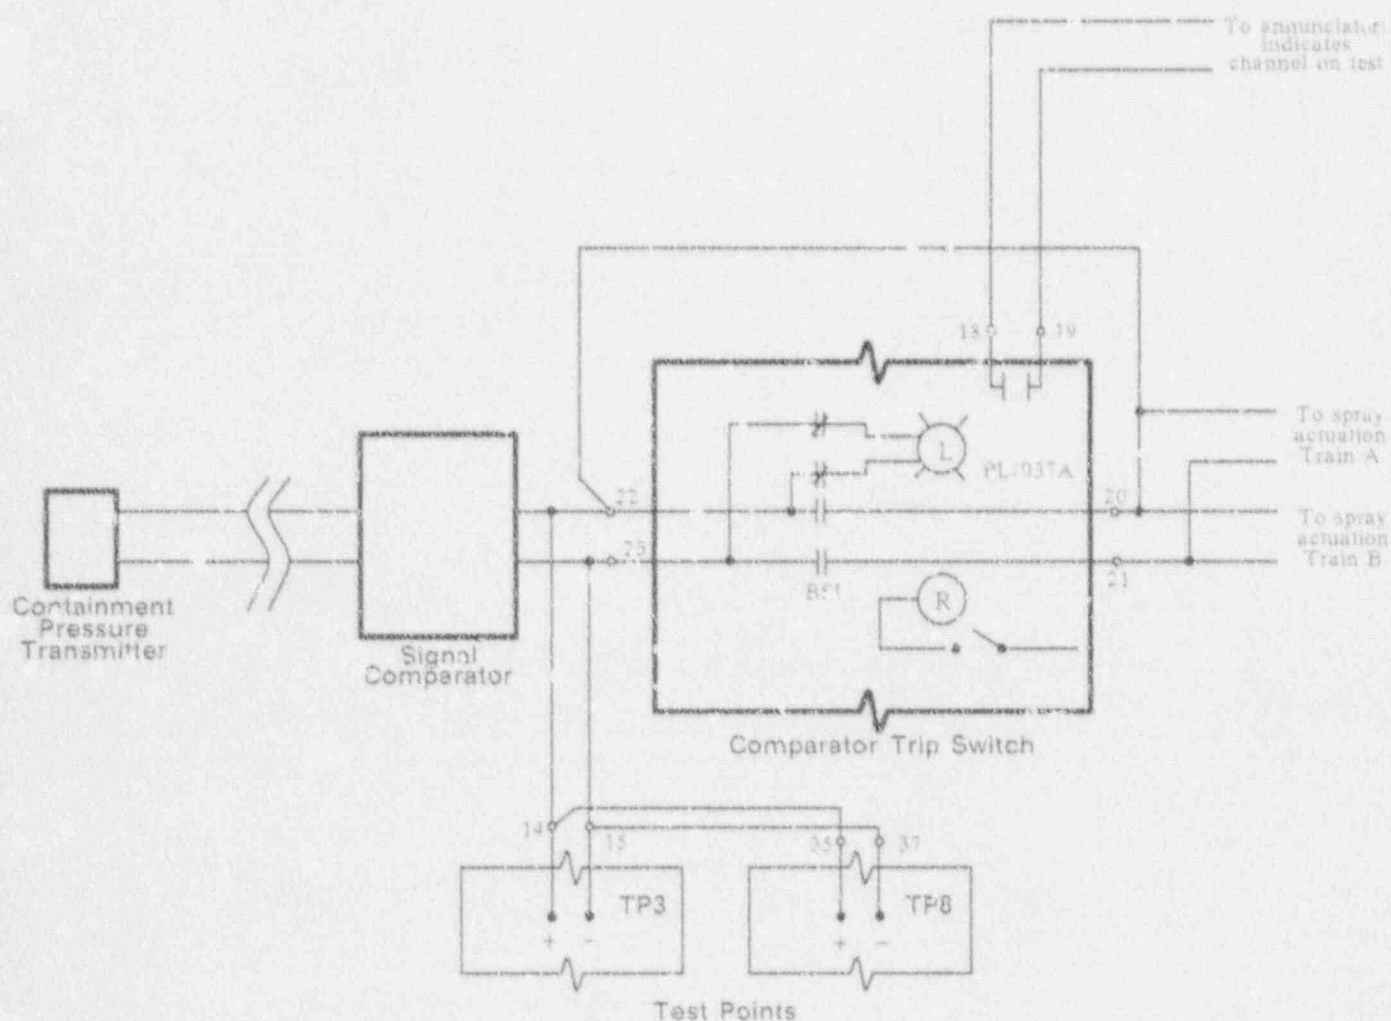
CDA Protection Channel Figure (Partial)

On August 20, 1991, at 0800 hours, while shutdown in Mode 5 (Cold Shutdown), at 95 degrees Fahrenheit and atmospheric pressure, Instrumentation & Controls (I&C) Department personnel reviewing the test methodology during the performance of the monthly analog operational check discovered that closure of the comparator trip switch auxiliary (BSI) contact, which enables transmission of the Containment Depressurization Actuation (CDA) signal, was not being verified. During the investigation of the event, it was determined that the refueling channel calibration procedures for the four CDA signal pressure channels were not in full compliance with the requirements of the Technical Specifications. The Technical Specifications require that overlap testing be performed as part of a channel calibration. The refueling channel calibration procedures did not verify closure of the BSI contact. This contact is in series to allow processing of a CDA signal from the Westinghouse 7300 instrument racks, to the Solid State Protection System (see the attached figure).

A channel calibration is performed on all four containment pressure instruments at least once every 18 months (i.e., at refueling) pursuant to the requirements of Technical Specification 4.3.2.1. However, the applicable procedures did not contain sufficient overlap to verify continuity between: a) the containment pressure instrument input to the comparator trip switch test card; the Westinghouse 7300 instrument racks and b) the output of the comparator trip switch test card (to the Solid State Protection System).

There are four utilized contacts on the comparator trip switch test card: two (normally open) contacts are used to light the associated bistable when the switch is in test. One (normally closed) contact is used to provide a channel in test annunciation. The (normally closed) BSI contact is used in line with the SSPS input relays to block an actuation signal while in test. Since they employ different sets of auxiliary contacts (from the same switch), neither the bistable light nor the "channel in test" annunciator provide positive indication of the position of the comparator trip switch BSI contact.

The monthly analog channel operational test procedures were modified to include guidance on continuity verification of the CDA comparator trip switch BSI contact for the four protection channels. These procedures were changed vice the channel calibration procedures since they are performed on a more conservative frequency. The modified surveillance procedures were satisfactorily performed. The review of other protection channel instrument loops did not identify similar deficiencies. A review of other I&C department procedures versus the vendor operating instructions has been performed to determine if similar conditions exist. Discrepancies were identified in the step sequence of some procedures. These discrepancies do not violate any of the Plant Technical Specifications or Final Safety Analysis Report (FSAR) requirements, and will be resolved via the internal commitment tracking program.
