VERMONT YANKEE NUCLEAR POWER CORPORATION

Subject: **Proposed Alternative for Compliance with
10CFR50.55a Regarding RPV Cladding Indications**

ENGINEERING EVALUATION
OF VERMONT YANKEE REACTOR PRESSURE
VESSEL CLAD INDICATIONS
1992 REFUELING OUTAGE

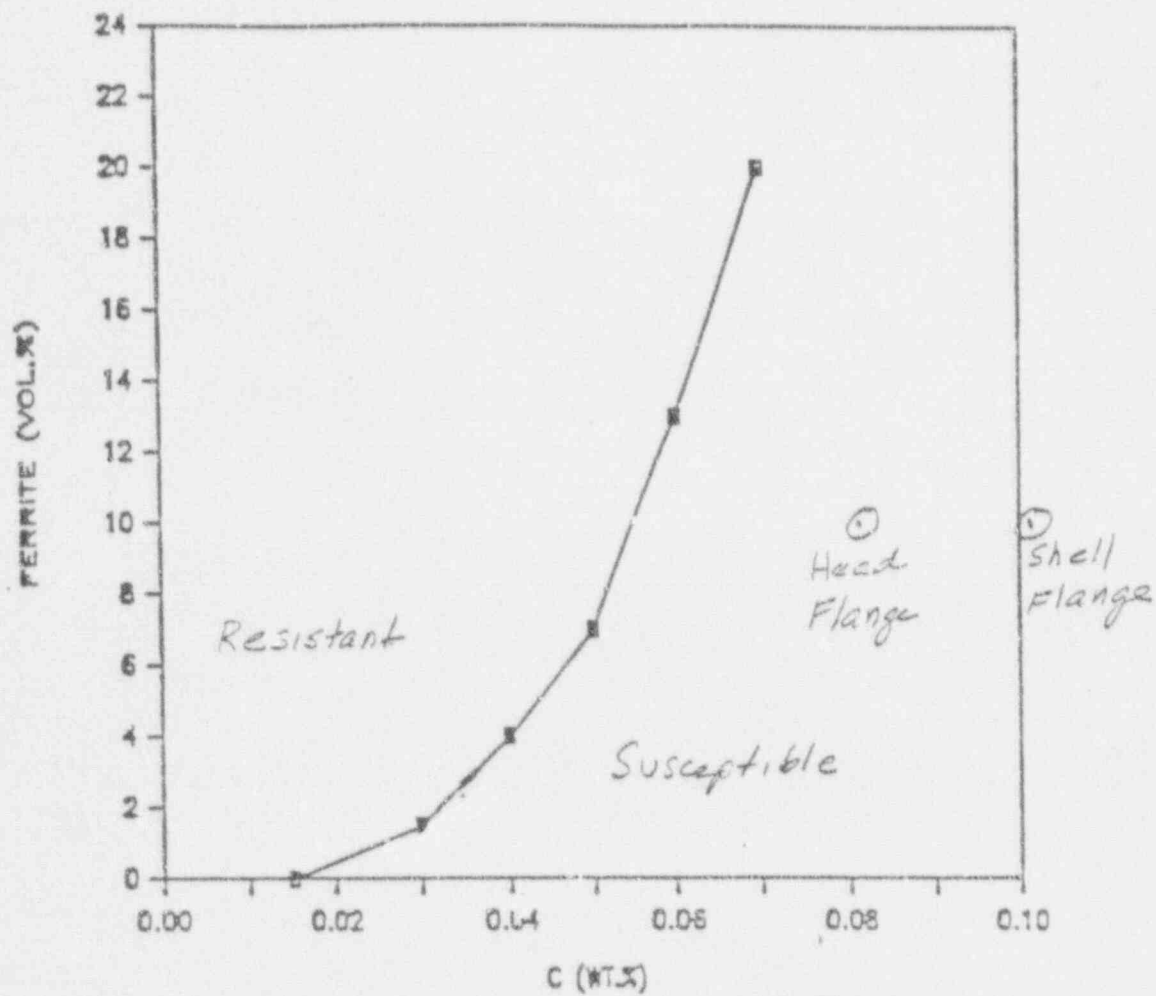
FIGURE 2

melts and mixes with the weld metal that is being deposited. As the welding heat input is increased, a greater amount of basemetal is melted. This results in an altered chemistry of the weld deposit, as compared with the original welding electrode. Depending on the heat input, this re alloying process can occur in multiple layers of weld deposit. Studies performed in 1986 during the development of the core spray nozzle weld overlay at Vermont Yankee showed that a minimum of three weld layers were needed to obtain an unaffected weld material chemistry sample, and this was from a very tightly controlled heat input welding process. Similar experiences are reported in the technical literature. An engineering investigation performed as part of the Vermont Yankee recirculation system pipe replacement project in 1985 showed that as carbon content increased above about 0.05 w/o the amount of ferrite required for IGSCC resistance increased rapidly [see Figure 2]. Therefore, it is likely that the cladding has low IGSCC resistance.

Metal chips were removed from the head and vessel flange area cladding for chemical analysis. The carbon content of the material removed was 0.079 w/o for the head flange and 0.11 w/o for the shell flange. The carbon content of the shell flange cladding is well above the specification upper limit for carbon of 0.08 w/o max. The head flange value is within specification range. However, a review of all the welding electrode material certifications showed no heats to be this high. Thus it can be concluded that the cladding has picked up carbon from the basemetal during welding of the cladding. These carbon levels place the cladding in the highly susceptible region for IGSCC [see Figure 2].

Predicted Ferrite Requirements Versus Carbon Content to Give Immunity Against SCC for Grade CF8 Castings

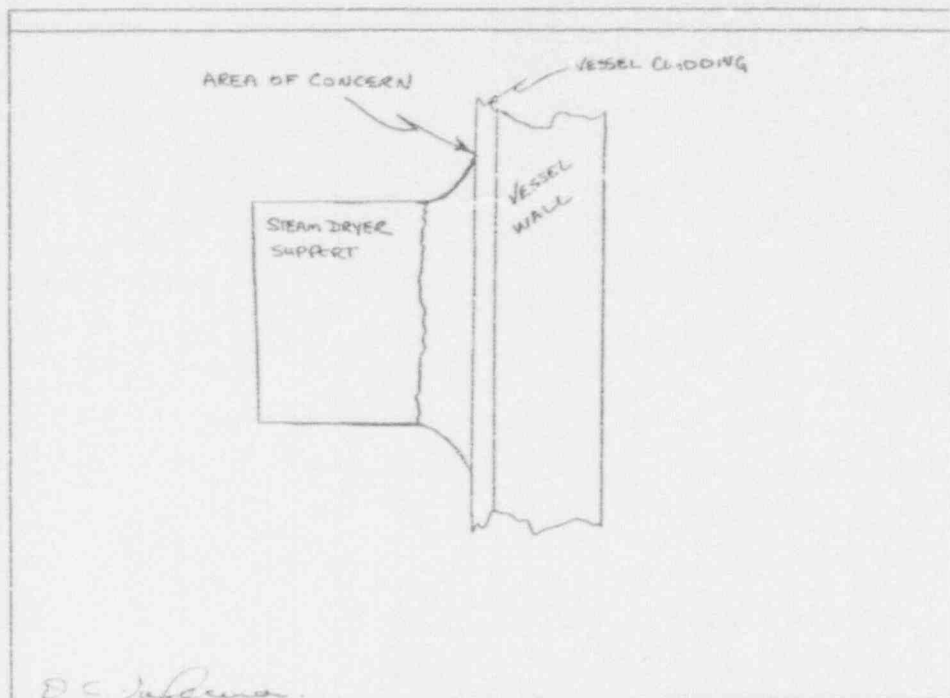
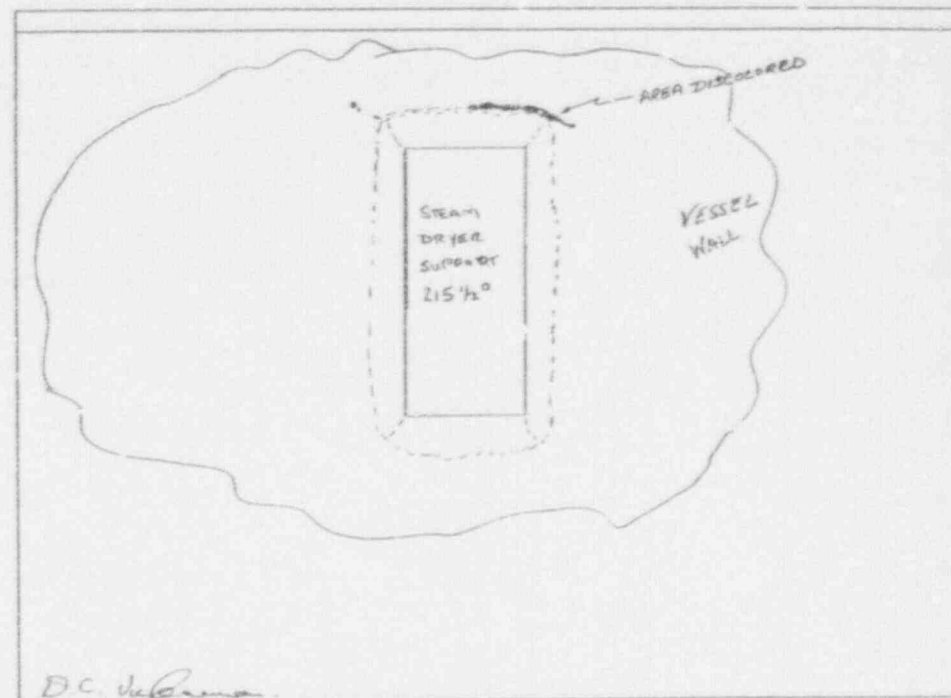
FIGURE 3

During the visual examination of the RPV internals, a rust area was observed adjacent to the fillet weld where the steam dryer support bracket weld meets the vessel cladding. This indication was quite visible since the in-vessel examinations were being conducted with a color camera. The 1983 black and white video tape of the same area was reviewed. In the same area as the rust, one could discern a slightly lighter region. This was not recorded as a region of concern in 1983 and if not for the increased contrast of the color view in the 1992 inspection, it would be hardly noticeable. The area was thoroughly UT examined from outside the vessel. No evidence of any flaw propagation into the basemetal was detected [see Figure 3].

Indication No. 1 Description STEAM DRYER SUPPORT BRACKET 215 1/2"

- re-inspect the dryer support bracket indication during the 1993 refueling outage and the following two examination periods.
- perform visual and UT inspection on the RPV head flange cladding during the 1993 refueling outage. The inspection areas will be within the same areas as inspected in 1992.
