Hope Creek Generating Station

HOPE CREEK GENERATING STATION
DOCKET NO. 50-354
UNIT NO. 1
LICENSEE EVENT REPORT 92-004

LICENSEE EVENT REPORT																													
FACILITY NAME (1) HOPE CREEK GENERATING STATION															DOCKET NUMBER (2) 0 5 0 0 0 3 5 4										PAGE (3) 1 OF 5				
TITLE (4): Engineered Safety System Actuation: Channel "B" Emergency Core Cooling System actuation during design change implementation due to design deficiency and personnel errors.																													
EVENT DATE (5)					LER NUMBER (6)										REPORT DATE (7)					OTHER FACILITIES INVOLVED (8)									
MONTH	DAY	YEAR	YEAR	*	NUMBER	*	REV	MONTH	DAY	YEAR	FACILITY NAME(S)					DOCKET NUMBER(S)													
0	3	0	8	9	2	9	2	-	0	0	4	-	0	0	0	4	0	6	9	2									
OPERATING (9) MODE					THIS REPORT IS SUBMITTED PURSUANT TO THE REQUIREMENTS OF 10CFR (CHECK ONE OR MORE BELOW) (11)																								
POWER LEVEL % 0 0 0					<div style="display: flex; justify-content: space-between;"> <div> 20.402(b) 20.405(a)(1)(i) 20.405(a)(1)(ii) 20.405(a)(1)(iii) 20.405(a)(1)(iv) 20.405(a)(1)(v) </div> <div> 20.405(c) 50.36(c)(1) 50.36(c)(2) 50.73(a)(2)(i) 50.73(a)(2)(ii) 50.73(a)(2)(iii) </div> <div> xx 50

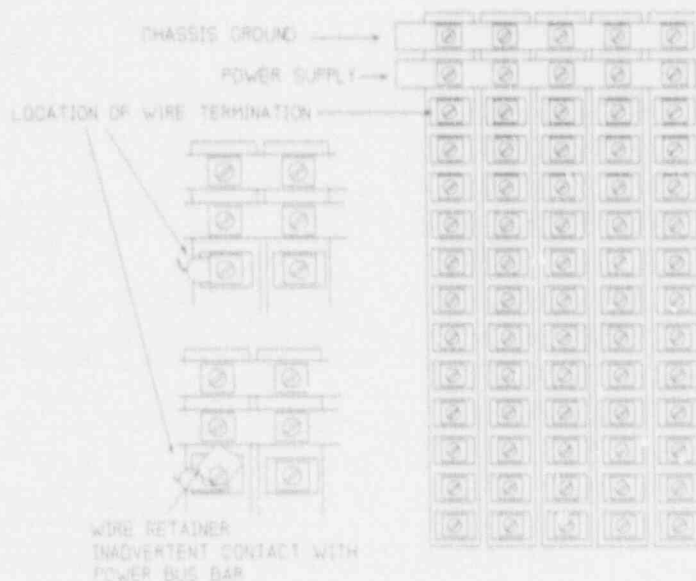
ROSEMOUNT TRIP UNIT CONNECTIONS

The Rosemount trip units monitor plant parameters and provide trip signals for ECCS equipment when predetermined action levels are exceeded. The system is configured with up to 12 trip units located in a rack with a common 24 vdc power supply and ground via bus bars which run the length of the cabinet rear. There are an additional 14 terminals on the rear of the rack for each trip unit for field wiring and interconnections. The location of the rack and the close proximity of the termination posts render modifications to the rear panel difficult. For this reason, and the previous ESF actuation which occurred during DCP implementation on 6/19/91 (see LER 91-014-00), it had been decided to complete the DCP during a shutdown.

As the leads were being landed to the rear of a Rosemount trip unit a wire retaining ring attached to the screw inadvertently rotated such that it came in contact with the power bus bar. When the bus bar was momentarily grounded a temporary loss of power to the channel "B" ECCS trip units in the cabinet occurred and when power to the trip units returned, selected trip units actuated.
