HOPE CREEK GENERATING STATION
DOCKET NO. 50-354
UNIT NO. 1
LICENSEE EVENT REPORT 91-018

LICENSEE EVENT REPORT																													
FACILITY NAME (1) HOPE CREEK GENERATING STATION															DOCKET NUMBER (2) 0 5 0 0 0 3 5 4										PAGE (3) 1 OF 4				
TITLE (4): Engineered Safety System Action - "F" Filtration Recirculation Ventilation System Fan start.																													
EVENT DATE (5)					LER NUMBER (6)										REPORT DATE (7)					OTHER FACILITIES INVOLVED (8)									
MONTH	DAY	YEAR	YEAR	*	NUMBER	*	REV	MONTH	DAY	YEAR	FACILITY NAME(S)					DOCKET NUMBER(S)													
0	9	1	4	9	1	9	1	-	0	1	8	-	3	0	1	0	0	9	9	1									
OPERATING (9) MODE					THIS REPORT IS SUBMITTED PURSUANT TO THE REQUIREMENTS OF 10CFR: (CHECK ONE OR MORE BELOW) (11)																								
POWER LEVEL % 1 0 0					20.402(b)										20.405(c)					xx 50.73(a)(2)(iv)					73.71(b)

Engineered Safety Feature Actuation - Unplanned start of standby Filtration Recirculation System Recirculation Fan F from non-ESF signal.

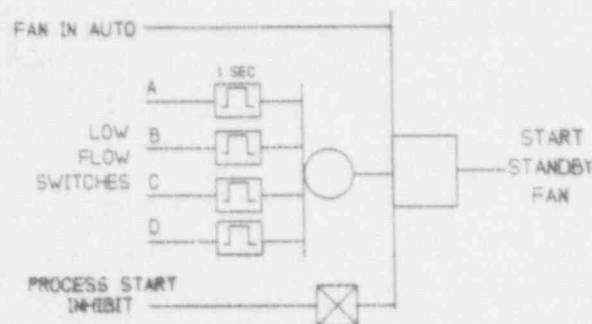
The low flow start signal is generated via flow switches located on the outlet of the recirculation units and is processed through the Bailey Logic panel. When the logic senses low flow on a running fan an auto start signal is generated to start a standby fan. The configuration of the logic will send an auto start signal whenever low flow is sensed; however, the duration of the signal is only one second long. This allows the standby fans to be placed in auto after the running fans have been secured. If the signal is reset by either a valid or spurious flow signal and subsequently low flow is sensed again, a new start signal will be generated to start the standby fan. The I&C Technician troubleshooting the auto start found water in the C FRVS recirc fan low flow switch. The switch has a range of 0 - .15" of water, with the trip setpoint set at .1" of water. The accumulation of water in conjunction with minor fluctuations in system pressure reset the switch momentarily simulating a normal flow condition in the logic. Subsequent pressure perturbation caused the switch to sense low flow and start the standby fan.

The cause of this event is the accumulation of water in the low flow switch combined with minor pressure perturbation in the ventilation system causing actuation of the low flow auto start logic for the F Recirc fan. The failure to revise all related FRVS system procedures when the surveillance procedure was revised also contributed to this event.

1. The FRVS system operating procedure will be revised to add a section for draining the low flow switches following fan runs.
2. A Design Change has been approved to modify the auto start logic to preclude spurious starts. Planning and System Engineering are reviewing the possibility of performing the design change while the unit is at power; however, due to the location and configuration of the wiring which must be modified there is a risk of rendering vital equipment inoperable and/or possible reactor scram. As the spurious start of the standby FRVS Recirc fan pose minimal safety significance, the design change is currently scheduled for shutdown conditions with implementation no later than the fourth refuel outage.

3. Procedure writers will be advised to consider all relevant system maintenance and operating procedures when improvements are made to one category.
4. System Engineering will review the configuration of the instrument tubing to determine if changes can be made to eliminate the accumulation of water in the flow switches.
