Donald C. Shelton
Vice President - Nuclear
Davis-Besse

Docket Number 50-346

October 15, 1991

Subject: License Amendment Request to Revise Technical Specification
5.3.1, Fuel Assemblies: Additional Information

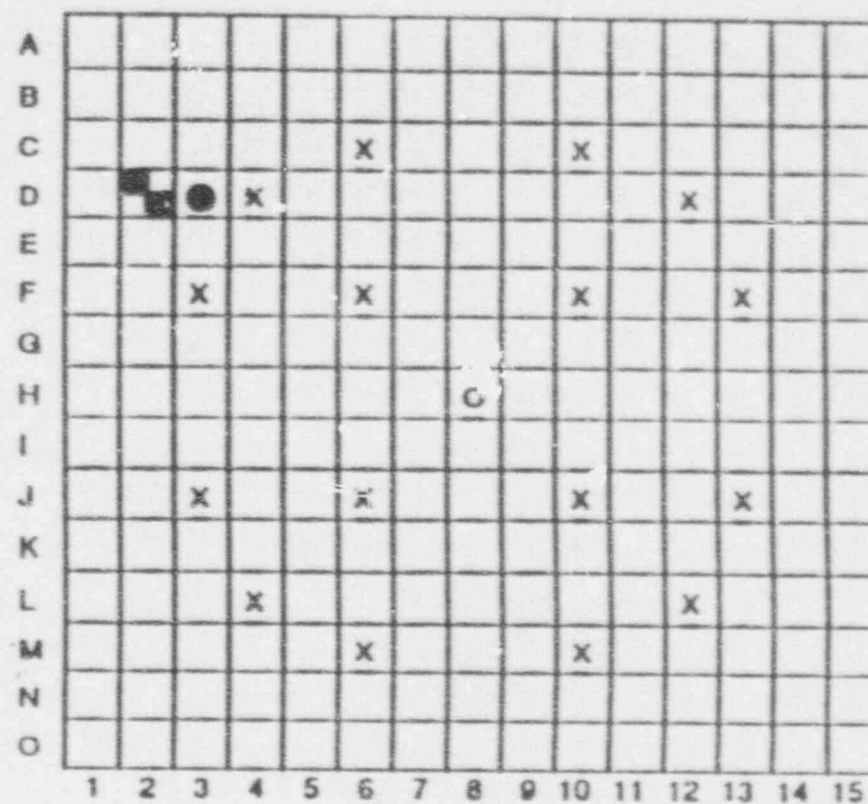
Fuel Assembly Map

The remaining Batch 9 FA had a defective fuel pin in a location adjacent to a control rod guide tube. This FA was reconstituted by removing the upper end fitting, extracting the defective fuel pin, moving an adjacent fuel pin into the location vacated by the defective fuel pin, inserting a solid stainless steel (SS) filler rod into the location vacated by the good pin, and then replacing the upper end fitting. The attached Figure 1 shows the location of the SS filler rod in the FA and the location of the FA in Cycle 8. The resulting configuration has the SS pin surrounded by heated rods (i.e., there are no adjacent cold walls). As discussed in the above-mentioned previous meetings with the NRC Staff, this FA configuration does not require any critical heat flux (CHF) penalties. The channels with the SS pin and surrounding fuel pins are not the lead channels for power generation in this FA. The minimum thermal margin for this FA will be greater than 5 percent relative to the lead power generation FAs in the core.

ASSEMBLY NJ0542
 BATCH 9
 RECONSTITUTABLE

● LOCATION WHICH HAD DEFECTIVE PIN
 ■ LOCATION CONTAINING SS FILLER ROD

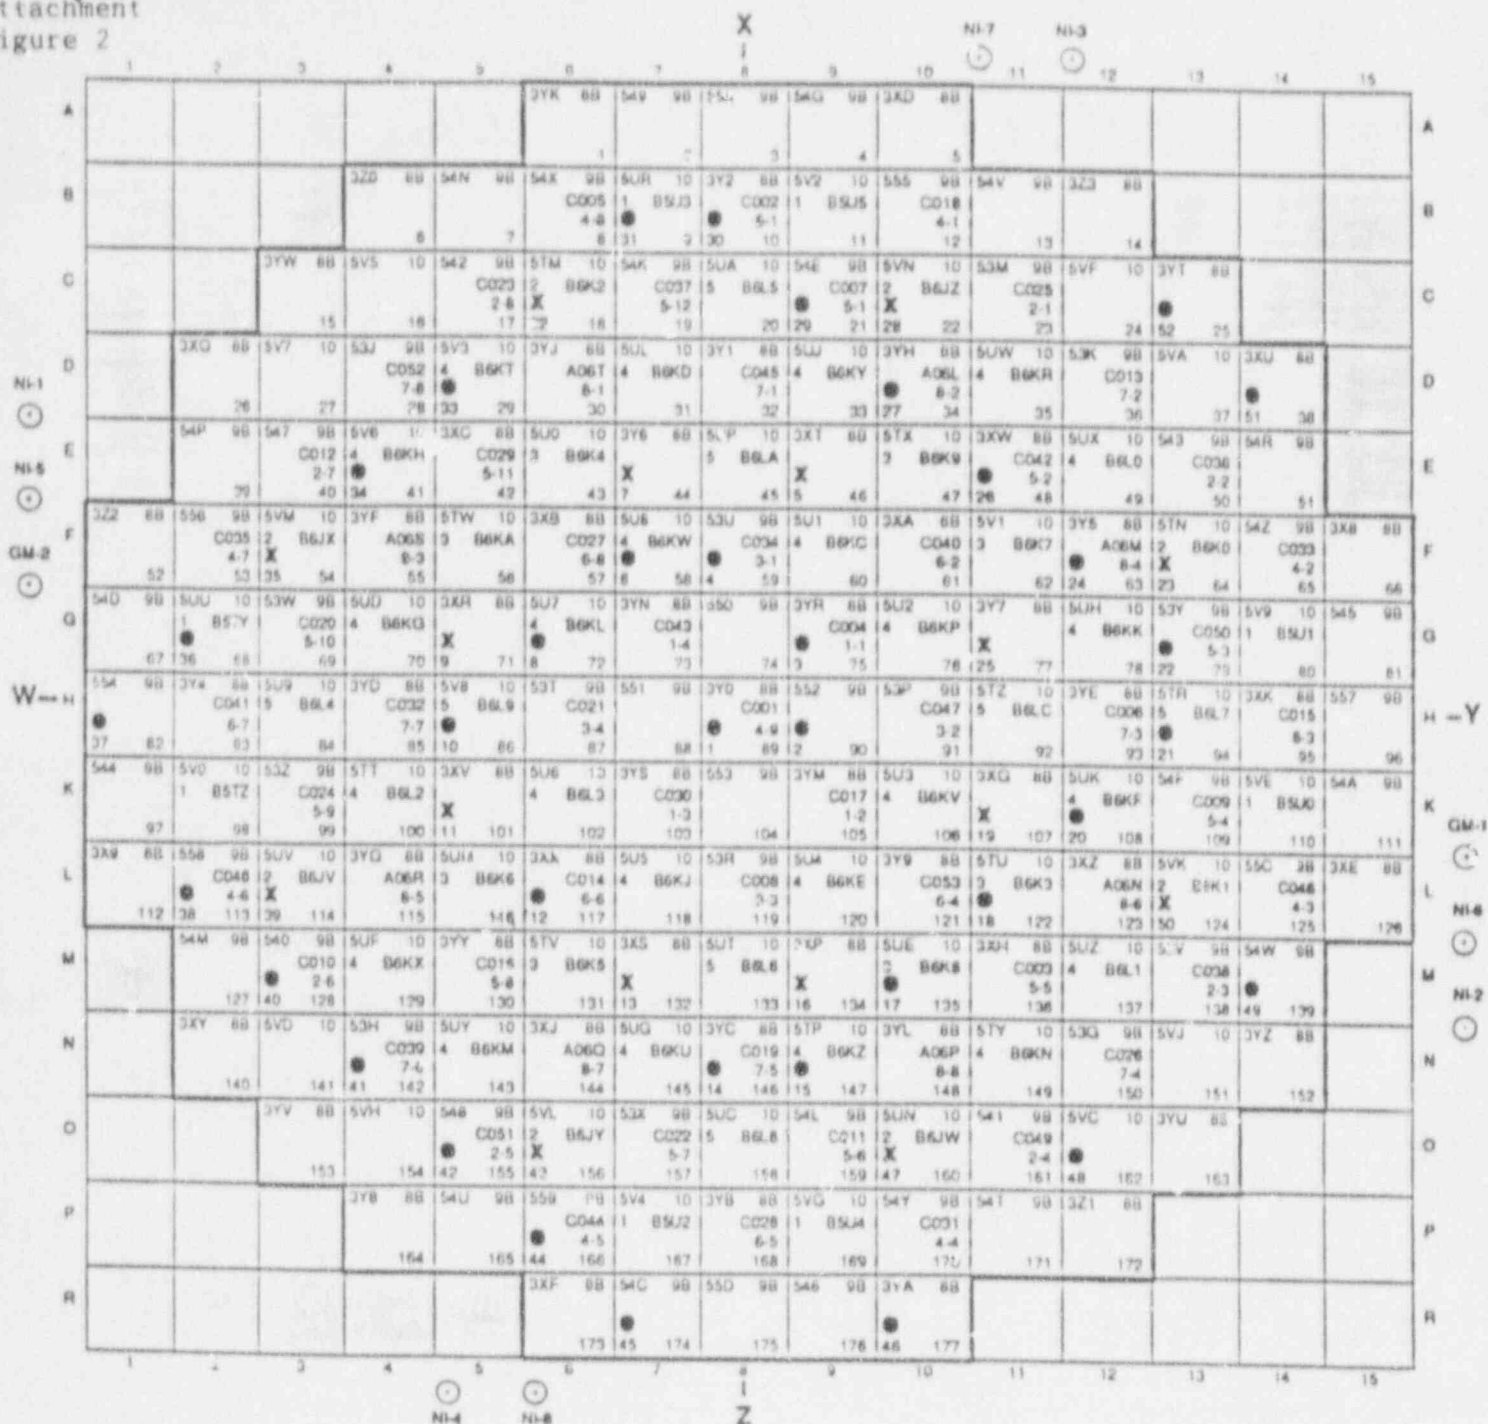
Docket Number 50-346
 License Number NPP-3
 Serial Number 1990
 Attachment
 Figure 2

The cycle-specific vendor analyses to support the Cycle 8 redesign are underway. Preliminary results show that the existing Reload Report conclusions will remain bounding. The cycle-specific analyses will further verify that acceptable safety margins are maintained. Conformance to existing design criteria and safety analysis limits will be confirmed. The attached Figure 2 shows the core map for Cycle 8.
