Subject: Quad Cities Station Units 1 and 2  
Core Shroud Repair Hardware Inadvertent Loading  
NRC Docket Nos. 50-254 and 50-265

Revised 10 CFR 50.59 Safety Evaluation - Core Shroud Repair  
Revision 4, June 16, 1995

## 10CFR50.59 SAFETY EVALUATION, REVISION 4

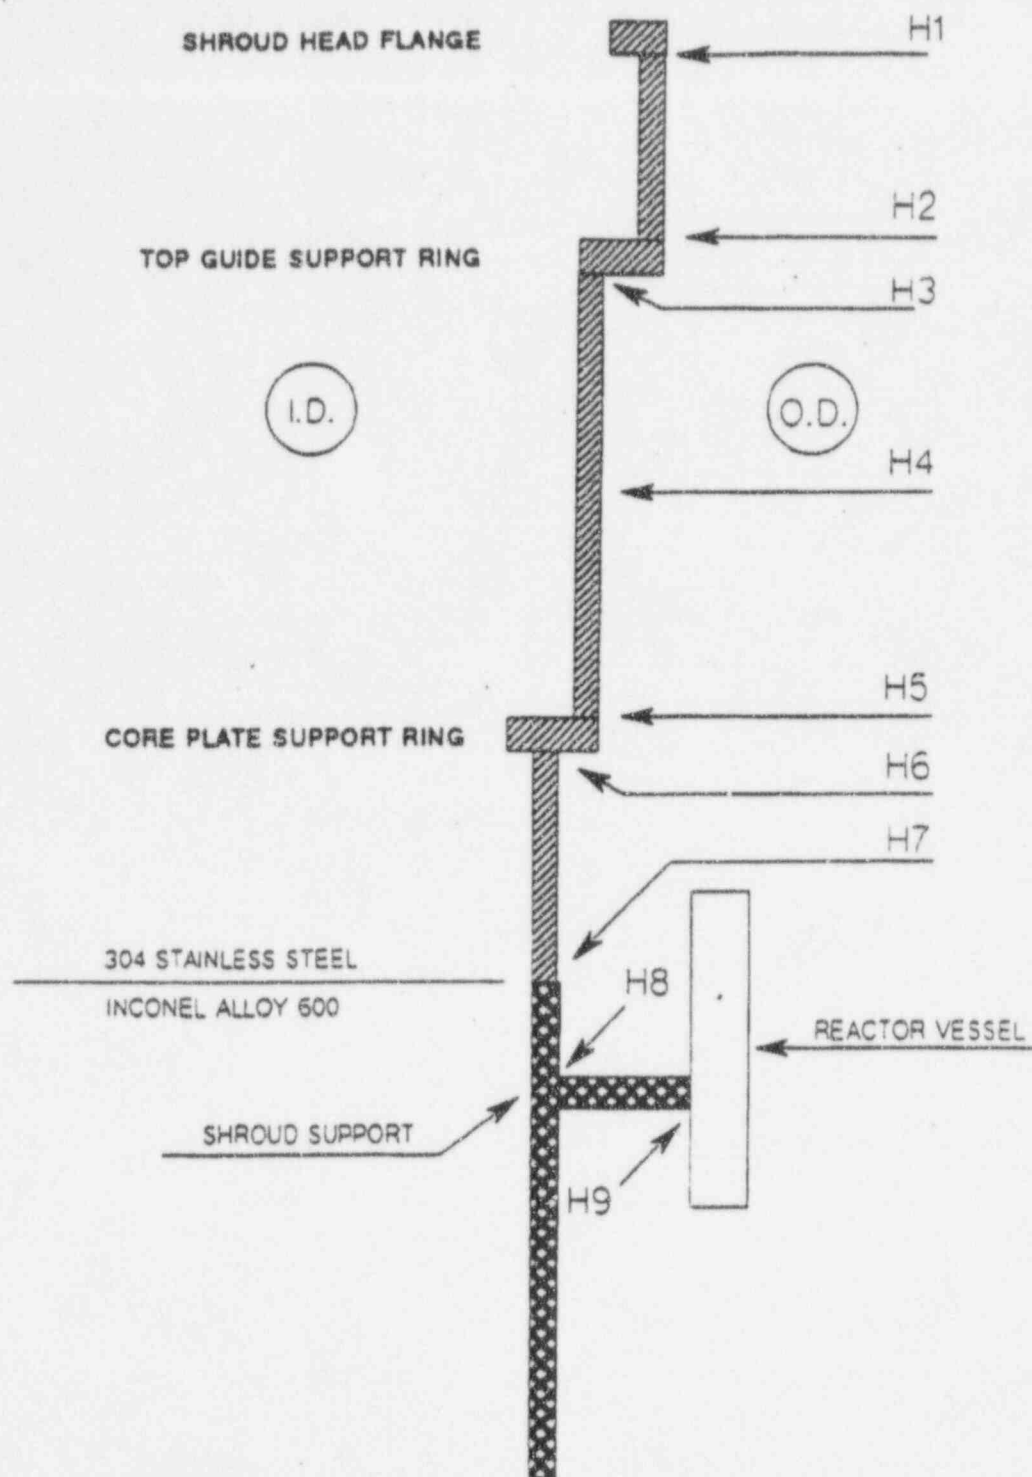
FIGURE 1. HORIZONTAL WELD LOCATIONS

In-vessel inspections found linear indications in the horizontal core shroud welds at Dresden Unit 3 and Quad Cities Unit 1 during the spring 1994 outages. Visual examination and ultrasonic testing at weld H5 indicated the crack extended 360 degrees around the circumference of the shroud. Two boat samples were taken (Quad Cities; azimuths 154 and 342-size 3"x 2"x 1.5"; Dresden; azimuths 153 and 324-size 3"x 2"x 1.35") to examine/analyze the root cause of the linear indications and compare measured crack depths in the samples to the depths determined by ultrasonic testing. Metallurgical evaluation determined intergranular stress corrosion cracking to be the root cause of the linear indications due to the application of the welded Type 304 stainless steel components in a strongly oxidizing aqueous environment.

Linear indications were found in the horizontal core shroud welds at Dresden unit 3 and Quad Cities unit 1 during the spring 1994 outages. At weld H5 the crack extended 360° around the circumference of the shroud. The depth and length of the cracking has made repairs unavoidable at these plants. It is anticipated that the two on line units, Dresden unit 2 and Quad Cities unit 2, will have similar linear indications and will also need repair. The core shroud horizontal welds have a potential of failing through wall. A decision was made that the best design approach was a comprehensive repair that included all the core shroud horizontal welds H1 through H7. In addition, for design purposes the circumferential jet pump support plate H8 weld is to be considered cracked completely through its thickness and 360 degrees.

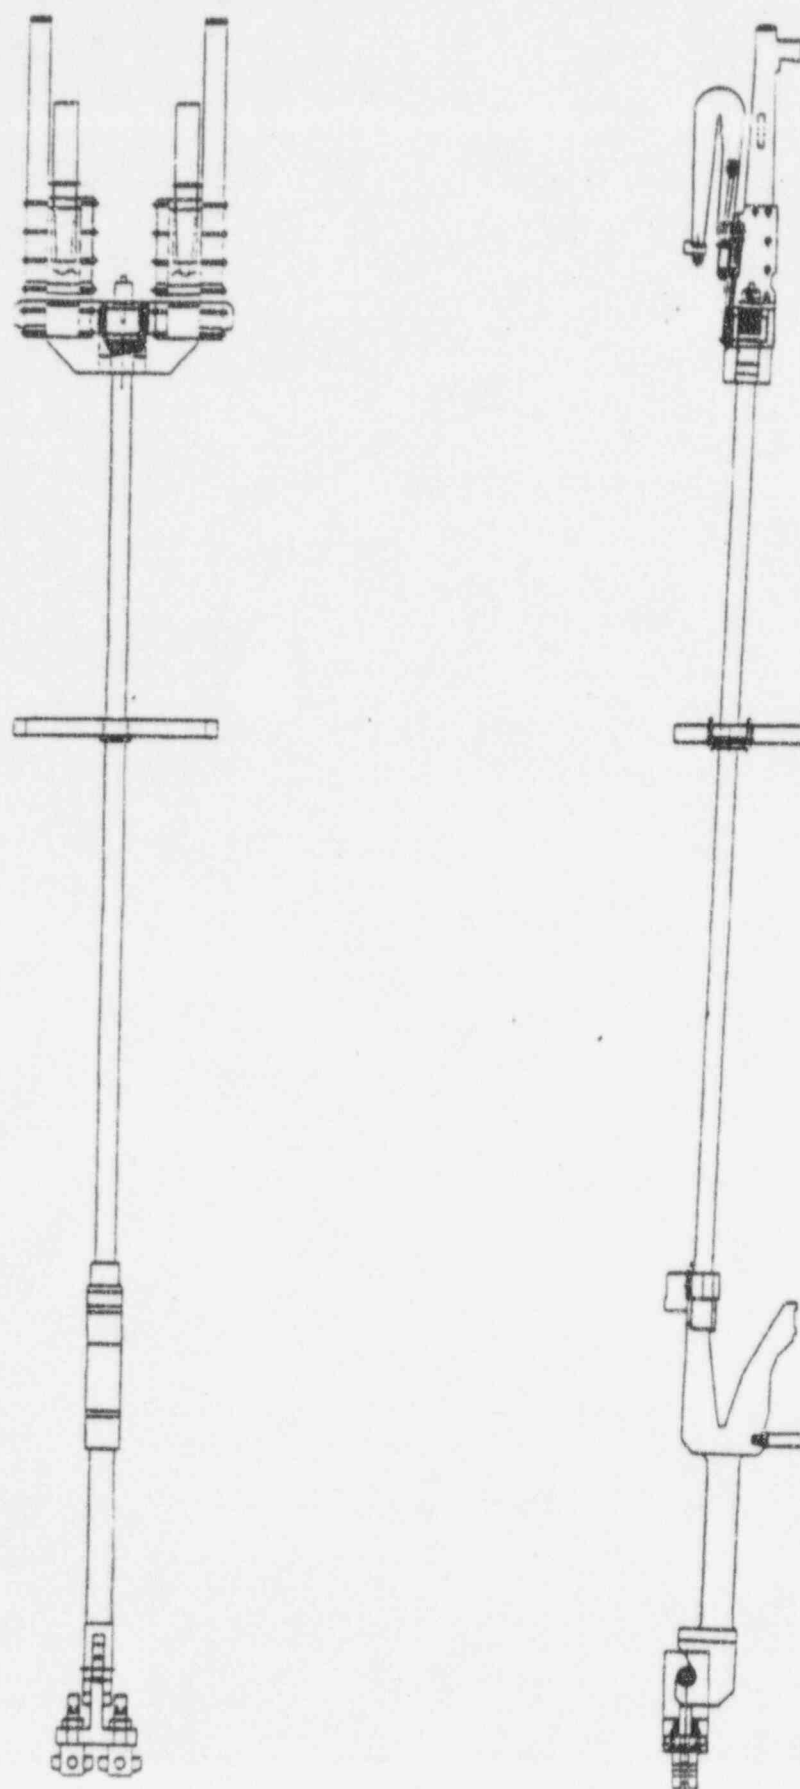
The core shroud repair is designed to structurally replace the core shroud's horizontal welds H1 through H7 and provide vertical clamping forces on the shroud in the event that any or all the seven shroud horizontal weld joints are cracked through wall. In general the core shroud repair design installs low tension tie rods with spring stabilizers connected between the separator head support ring and the jet pump support plate. Four tie rods will be evenly distributed in the annulus region of the reactor pressure vessel. Spring stabilizers will be mounted at the top guide support ring (welds H2/H3) and the core plate support ring (welds H5/H6) in the annulus area between the core shroud and the reactor pressure vessel wall. A middle spring stabilizer is mounted on the tie rod at the same elevation as the jet pump riser braces.
