Subject: Byron Station Units 1 and 2
Braidwood Station Units 1 and 2
Battery Area Woven Wire Fences
NRC Docket Nos. 50-454/455 and
50-456/457

Inspection Report Nos. 50-456/83-17; 50-457 (83-16)

Item 3 - Inspection of Safety-Related 125 Volt DC Battery
Areas for Unit 1 and 2

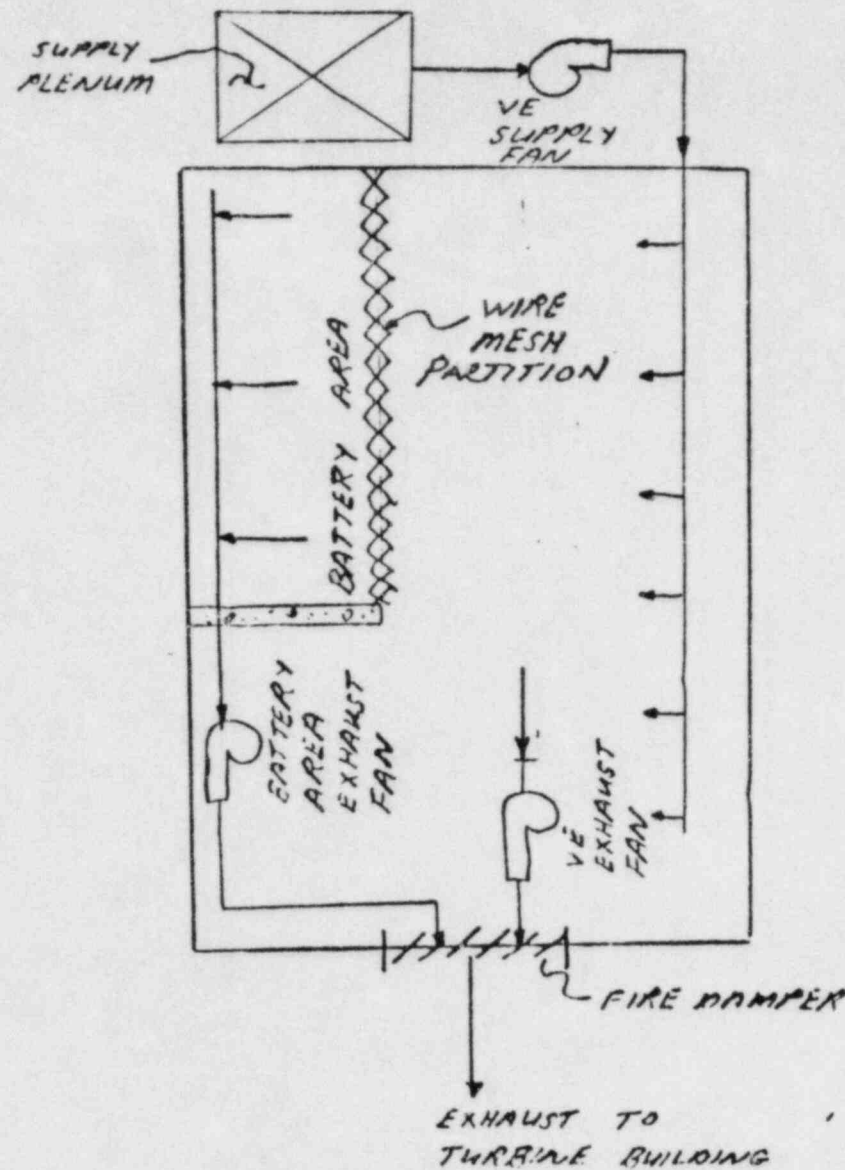
Figure b-1: Miscellaneous Electric Equipment Room
(and Battery Area) Ventilation System
(Typical)

Figure b-1 illustrates the equipment arrangement and air flow for the Miscellaneous Electric Equipment Room ventilation system. As previously noted, the safety-related 125V DC Battery Area is a part of the Miscellaneous Electric Equipment Room, which is enclosed by a three-hour fire-rated barrier. The battery area exhaust ventilation system will remove 475 CFM from the battery area. Based on the volume of the battery area, and on the calculated maximum hydrogen evolution rate (which could occur with a failure of the battery charging system), the ventilation system will limit the hydrogen concentration in the battery area to 1.44%; 2% less than the "2% of the total volume of the battery area" allowed by IEEE Std. 484-1981 (which itself is conservative). All of the make-up air for the battery area exhaust is drawn

from the Miscellaneous Electric Equipment Room. In order to purge (i.e., sweep) the total volume of the battery area, the exhaust duct is located adjacent to the wall opposite the wire mesh partition. The exhaust ductwork is located at the highest practical point in the room (i.e., immediately under the intermediate roof structural steel) and extends over the entire length of the rear battery rack.

Even if it is assumed that a fraction of the hydrogen gas (say 30%) escapes to the Miscellaneous Electric Equipment Room, the maximum concentration of hydrogen in this room is 0.022%, which is insignificant in comparison to the maximum allowable design concentration of 2%.

Since this ventilation system will limit the hydrogen concentration in the battery area to less than 2%, "the battery area (per IEEE Std. 484-1981) . . . should be considered non-hazardous, thus special electrical equipment enclosures to prevent fire or explosions should not be necessary." However, to provide additional conservatism, spark-proof fans with explosion-proof motors are provided for the Battery Area Exhaust Fans (1/2VE02C and 1/2VE03C).

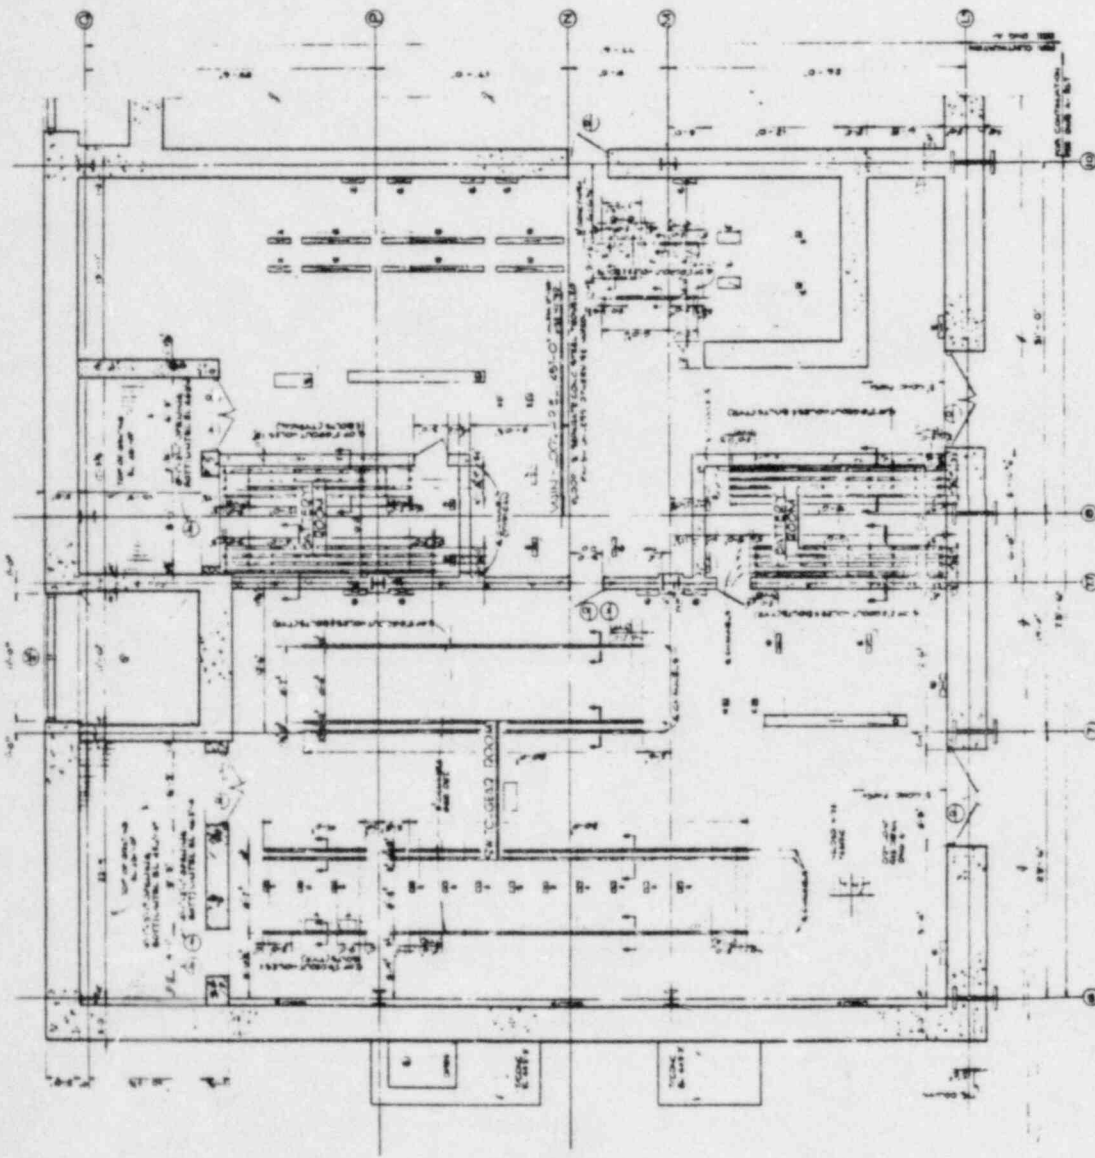
AUXILIARY BUILDING MAIN FLOOR PLAN EL. 45'-0"

- (1) Drawing A-266, dated August 7, 1974, (referenced by the inspector) copy attached, did show a concrete block wall on the south side of Batteries 111 and 112 (the wall in question); however, it should be noted that this issue of this drawing was a preliminary, unsigned drawing showing one (of several) alternate conceptual designs (being considered at the time) which was issued only for "Ref. for bids Spec. F/L-2722" (i.e., this issue of this drawing was utilized only to hire a concrete contractor for the project). Drawing A-266 was not signed (approved) nor released

for construction until Rev. B, dated March 24, 1978 (copy attached). This issue (Rev. B), and all subsequent issues, of this drawing shows a "wire mesh door and partition" on the south side of Batteries 111 and 112.

(2) Contrary to the report, which states that "This revision removed one twenty-two foot concrete Category I block wall from each safety-related battery room and replaced it with an expanded metal wire mesh fence," the concrete block wall was not "removed" because it never existed on a drawing released for construction; i.e., the only approved design ever shown on A-266 was (and still is) a "wire mesh door and partition."
