## LICENSEE EVENT REPORT (LER)

FACILITY NAME (1)  
Duane Arnold Energy CenterDOCKET NUMBER (2)  
0 5 0 0 0 3 3 1 1 OF 0 5TITLE (4)  
MSIV Failure Due to Disc Separation

Subject: Duane Arnold Energy Center  
Docket No. 50-331  
Op. License DPR-49  
Licensee Event Report No. 84-016

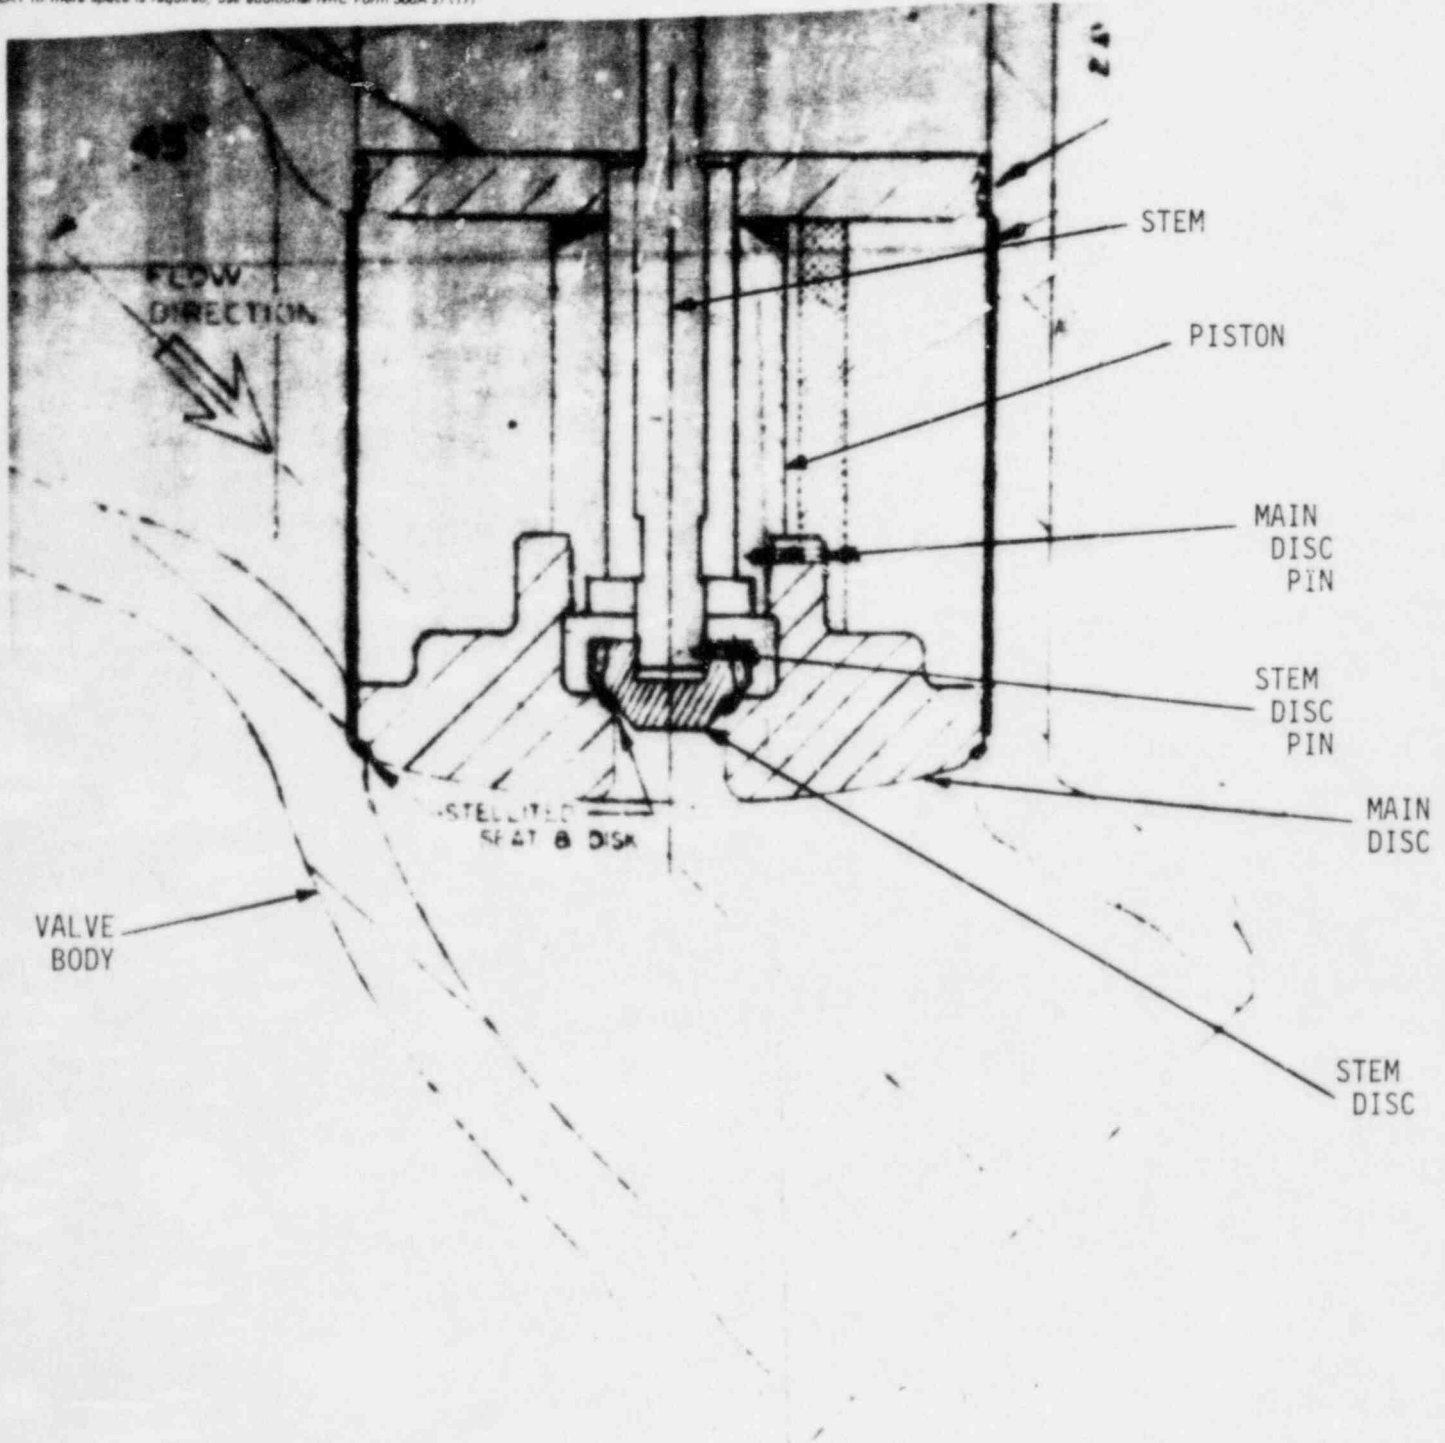
FIGURE 1

Following shutdown, maintenance activities were initiated on the "C" inboard MSIV. This component is a Rockwell International 16" valve (See Figure 1). The as-found condition of the "C" inboard valve was that the main disc had separated from the piston and was turned 90 degrees from its normal position in the valve body. This is the first occurrence of MSIV main disc failure at Duane Arnold. Previous failures at other facilities resulted in the disc seating in the closed position (See, for example, IE Information Notice 81-28).

Removal and inspection of the valve assembly and the loose disc found that: 1) the main disc to piston pin was still in the disc but had been "rolled over" following the separation, 2) the pin hole in the piston was elongated in the axial direction, 3) the piston and main disc threads where the main thread engagement had been were stripped, and 4) the top 2 to 3 piston threads showed no indications of having been engaged. Metallurgical defects or flaws were determined not to be a contributing cause. It was determined that the maintenance reassembly activities when the valve was last reassembled during the Spring, 1982 outage were the cause of the eventual piston/disc separation. The Repair Procedure and instruction manual used to attach the disc to the piston required the disc/piston assembly to be "torqued tight". In this specific case, this left the top threads unengaged and the disc not threaded completely onto the piston. Normal flow conditions caused the disc to vibrate on the piston and eventually wear the threads and locking pin to the point where the assembly separated. Material wear markings on top of the stem-disc indicated the piston/disc assembly was oscillating against it. Over the past two years of operation, the disc began to move on the piston until the threads were finally worn down and only the pin held the disc in place. The final result was a piston/disc separation. This failure mode is the joint conclusion of Iowa Electric Engineering, Maintenance, and an onsite Rockwell service representative. Rockwell has recently revised the torque recommendation for reassembled piston/disc assemblies to 500 ft-lb. However, Rockwell and IE Engineering agree that the revised recommendation does not necessitate piston/disc disassembly and retorquing of the remaining valves in service. As discussed below, our lack of prior piston/disc failures, inspections during previous valve maintenance activities and disassembly of two additional MSIVs support this conclusion.

- 1) MSIV repair procedure have been updated to include the new torque recommendations.
- 2) "B" and "C" inboard MSIVs are being reassembled and reinstalled using the new valve assemblies and the updated repair procedure.
- 3) "C" outboard MSIV have been reassembled and reinstalled using the existing valve assembly and the updated repair procedure.
- 4) Each of the three reassembled valves will pass a local leak rate test which is standard practice for a reworked valve.
- 5) The remaining five MSIVs will be disassembled for inspection at the next refueling outage.
