ST-HL-AE-1094

South Texas Project
Units 1 & 2
Docket Nos. STN 50-498, STN 50-499
Final Report Concerning
Vendor-Fabricated Structural Steel

Final Report Concerning
Vendor-Fabricated Structural Steel

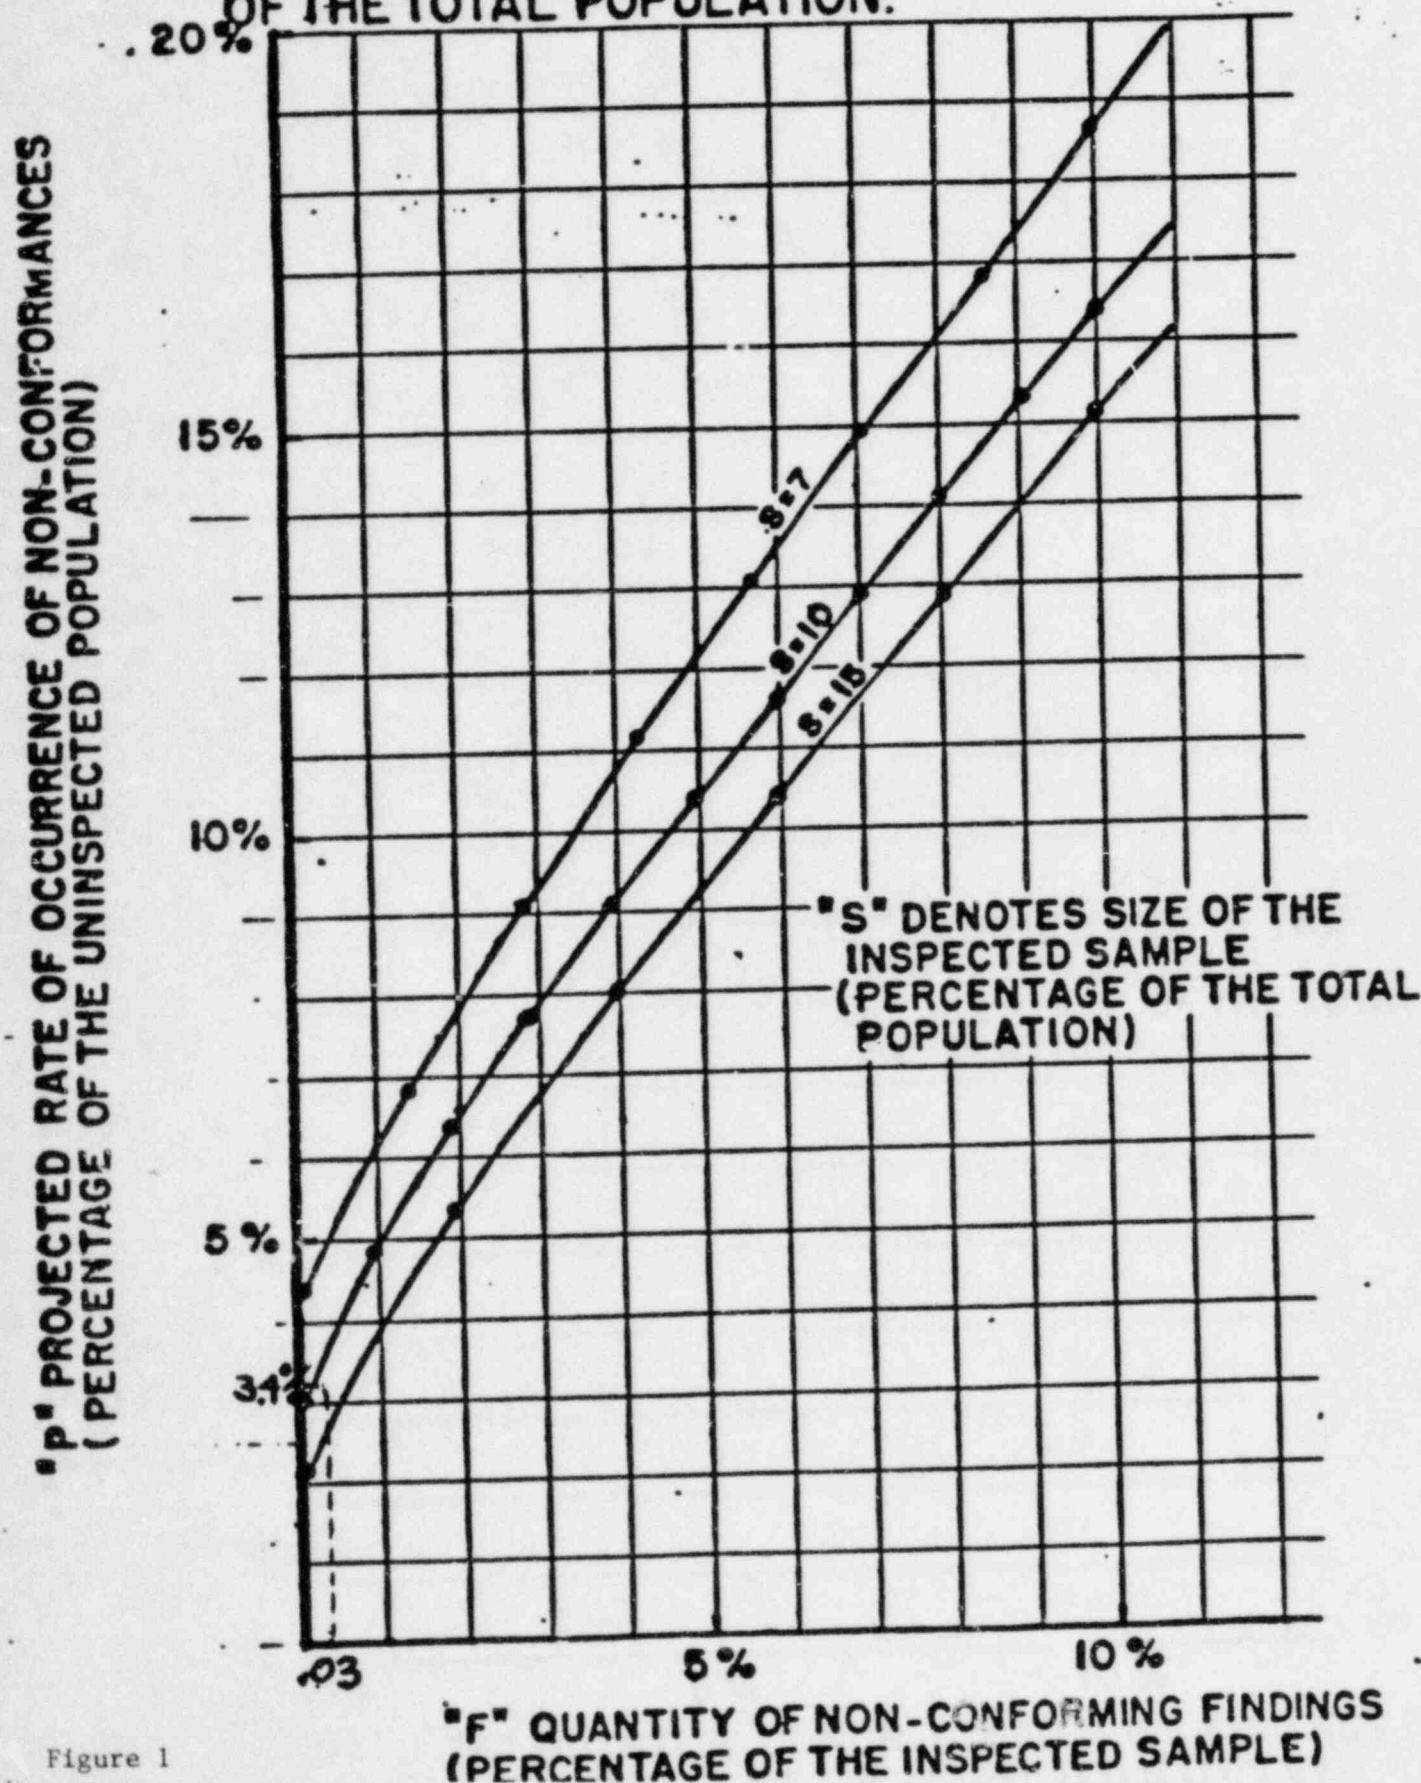
The corresponding projections as a function of observed findings, for various sample sizes, at a 95% confidence level, are presented in Figure 1.

The structural review of 956 non-conforming members resulted in the rejection of weld connections of three members on the basis of the derated load being less than the required design load ("F" on Figure 1 = $3/956 = .03\%$). The sample used for the design review, i.e., the non-conformances out of the inspection sample, represented approximately 11% of the population (S on Figure 1). As illustrated on Figure 1, based on a 95% confidence level statistical projection in accordance with the hyperbinomial distribution, the potential rate of occurrence of rejected members in the balance of the population was 3.4%. The projected occurrence rate of 3.4% is conservatively based on design load, whereas actual loads are typically significantly lower. Further, the worst case overstress in the sample was 18% over the AISC Code. To put this overstress in perspective, the AISC Code values have a 1.6 factor of safety to yield strength load capacity. Based on this analysis, Bechtel concluded and HL&P concurs that inspection of the balance of the population is not warranted. While not essential to ensure plant safety, the welded connections of the three members that were determined to exceed allowables will be reworked since they are accessible and the defects can be easily corrected.

RATES OF OCCURRENCE IN UNINSPECTED
POPULATION, PROJECTED AT A 95 %
CONFIDENCE LEVEL, BASED ON THE FINDINGS
OBTAINED FROM THE INSPECTION OF A RANDOM
SAMPLE REPRESENTING A SPECIFIC FRACTION
OF THE TOTAL POPULATION.
