SUBJECT: Waterford SES Unit No. 3  
Docket No. 50-382  
Significant Construction Deficiency No. 74  
"T&B Undersized Socket Welds"

Subject: LOUISIANA POWER & LIGHT COMPANY  
WATERFORD SES - UNIT NO. 3  
NCR 7680 IMPACT ON SCD 74; SCHEDULE 80  
UNDERSIZE SOCKET WELDS

NCR 7680 was initiated as a result of LP&L QA identification of 12 undersize schedule 80 socket welds on piping isometric CC-IC-47. Six of the welds require repair in order to meet ASME Code requirements. These welds were not originally in the inspection sample conducted as part of SCD 74. One requests engineering to assess the impact of this NCR on SCD 74 evaluation.

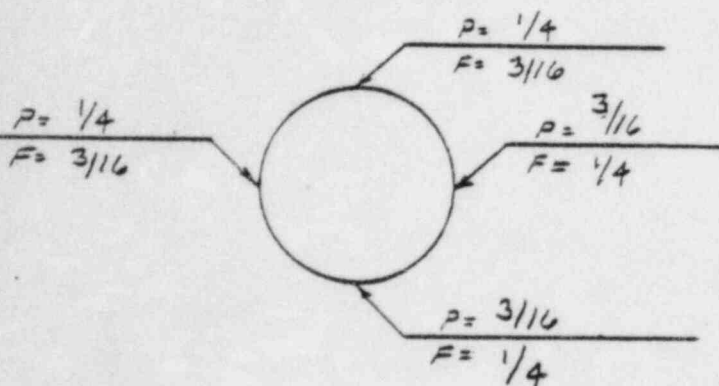
WELD NO. FW-2  
EL. LOOKING S.W.

Walkdown shows 90° ELL, WCR states 45° ELL.

A review of Weld Control Record (WCR) shows HT#S201, review of CMTR shows HT#S201 to be 90° ELL. Based on this review and field verification we find no basis for the concern.
