NORTHEAST UTILITIES

This letter forwards Licensee Event Report (LER) 91-025-01 which is being submitted to provide update information on LER 91-025-00. LER 91-025-00 was submitted pursuant to 10CFR50.73(a)(2)(i), any operation or condition prohibited by the plant's Technical Specifications.

LICENSEE EVENT REPORT (LER)

FACILITY NAME (1) Millstone Nuclear Power Station Unit 3										DOCKET NUMBER (2) 0 5 0 0 0 4 2 3				PAGE (3) 1 OF 0 6					
TITLE (4) Failure To Verify De-energization of Solid State Protection Input Relays For Cold Overpressure Protection Due to Procedural Deficiency																			
EVENT DATE (5)			LER NUMBER (6)				REPORT DATE (7)			OTHER FACILITIES INVOLVED (8)									
MONTH	DAY	YEAR	YEAR	SEQUENTIAL NUMBER	REVISION NUMBER	MONTH	DAY	YEAR	FACILITY NAMES										
0	9	1	0	9	1	0	1	2	0 5 0 0 0 0 0 0										
0	9	1	0	9	1	0	1	2	0 5 0 0 0 0 0 0										
OPERATING MODE (9)		THIS REPORT IS BEING SUBMITTED PURSUANT TO THE REQUIREMENTS OF 10 CFR 5. (Check one or more of the following: (1))																	
5		20.402(b)				20.402(c)				50.73(a)(2)(iv)				73.71(b)					
POWER LEVEL (10)		20.405(a)(1)(i)				50.36(c)(1)				50.73(a)(2)(v)				73.71(c)					
0 0 0 0		20.405

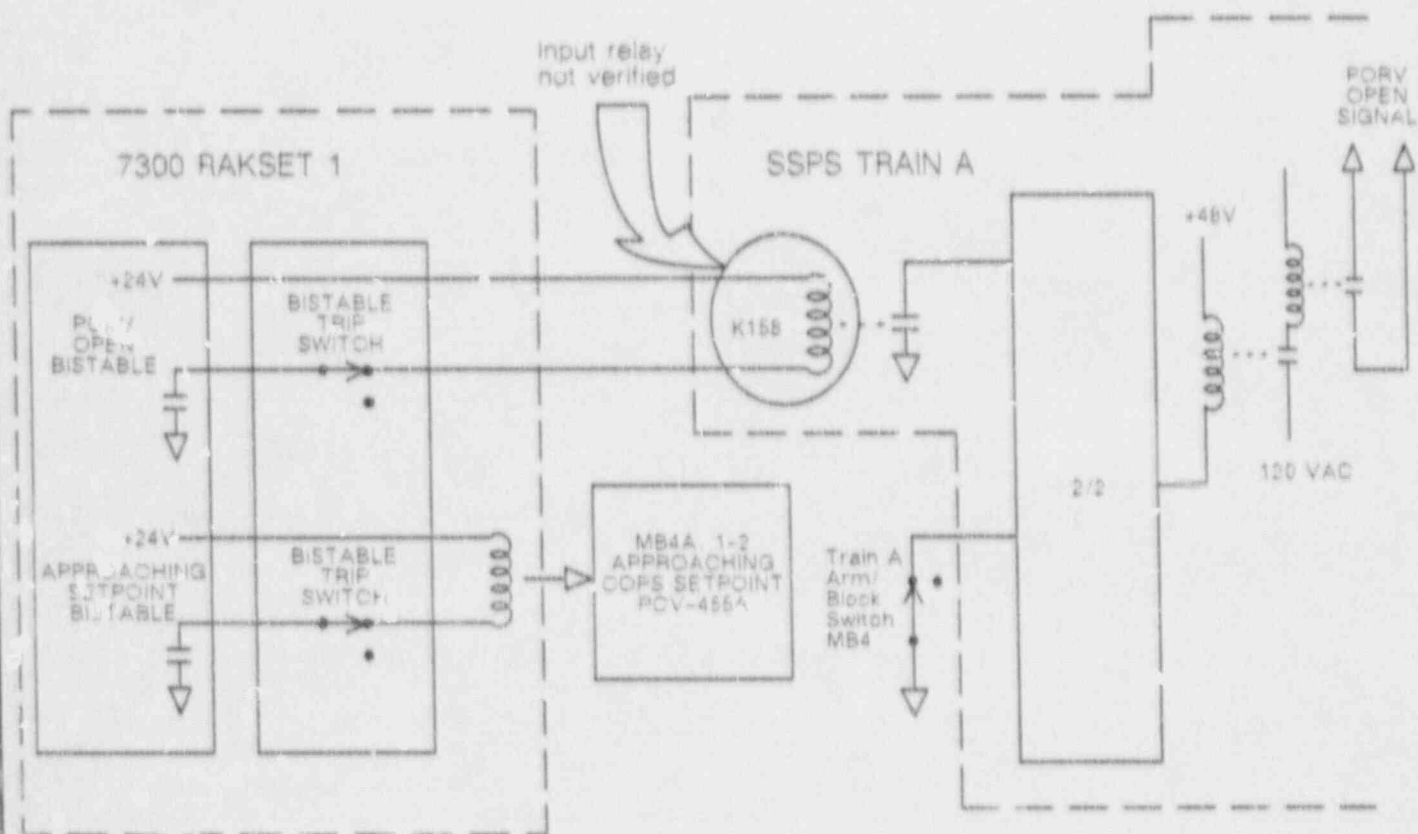
COPS Actuation Circuit (Simplified)

The de-energize to actuate design of the COPS circuit does not provide annunciation which directly monitors relay status. The typical protection channel design places the channel in "trip" during testing and utilizes annunciators to provide indication of off-normal contact status. The COPS bistable annunciator is upstream of the input relay. This annunciation does not verify the SSPS input relay status. To verify de-energization of the input relays for COPS, a voltmeter must be placed across the associated SSPS contact output to verify continuity.
