PHILADELPHIA ELECTRIC COMPANY

June 4, 1984

Docket Nos. 50-277
50-278

SUBJECT: Generic Letter 84-11, "Inspections of
BWR Stainless Steel Piping"

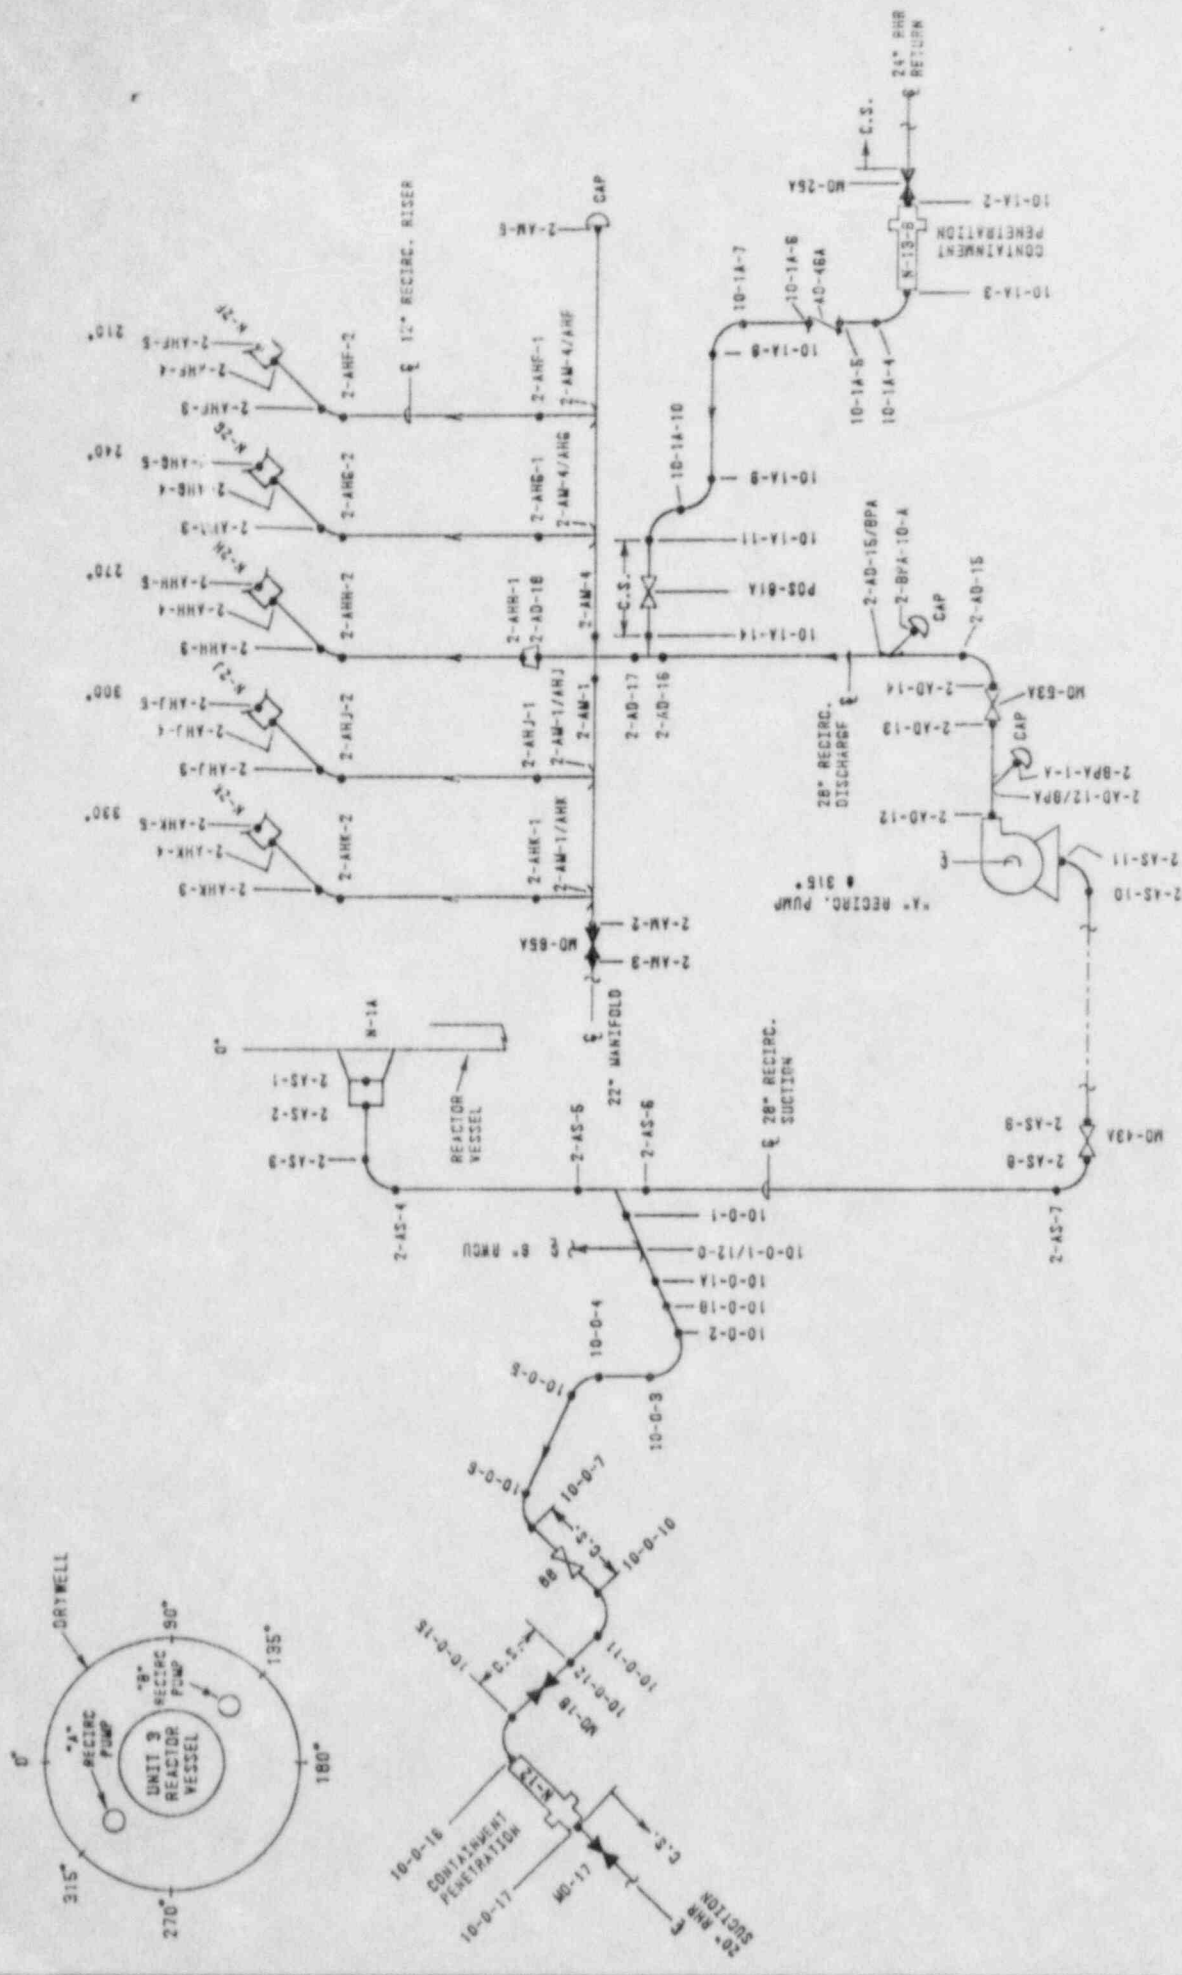
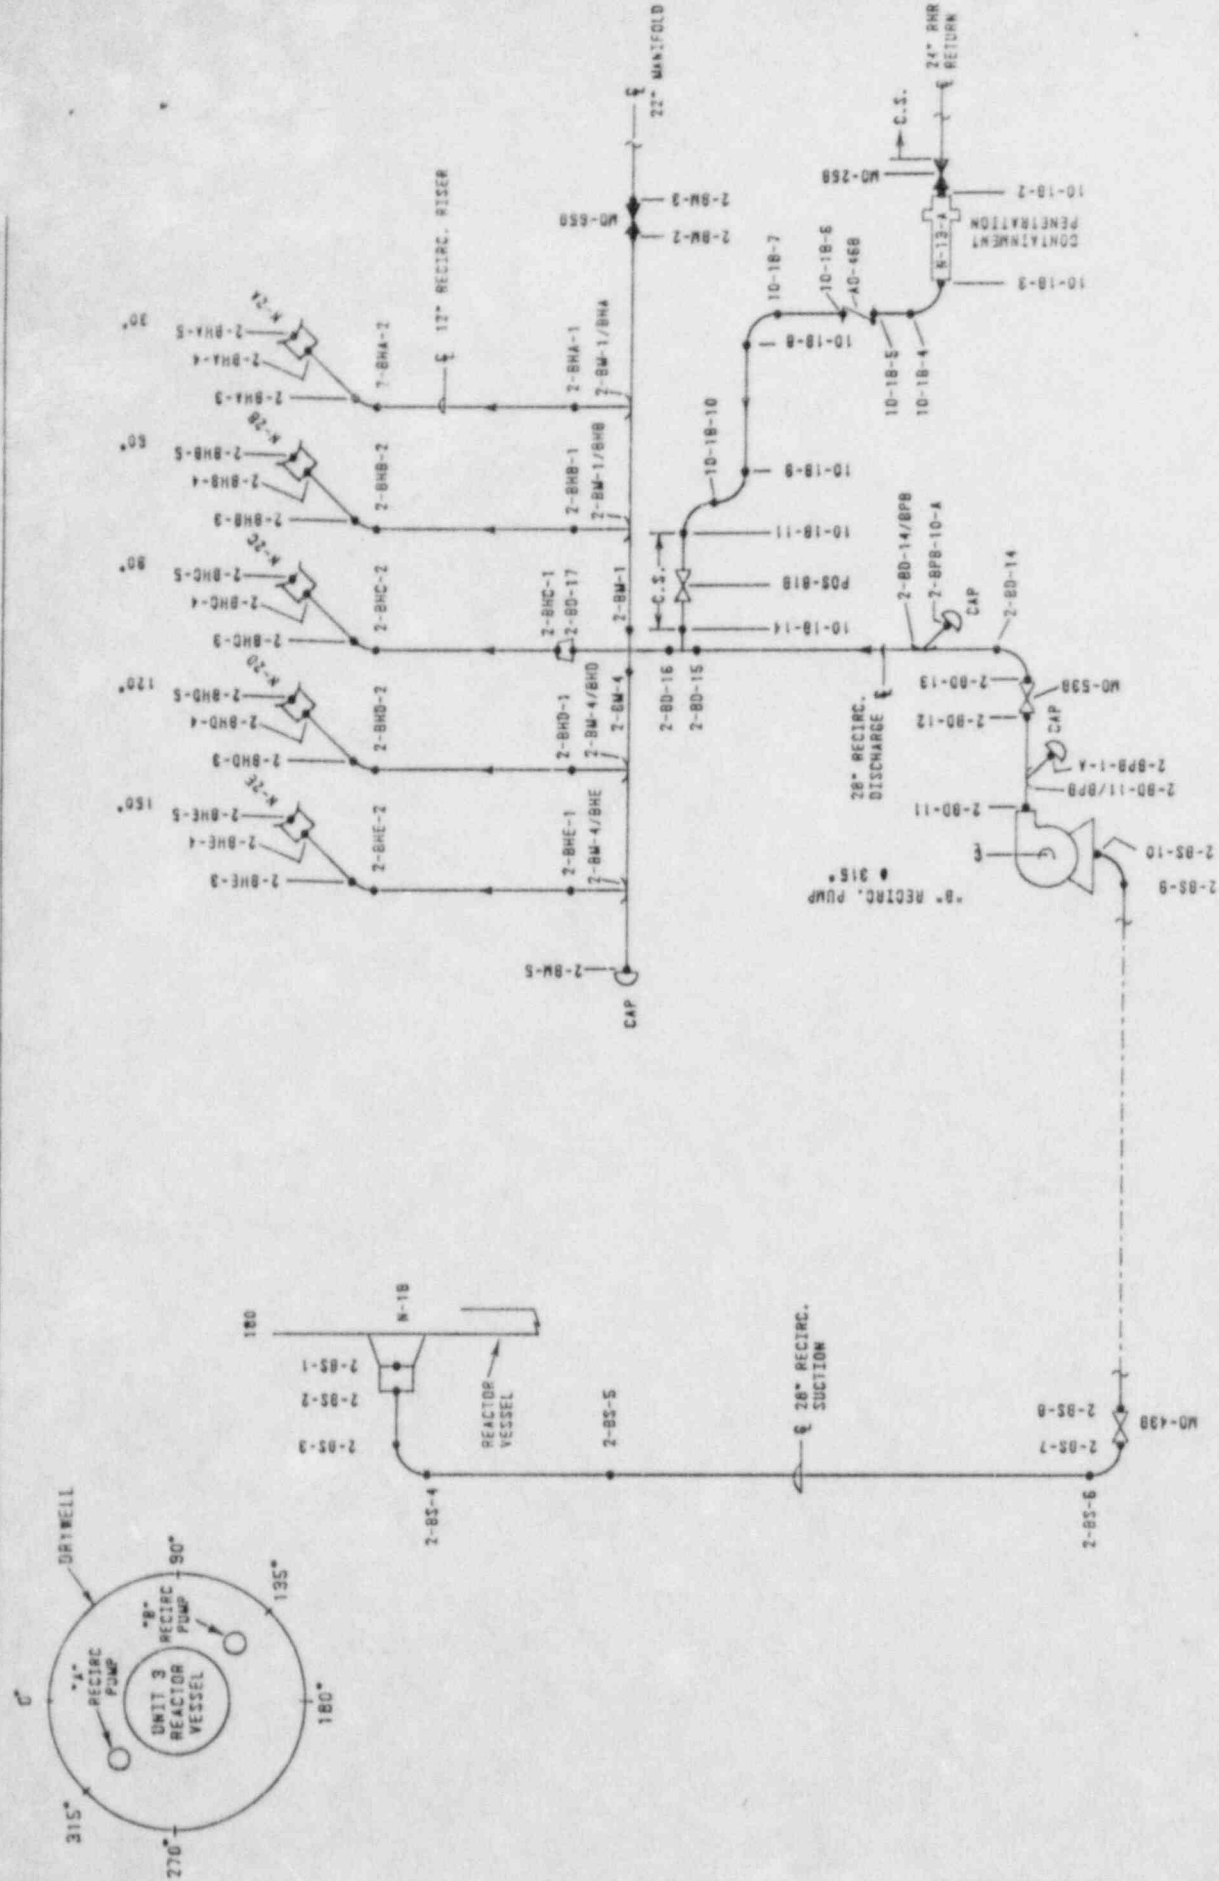
The reinspections specified below will be performed during the next Unit 3 refueling outage currently scheduled to begin March 30, 1985. Recirculation and RHR system inspections were previously performed during the summer of 1983. Based on results of those inspections, the scope of the reinspections is as follows in accordance with items 2a through 2e of the Generic Letter. Attachments 1 and 2 depict the Unit 3 Recirculation and RHR System.

- 12-inch risers - All non-conforming welds were previously inspected. Therefore, no riser welds will be reinspected during the next outage.
- 22-inch manifold - Two welds were not inspected previously. These two welds, 2-BM-2 and 2-BM-3 will be inspected during the next outage.

- 28-inch discharge and suction - Eight welds were not inspected previously. The following welds will be inspected during the next outage:

2-AS-9
2-AD-13
2-BS-8
2-BD-16

- 24-inch return - Two welds were not inspected previously. Welds 10-1A-2 and 10-1B-2 are not inspectable due to their configuration and cannot be inspected during the next outage.
