SUBJECT: COMANCHE PEAK STEAM ELECTRIC STATION (CPSES)
DOCKET NO. 50-445
CONDITION PROHIBITED BY TECHNICAL SPECIFICATIONS
LICENSEE EVENT REPORT 91-030-01

Enclosed is Licensee Event Report 91-030-01 for Comanche Peak Steam Electric Station Unit 1, "Personnel Error Leading to Mispositioned Residual Heat Removal System Crosstie Valves".

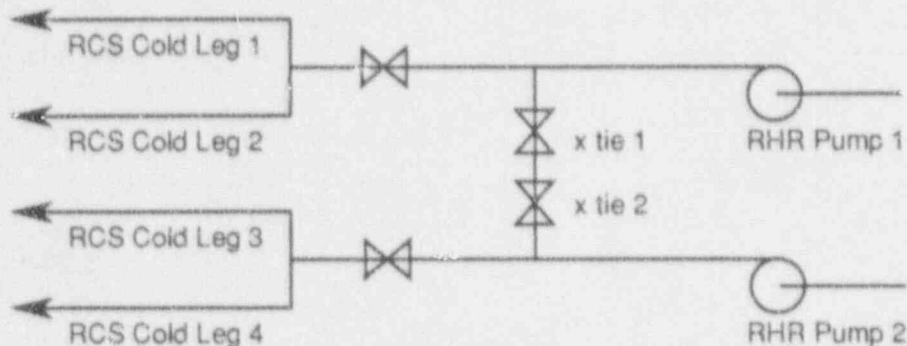
Figure 1

On December 4, 1991, following the first refueling outage, activities were in progress to bring the plant to Hot Standby. Various valves in the Emergency Core Cooling System (ECCS) (EIS:(BP)) associated with the Residual Heat Removal (RHR) system (EIS:(BP)) were placed in the required Mode 3 alignment in accordance with the integrated plant operating procedures. Train A of the RHR system had previously been placed in Standby Readiness, and Train B was operating in the shutdown cooling mode. RHR cross-tie valve 1 (refer to Figure 1) (EIS:(V)(BP)) was open and cross-tie valve 2 was closed in accordance with the alignment specified in the system operating procedure.

In preparation for testing of several check valves, Train B of the RHR system was secured. Difficulties encountered during check valve testing necessitated realignment of the system to allow the discharge header to be filled. During this activity, crosstie valve 1 was closed. Following completion of check valve testing, the RHR pumps and system were vented to satisfy the related surveillance requirement.

The Reactor Operator (utility, licensed) was directed by the Unit Supervisor (utility, licensed) to place the RHR system in standby readiness in accordance with the system operating procedure. While performing the alignment, the Reactor Operator failed to complete all steps necessary to place the RHR system in the required alignment, and inadvertently left the RHR crosstie valves closed. At 1333 the plant was declared to be in Mode 3.
