SUBJECT: Licensee Event Report, Peach Bottom Atomic Power Station-Unit 3

Reference:	Docket No. 50-278
Report Number:	3-95-003
Revision Number:	00
Event Date:	07/30/95
Report Date:	08/28/95
Facility:	Peach Bottom Atomic Power Station RD1, Box 208, Delta, PA 17314

Unit 3 Scram when the "A" Reactor Feed Pump Speed Increased

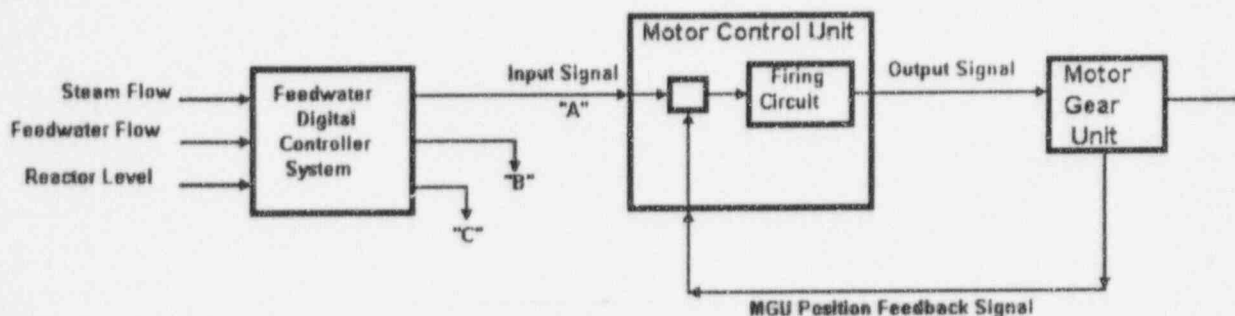
The cause of the scram was that a Main Turbine trip occurred due to a high reactor water level condition. Troubleshooting revealed that the "A" RFP Motor Control Unit (MCU) (see attached figure) failed causing an increase in the "A" RFP speed. This resulted in the high reactor water level condition.

Additional troubleshooting was performed which determined that the Firing Circuit within the "A" MCU failed. The MCU Firing Circuit drives the RFP Motor Gear Unit (MGU) which regulates RFP speed.

Following replacement of four electronic cards within the Firing Circuit, the instrument loop was tested satisfactorily.

A Failure Analysis is being performed on the electronic cards at a PECO Energy Test Facility to determine the exact cause of the failure. Based on the results of the Failure Analysis, generic implications will be considered and corrective actions will be implemented as appropriate.

In addition, a modification is being considered which may replace the firing circuits with an improved digital logic. The modification is currently in the design stage and is planned for a future refueling outage.
