Subject: Duane Arnold Energy Center
Docket No: 50-331
Op. License No: DPR-49
Licensee Event Report #95-008.
File: A-118a

LICENSEE EVENT REPORT (LER)

Potential Loss of Both Trains of Standby Gas Treatment Due to Leaking Valves

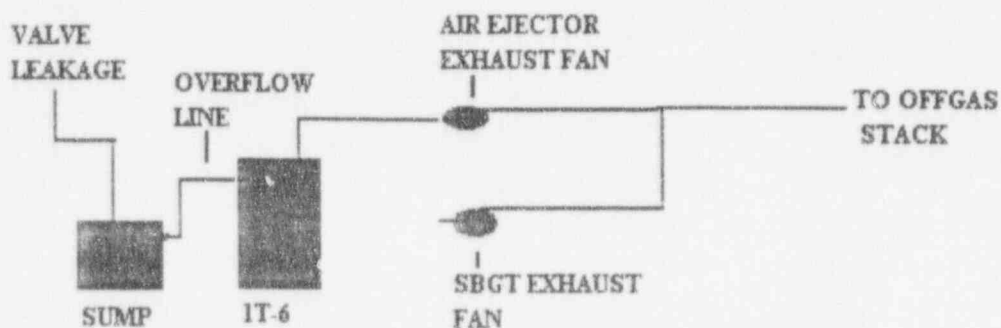
The cause of the 'B' SBGT exhaust fan trip was water in the fan housing resulting from leakage past various Turbine Building high energy steam valves. Leakage past these high energy steam valves is directed to the turbine building equipment drain sump (see diagram). This leakage led to elevated temperatures in the sump. The Turbine Building equipment drain sump is connected to the condensate demineralizer backwash receiving tank (1T-6) via the latter tank's overflow line. The elevated temperatures in the sump were transmitted to 1T-6, which led to an increase in 1T-6 humidity. 1T-6 is vented to the suction ducting of the air ejector exhaust fan. The air ejector exhaust fan discharges to a duct common with SBGT exhaust ducting. The increased humidity from 1T-6 condensed in this line and drained back to the SBGT exhaust fan housings.

Once it was determined that the source of the condensation was the high humidity air in the condensate demineralizer backwash receiving tank, the air from the tank was redirected to the turbine building exhaust ducts. Since this action, there has been no buildup of moisture in the SBTG fan housings.

A plan will be developed to isolate the leaks into the turbine building equipment drain sump and repair the leaking valves. As part of this effort, the maintenance history of those valves will be reviewed and long term actions initiated as appropriate. These actions will be completed by September 29, 1995.

Additionally, the connections between 1T6 and the Turbine Building equipment drain sump are being reviewed for design adequacy. Corrective actions will be taken as appropriate.
