VERMONT YANKEE NUCLEAR POWER CORPORATION

LICENSEE EVENT REPORT (LER)

HPCI/RCIC SYSTEM INOPERABLE DUE TO LOW SPIKING OF LEVEL TRANSMITTER LT-2-3-72B INSTRUMENT LOOP

ATTACHMENT 1, - LER 94-008

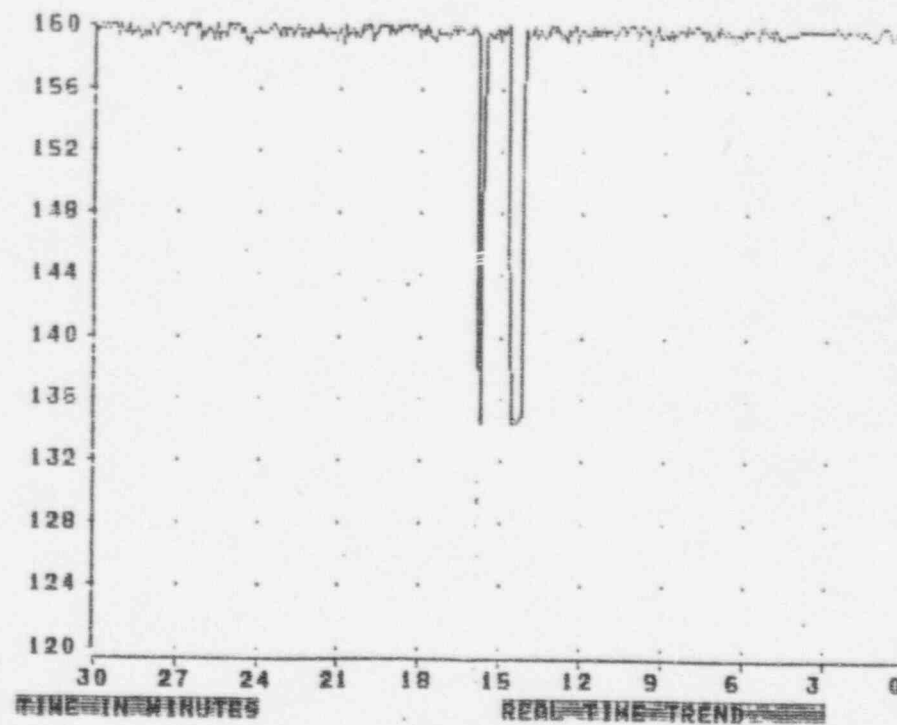
Subsequent evaluation of a process loop computer trend confirmed that the downspiking observed is consistent with one of the reported K1 relay contact failure modes. Subsequent discussions with the equipment manufacturer also suggest that the downspiking experienced is not a typical failure mode for the loop transmitter itself and is more likely to be associated with a malfunction of the master trip unit. In pursuit of the above belief, the master trip unit was replaced on 11/07/94 with a spare trip unit and the original returned to Rosemount for failure analysis. Strip chart trending of the process point was continued for a 3 day period subsequent to the replacement. Data reviewed during this period did not reveal the presence of any additional spiking in the instrument loop, and as a result, monitoring of the loop was terminated on 11/10/94.

PLANT MODE	LEVEL 72B LEVEL	ERFIS
RUN		10/03/94
		15:09:32

REACTOR WATER LEVEL 72B
