Subject: W. O. 3900/4000
Washington Public Power Supply System
WNP-2
Defect and Noncompliance
Evaluation Report No. 83-14
Standby Service Water System Flow

EVALUATION REPORT

83-14

STANDBY SERVICE WATER SYSTEM FLOW

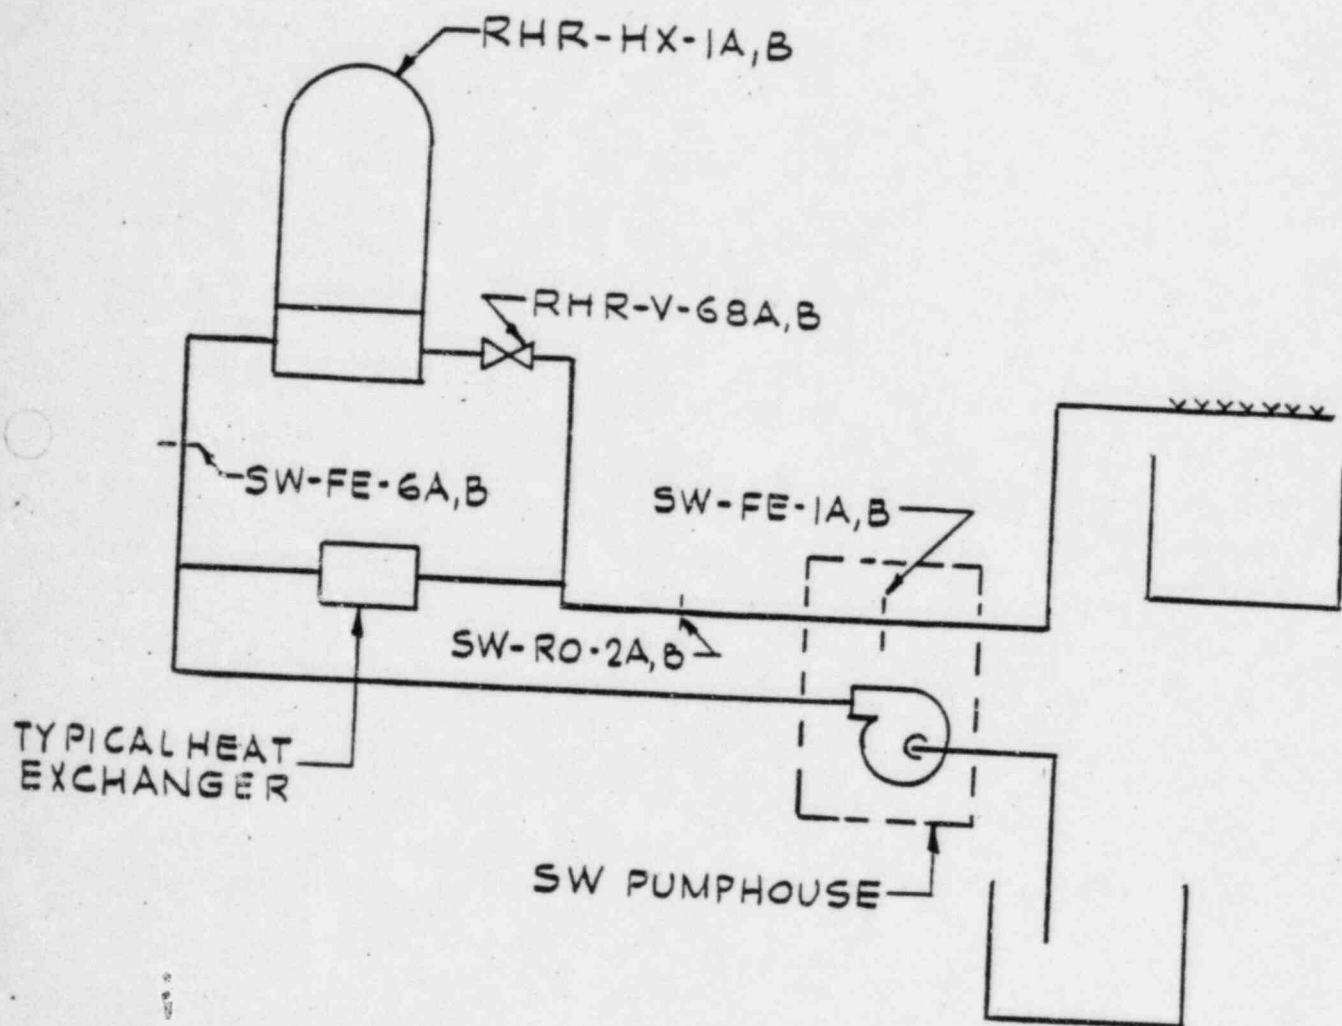
FIGURE 1

SIMPLIFIED STANDBY SERVICE WATER FLOW DIAGRAM
