Subject: Clinton Power Station - Unit 1
Licensee Event Report No. 92-001-00

Please find enclosed Licensee Event Report No. 92-001-00:
Internal Fault In The "B" Phase Main Power Transformer Resulted In A
Turbine Generator Trip And An Automatic Reactor SCRAM. This report is
being submitted in accordance with the requirements of 10CFR50.73.

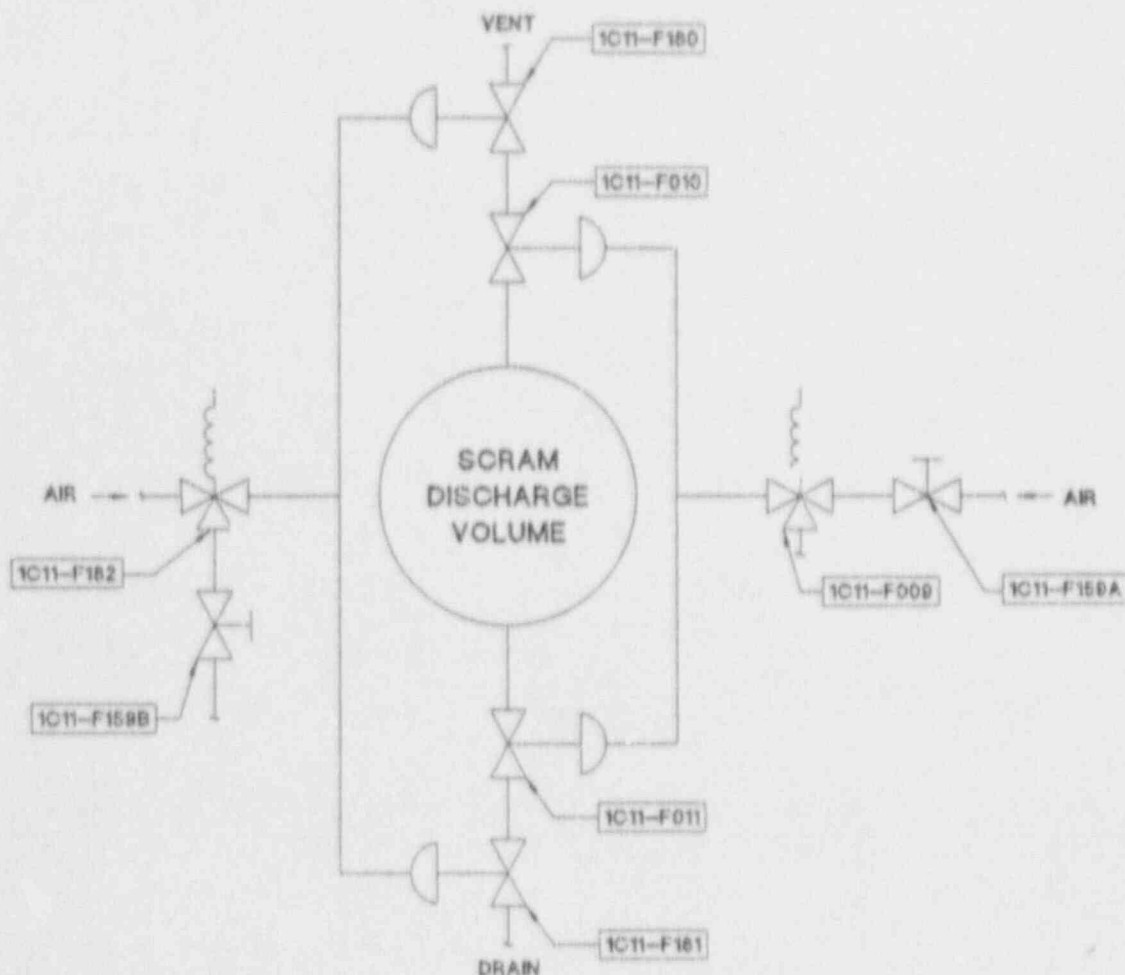
Figure 1

Subsequent to the event, troubleshooting of the SDV drain and vent valves identified the following deficiencies (refer to Figure 1):

- ° Air leaked out of the vent ports of the three-way solenoid valves 1C11-F009 and 1C11-F182 when they were energized.

- * Valve 1C11-F011 immediately closed and remained open when the instrument air time delay valve (1C11-F159A) was manually opened about one-eighth of a turn.

- * A small piece (less than 1/16 inch) of foreign material (believed to be solder) was found between the backseat and disc of valve 1C11-F009.
- * The bench settings for valve 1C11-F010 were found to be 6 and 30 pounds per square inch gauge (psig). Bench settings of 6 and 30 psig means that the valve starts to open at 6 psig and is fully open or backseated at 30 psig. The correct opening bench settings for 1C11-F010 are 18.5 and 60 psig.

- * The bench settings for valve 1C11-F011 were found to be 20 and 62 psig. The correct bench settings for 1C11-F011 are 18.5 and 60 psig.
- * Maintenance noted that the SDV vent valve (1C11-F180) operated erratically when stroked repeatedly. The valve stem was found to be bent and galling was noted on the disc and stem. Additionally, the bench settings for 1C11-F180 were found to be 8 and 25 psig whereas the correct bench settings are 3 and 15 psig.

Based on the deficiencies identified above, the cause of valve 1C11-F011 failing to open and valve 1C11-F010 only opening to an intermediate position is attributed to the air leakage past the seat of valve 1C11-F009. In May of 1991, personnel discovered that valve 1C11-F011 took approximately 17 minutes to reopen, and Maintenance Work Request MWR D17319 was written to address the slow reopening time. However, MWR D17319 was not scheduled to be worked until the next refueling outage, currently scheduled to begin March 1992. Based on the findings noted above, the slow opening time of valve 1C11-F011 noted in May 1991 is attributed to the small amount of air leaking past the seat of valve 1C11-F009 and out the vent port. In May of 1991, valve 1C11-F159A provided sufficient air volume to eventually pressurize the air header enough to open valve 1C11-F011, but the leakage past valve 1C11-F009 continued to increase. Valve 1C11-F159A is a throttle valve which creates a time delay for the closing of valves 1C11-F011 and 1C11-F010. In January, due to the increased leakage past the seat of valve 1C11-F009, valve 1C11-F159A at the throttled position was not capable of supplying enough air volume to pressurize the air header completely. Therefore, due to the variance between the bench settings of valves 1C11-F010 and 1C11-F011 and the reduced pressure in the air header, valve 1C11-F010 opened to an intermediate

position and valve 1C11-F011 failed to move from the closed position.

Valves 1C11-F009 and 1C11-F182 have been rebuilt per preventive maintenance tasks (PM) PMMRDM003 and PMMRDM004. In addition, the bench settings for valves 1C11-F010, 1C11-F180, and 1C11-F011 were reset to their correct values, and valve 1C11-F180 was rebuilt per MWR D17319.

Station procedure 9012.01, "SCRAM Discharge Volume Vent and Drain Valve Operability Test" will be revised to ensure that the opening and closure times for valves 1C11-F011, 1C11-F010, 1C11-F180 and 1C11-F181 are recorded and verified against the design criteria. This action is scheduled to be completed by May 30, 1992.
