PERRY NUCLEAR POWER PLANT

Perry Nuclear Power Plant
Docket No. 50-440
Response to NRC
Confirmatory Action Letter

AUXILIARY CIRCULATING WATER
PIPING SYSTEM ANALYSIS

Analysis of Failed Bolts from the
Support System of PNFP Circulation
Water Piping Supply Line to the
Auxiliary Condensers - Final Report

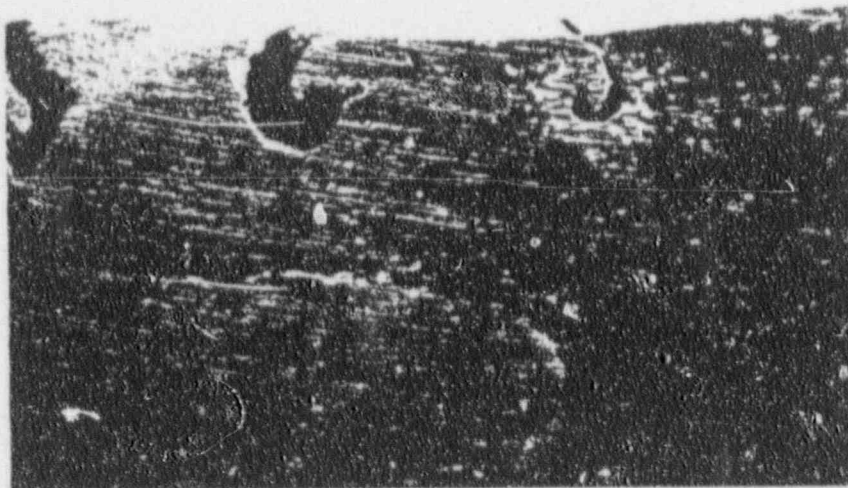
Fig. 1.

1. Two bolts (NE and NW corners) failed below the lower nuts.
2. Two bolts (SE and SW corners) failed between the nuts, within the plate thickness.
3. The threads of three out of four bolts were hammered flat in between the nuts (Fig. 1).
4. All four bolts failed in ductile mode with significant plastic bending.

Crosssections of the bolt with threads
compressed (hammered).

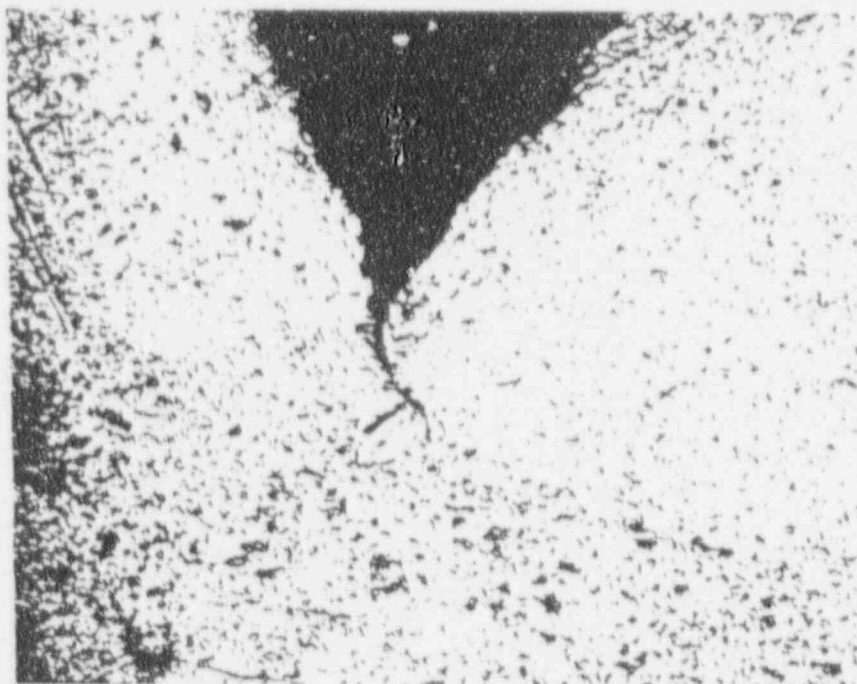
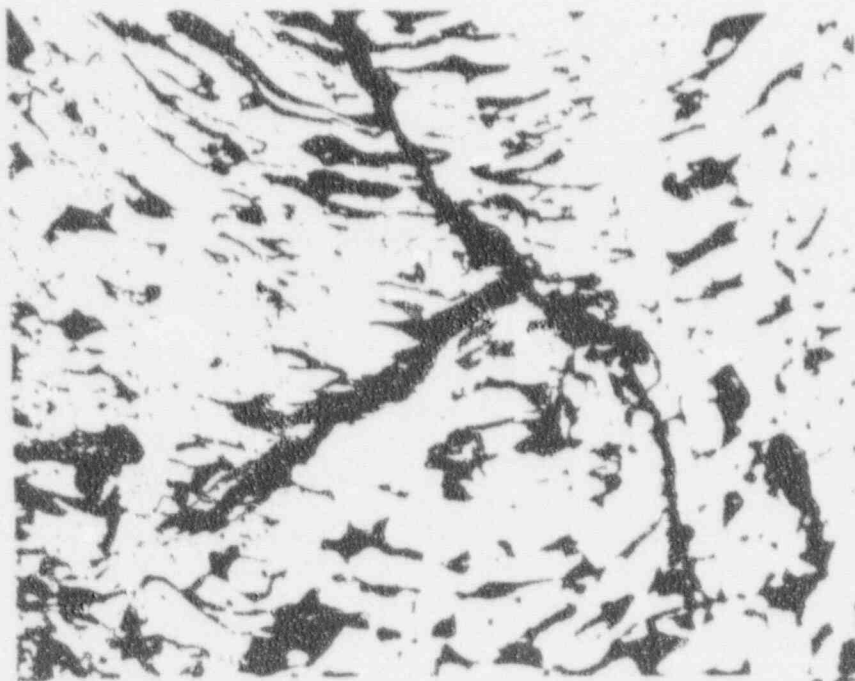
Fig. 2.

5. No signs of fatigue on the fracture surface were found.
6. Fatigue cracks were found at other locations on the bolts with indications of corrosion assistance (Fig. 2).
7. Observations made on the nuts showed that only one nut of each couple was in contact with the plate.
8. Chemical analysis (Table 1) showed that nuts and bolts were made of carbon steel. Very low silicon and aluminum content indicated that rimmed steel was used. The Hilti Drop-in assembly was made from low carbon rimmed steel with high sulfur content added for machinability.

- d. The metallographic analysis of the bolts confirmed the presence of fatigue cracks filled with iron oxide at locations other than the fracture surface. Analysis of one of the cracks was performed on SEM by mapping the iron and oxygen contents. As it can be seen on Fig. 4, the crack is filled with iron oxide. That confirms the corrosion fatigue origin of the crack and its slow propagation.

Typical corrosion fatigue crack.

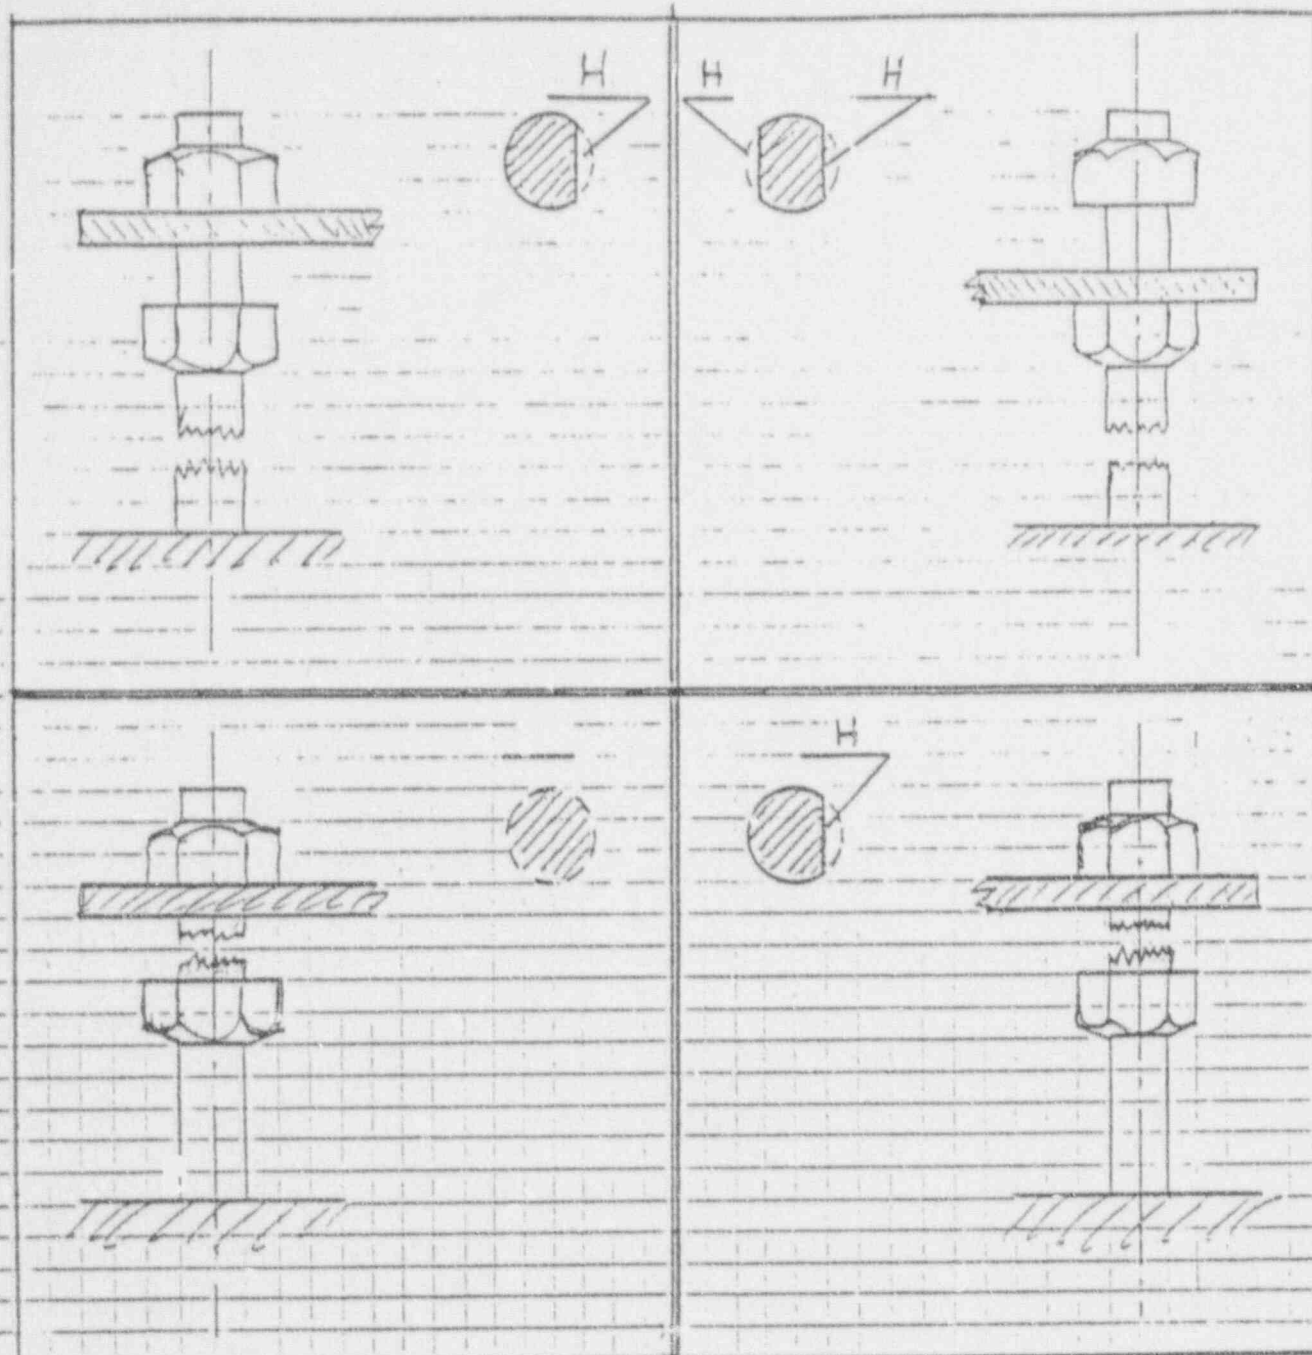
Fig. 3.

- a. The nuts were not tightened down, which allowed the plate to move (see fig. 3).
- b. The plate had a significant lateral movement, which was proven by the signs of friction between the plate and nuts and by the hammered threads.

H - THREADS ARE HAMMERED FLAT

Pictographic presentation of the observations summarized in Table 2 and showing the location of the plate in between the nuts.

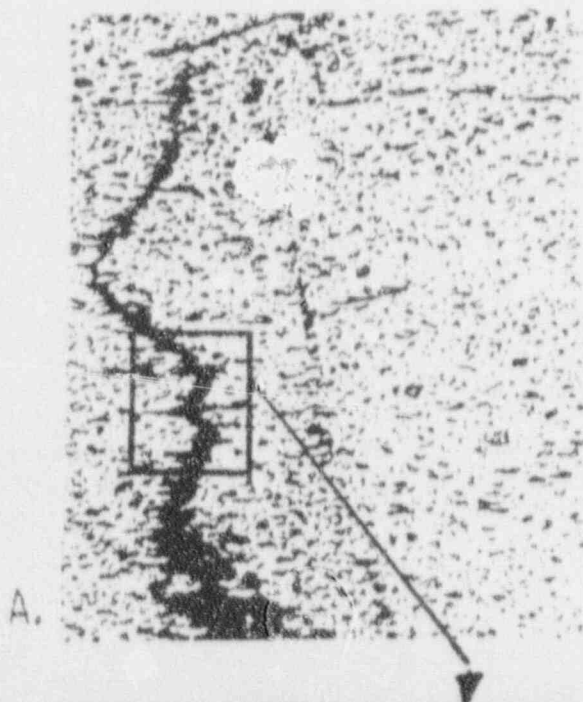
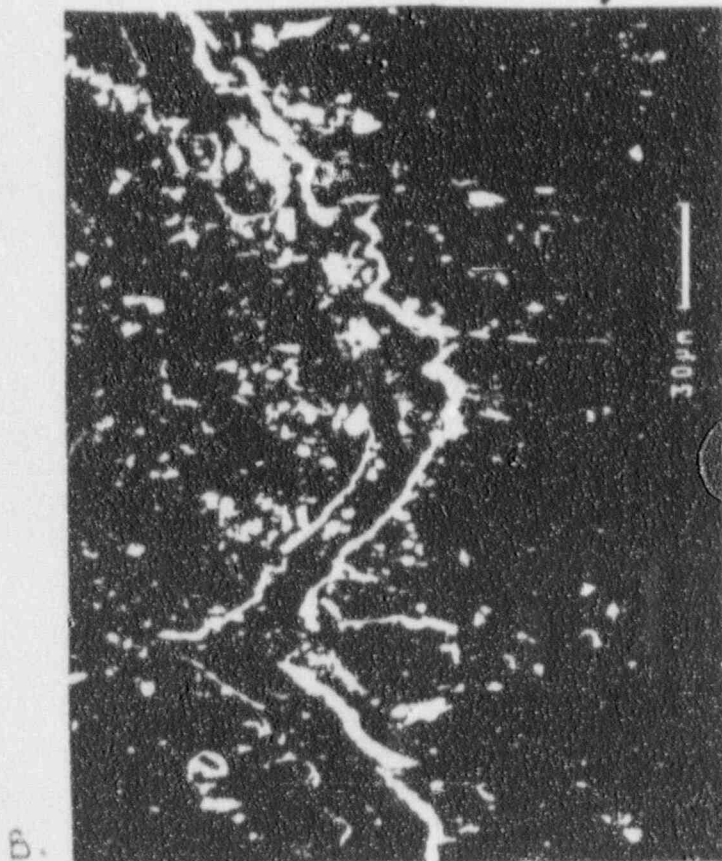
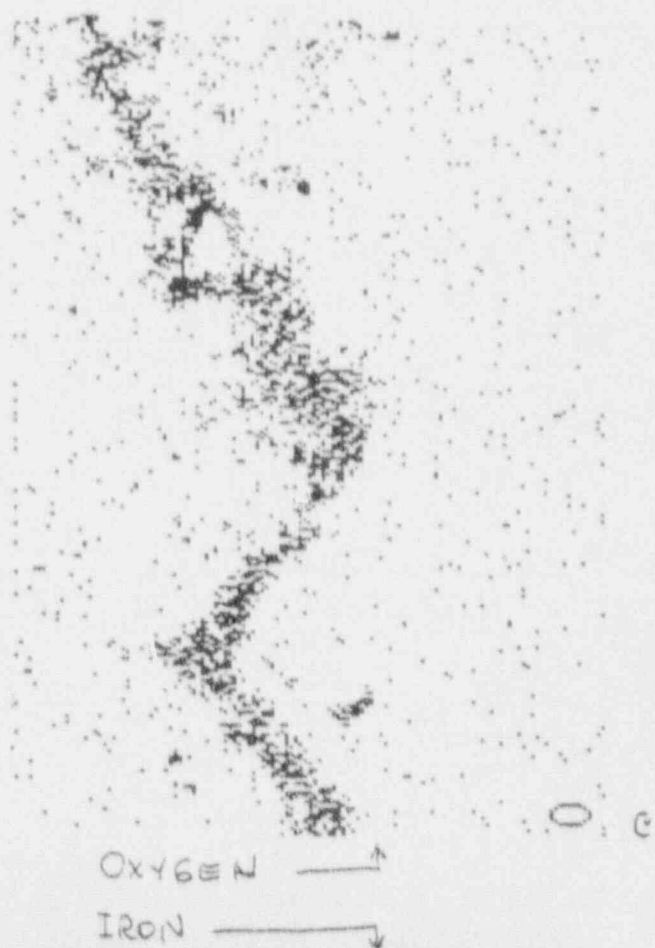
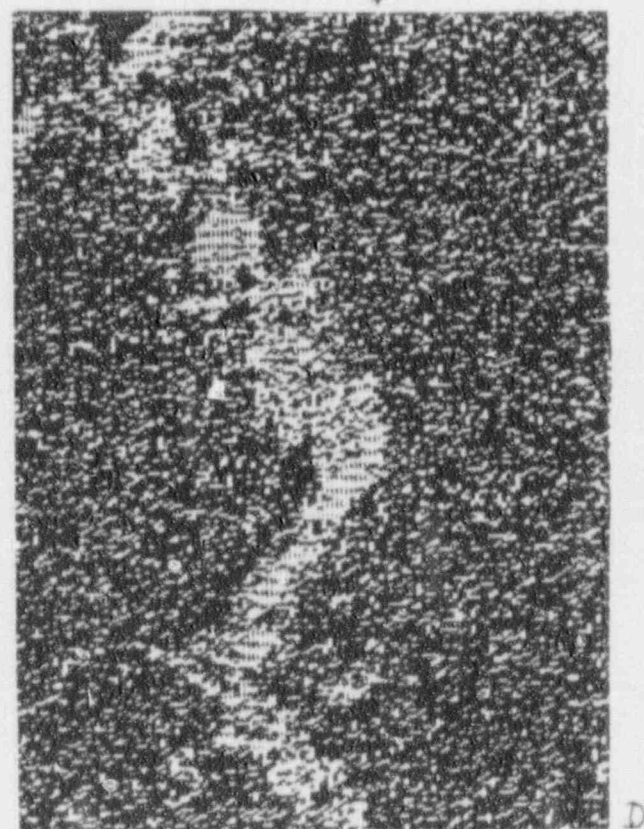
Fig. 4.

Stress corrosion crack and chemical elements distribution.

A. Optical photograph of the crack at magnification 50x.

B. SEM photograph of the part of the crack A at 480x.

C&D. EDS map of oxygen and iron.

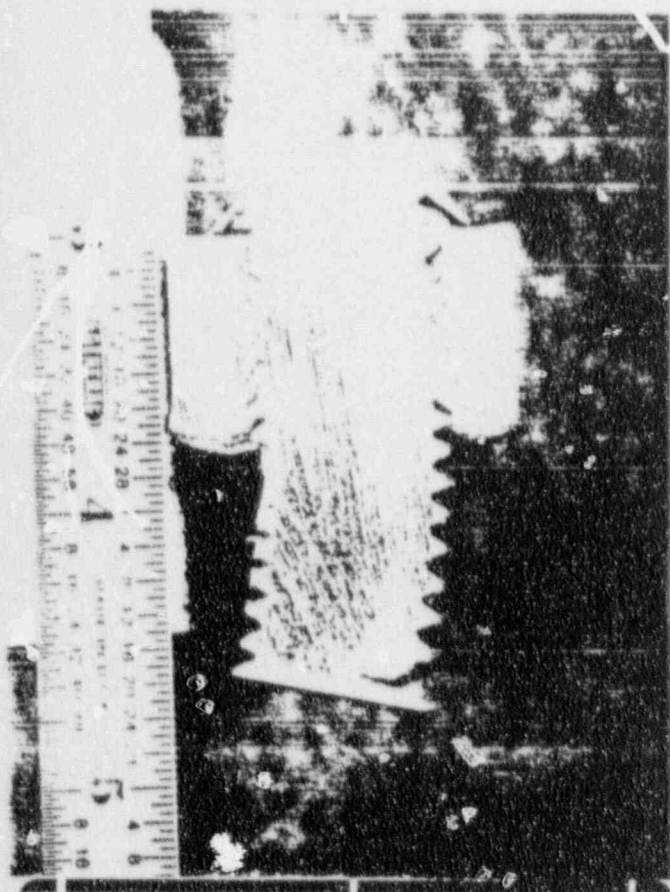
2. The same laboratory analysis concluded that the fiberglass piping catastrophically failed first, with subsequent failure of all four bolts due to extreme overload caused by the water discharge. The primary basis for this conclusion is the severe deformation (bending) present in the failed bolts. Refer to Addendum B for photographs of the failed bolts which have been sectioned.

SECTIONED ANCHOR BOLT AND NUT
NW CORNER

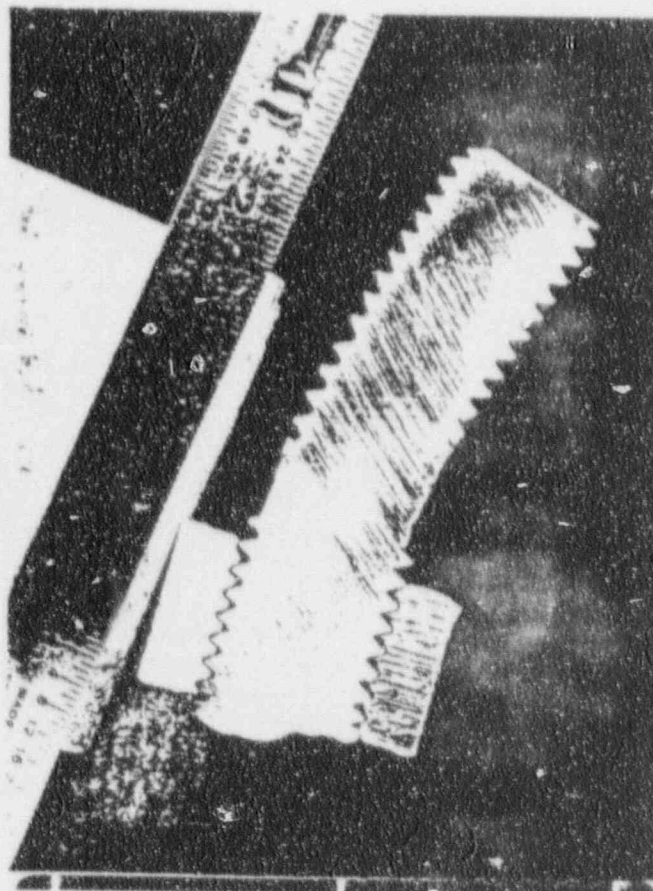
SECTIONED ANCHOR BOLT AND NUT
NE CORNER

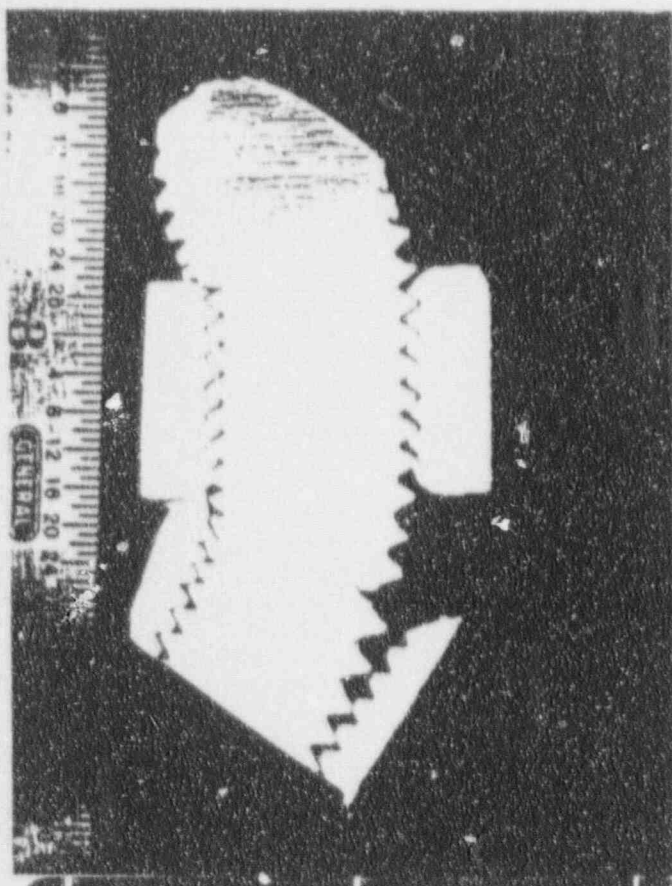
SECTIONED ANCHOR BOLT AND NUT
SW CORNER

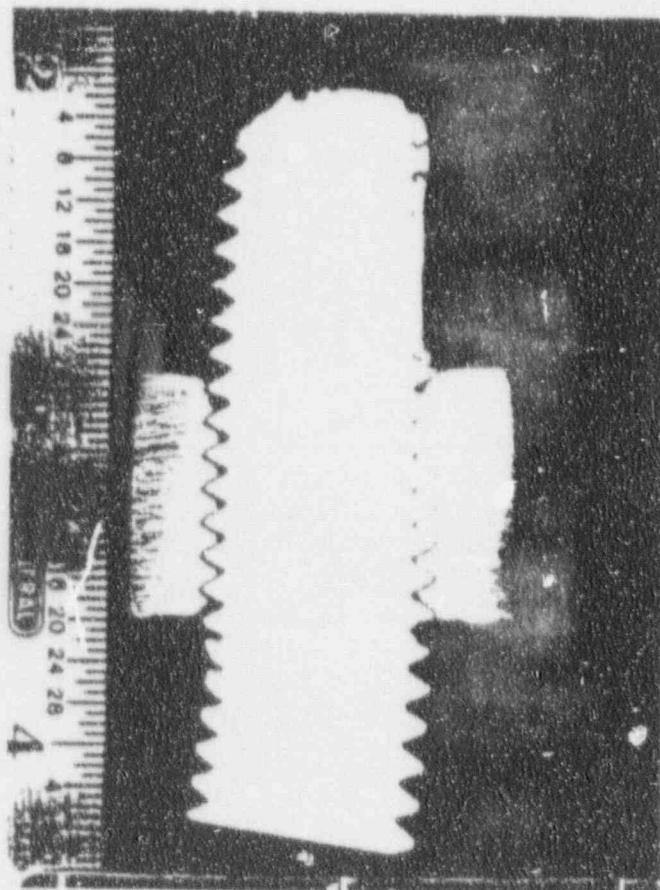
SECTIONED ANCHOR BOLT AND NUT
SE CORNER

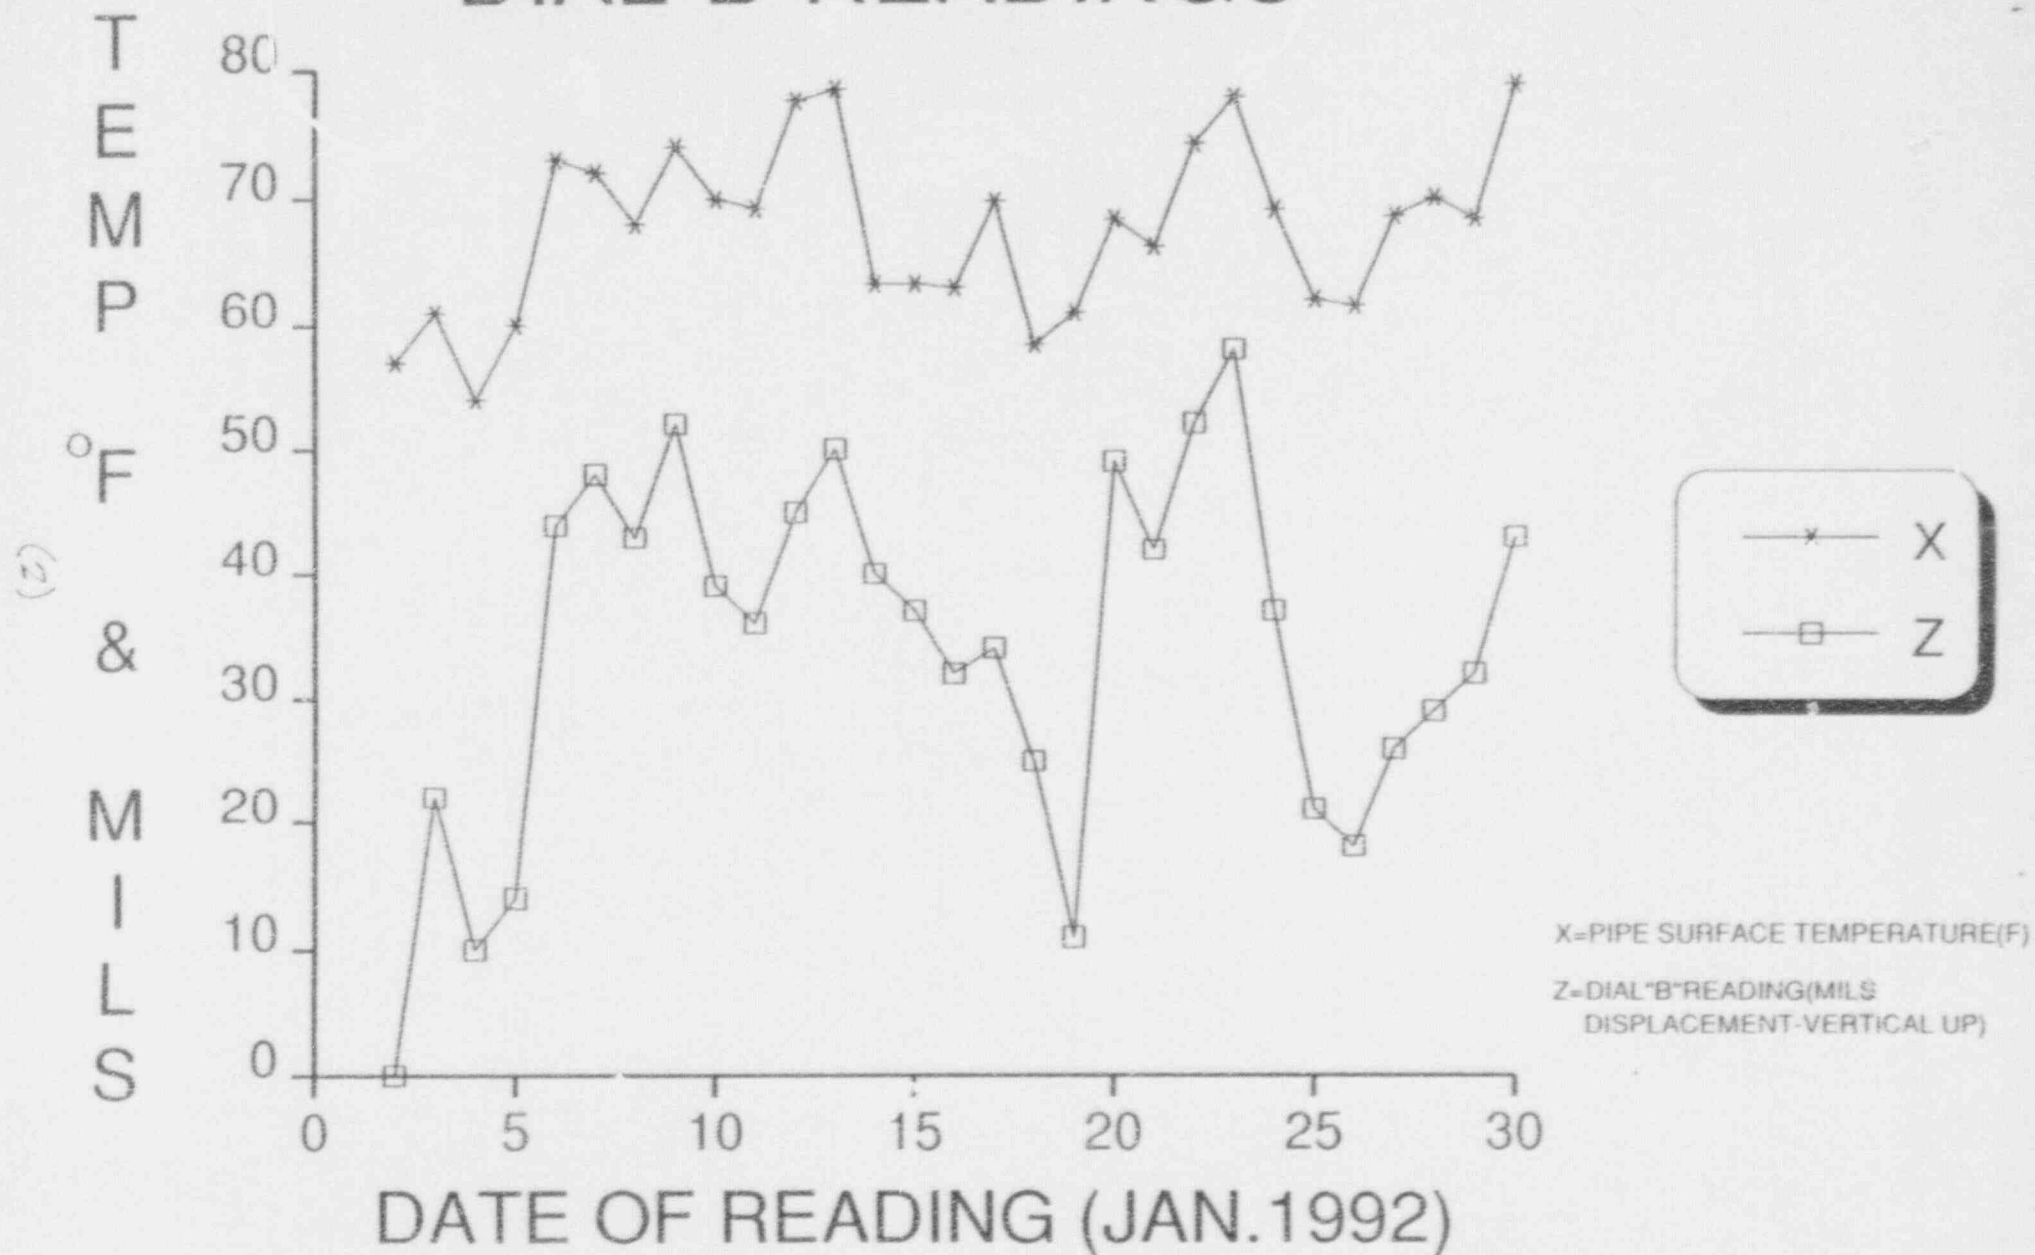
DIAL "B" READINGS

Refer to Addendum E for plots of Dial Indicator "A" and "B" readings which have been recorded (per TXI-0131) since January 2, 1992 (startup). For reference purposes, the recorded displacements are also plotted against variation in recorded 471 pipe temperature. As can be seen, there is general trending between the two plots. Concerning the baseplate scratch pad for anchor LN71-H0013, no movement has been recorded to date as anticipated.

It should also be noted that the calculated limiting displacement values for the anchor support envelope the recorded N71 displacements to date, Addendum E, with ample margin (approximately 1.6, minimum).
