G/C REPORT: EA-182 REVISION 0
PERRY NUCLEAR POWER PLANT (TA #92-0002)

N71 PIPE RUPTURE EVALUATION

JANUARY 31, 1992

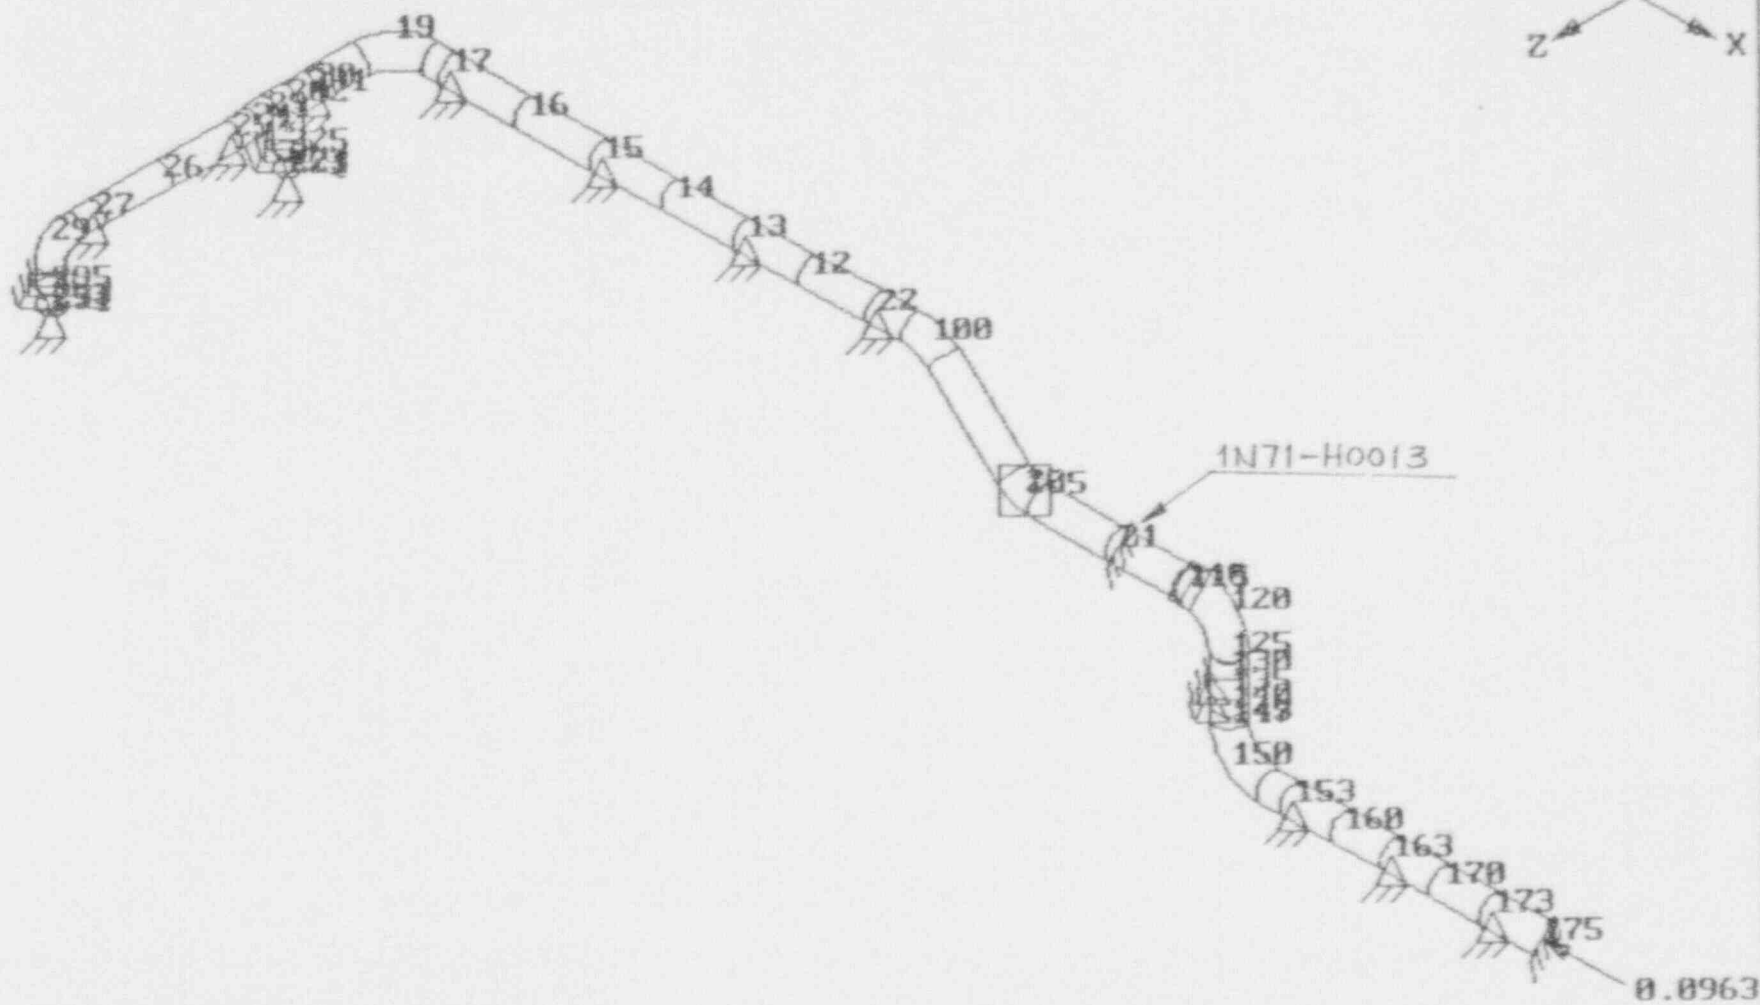
N71 CIRC WATER TO AUX CONDENSER (OPERATING, II)

The expanded inlet model was run for a design/operating condition with a ΔT of 65°F (30-95°F) above ground, 40°F below ground, and a pressure of 60 psig. Horizontal and vertical soil springs were included corresponding to the values of soil modulus of subgrade reaction of 135 lb/in² vertical and 70 lb/in² lateral as previously determined.

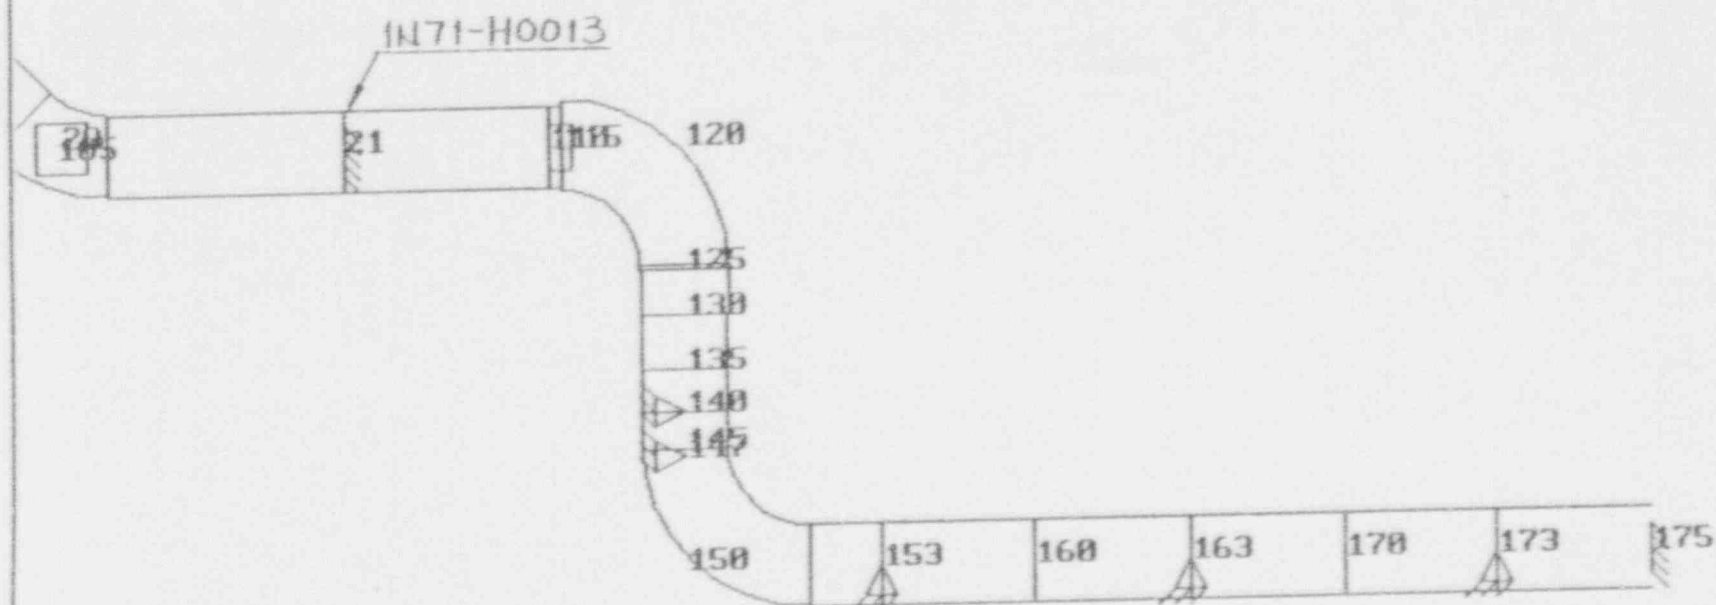
N71 CIRC WATER TO AUX CONDENSER (OPERATING, 11)

The expanded inlet model was run with forced displacements at the flange location to better define the original criteria with respect not only to stresses in the FRP elbow but also the resulting loads on the anchor 1N71-H0013. As a means of providing a criteria to monitor operation of the system, displacements were induced in the piping models corresponding to movements of 0.125 inches in the vertical direction and 0.135 inches in the horizontal direction. These displacement values were supplied by CEI as conservative envelopes of monitored displacement data.

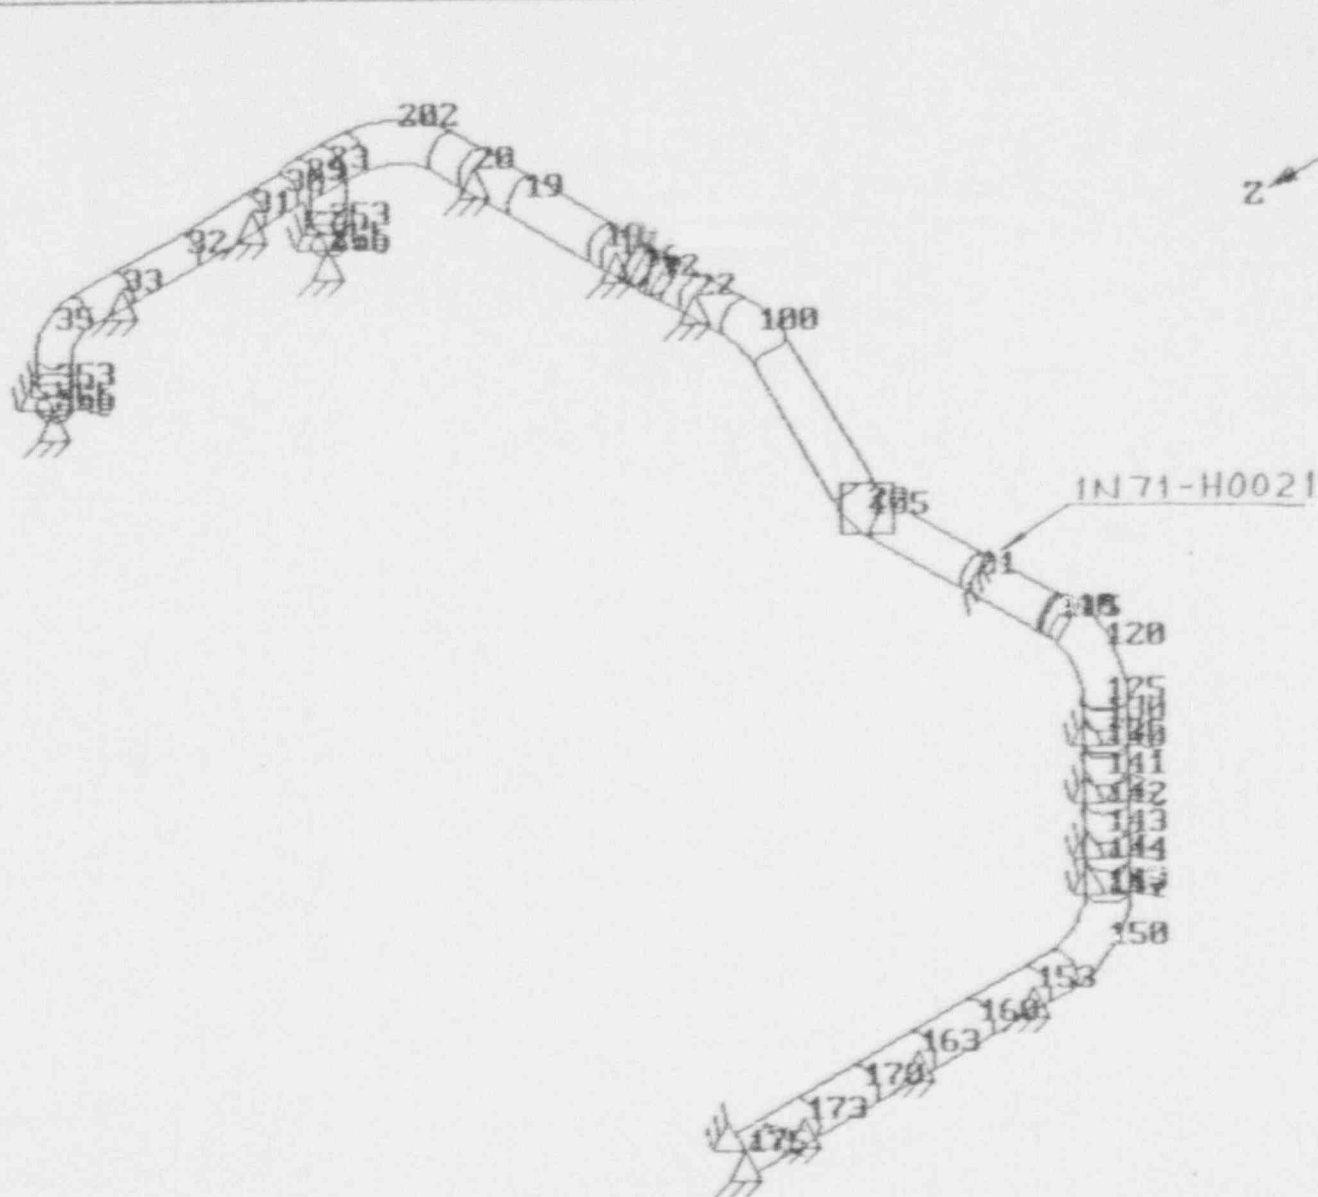
FW PUMP TURB COND COOL WATER PIPE (4. DESN/OPER)

A separate model was utilized for the Circulating Water Auxiliary Condenser outlet piping because of differences in configuration both above and below grade. The outlet piping was analyzed at a 12°F higher temperature than the inlet piping and at a pressure of 39 psi. As was done for the inlet piping, concurrent maximum loadings resulting from a flow transient analysis were included in the analysis.
