TENNESSEE VALLEY AUTHORITY

RESPONSE - NRC INSPECTION REPORT NOS.
50-259/84-11, 50-260/84-11, AND 50-296/84-11
RICHARD C. LEWIS'S LETTER TO H. G. PARRIS
DATED APRIL 27, 1984

259, 260, 296/84-11-01

REQUEST FOR RELIEF ISI-3

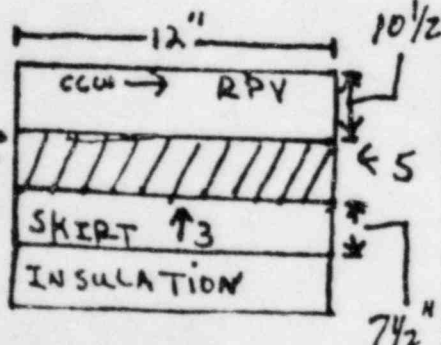
REPORT NO. R-173

NO SCAN 4 due to INSULATION
