**SG Structural Inspection Plan
In Support
of Braidwood-1 and Byron-1
3.0 Volt IPC**

**COMMONWEALTH EDISON COMPANY
SEPTEMBER 1995
REV.0**

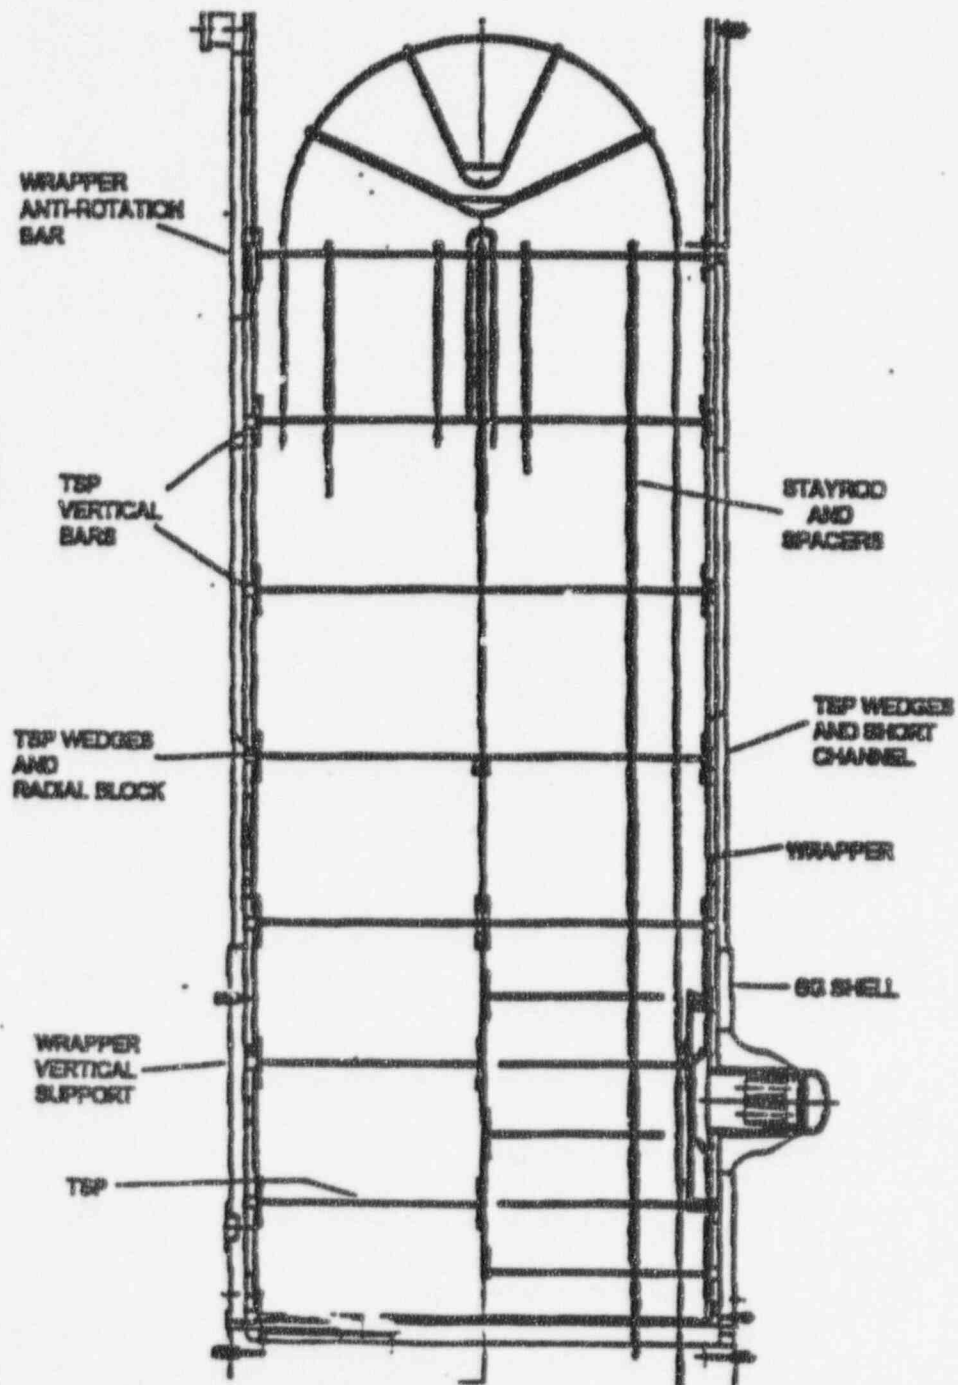
FIGURE 1

The TSPs are supported by stayrods with spacers, and by vertical support bars welded to the wrapper, which is supported by the SG shell. Figures 1 and 2 give an outline of the location of these components.

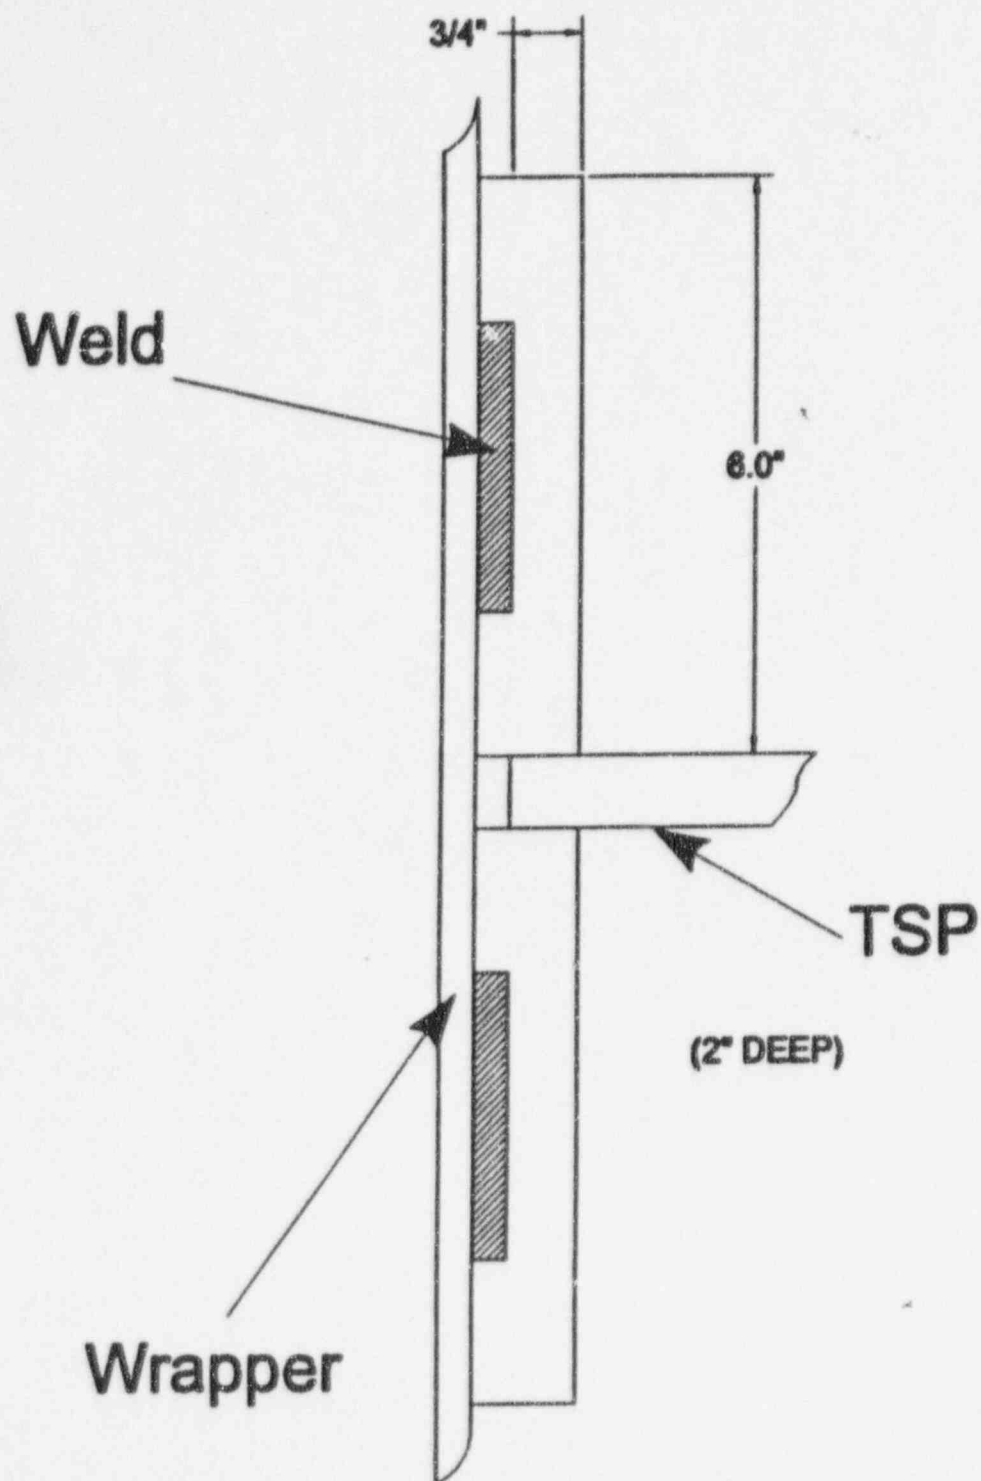
**MODEL D4
TSP SUPPORT
(12 PER PLATE)**

The TSP vertical support bars have longitudinal welds on each side attaching the bars to the wrapper (see Figure 3). These welds provide a factor of 6 margin against the largest SLB load on any bar. Therefore, only 1/6 of the total weld length or 1/3 of one weld must be structurally sound to support the TSP displacement analyses. Since less than one weld without cracks is acceptable, each weld, rather than each bar, can be considered to be an inspection sample.

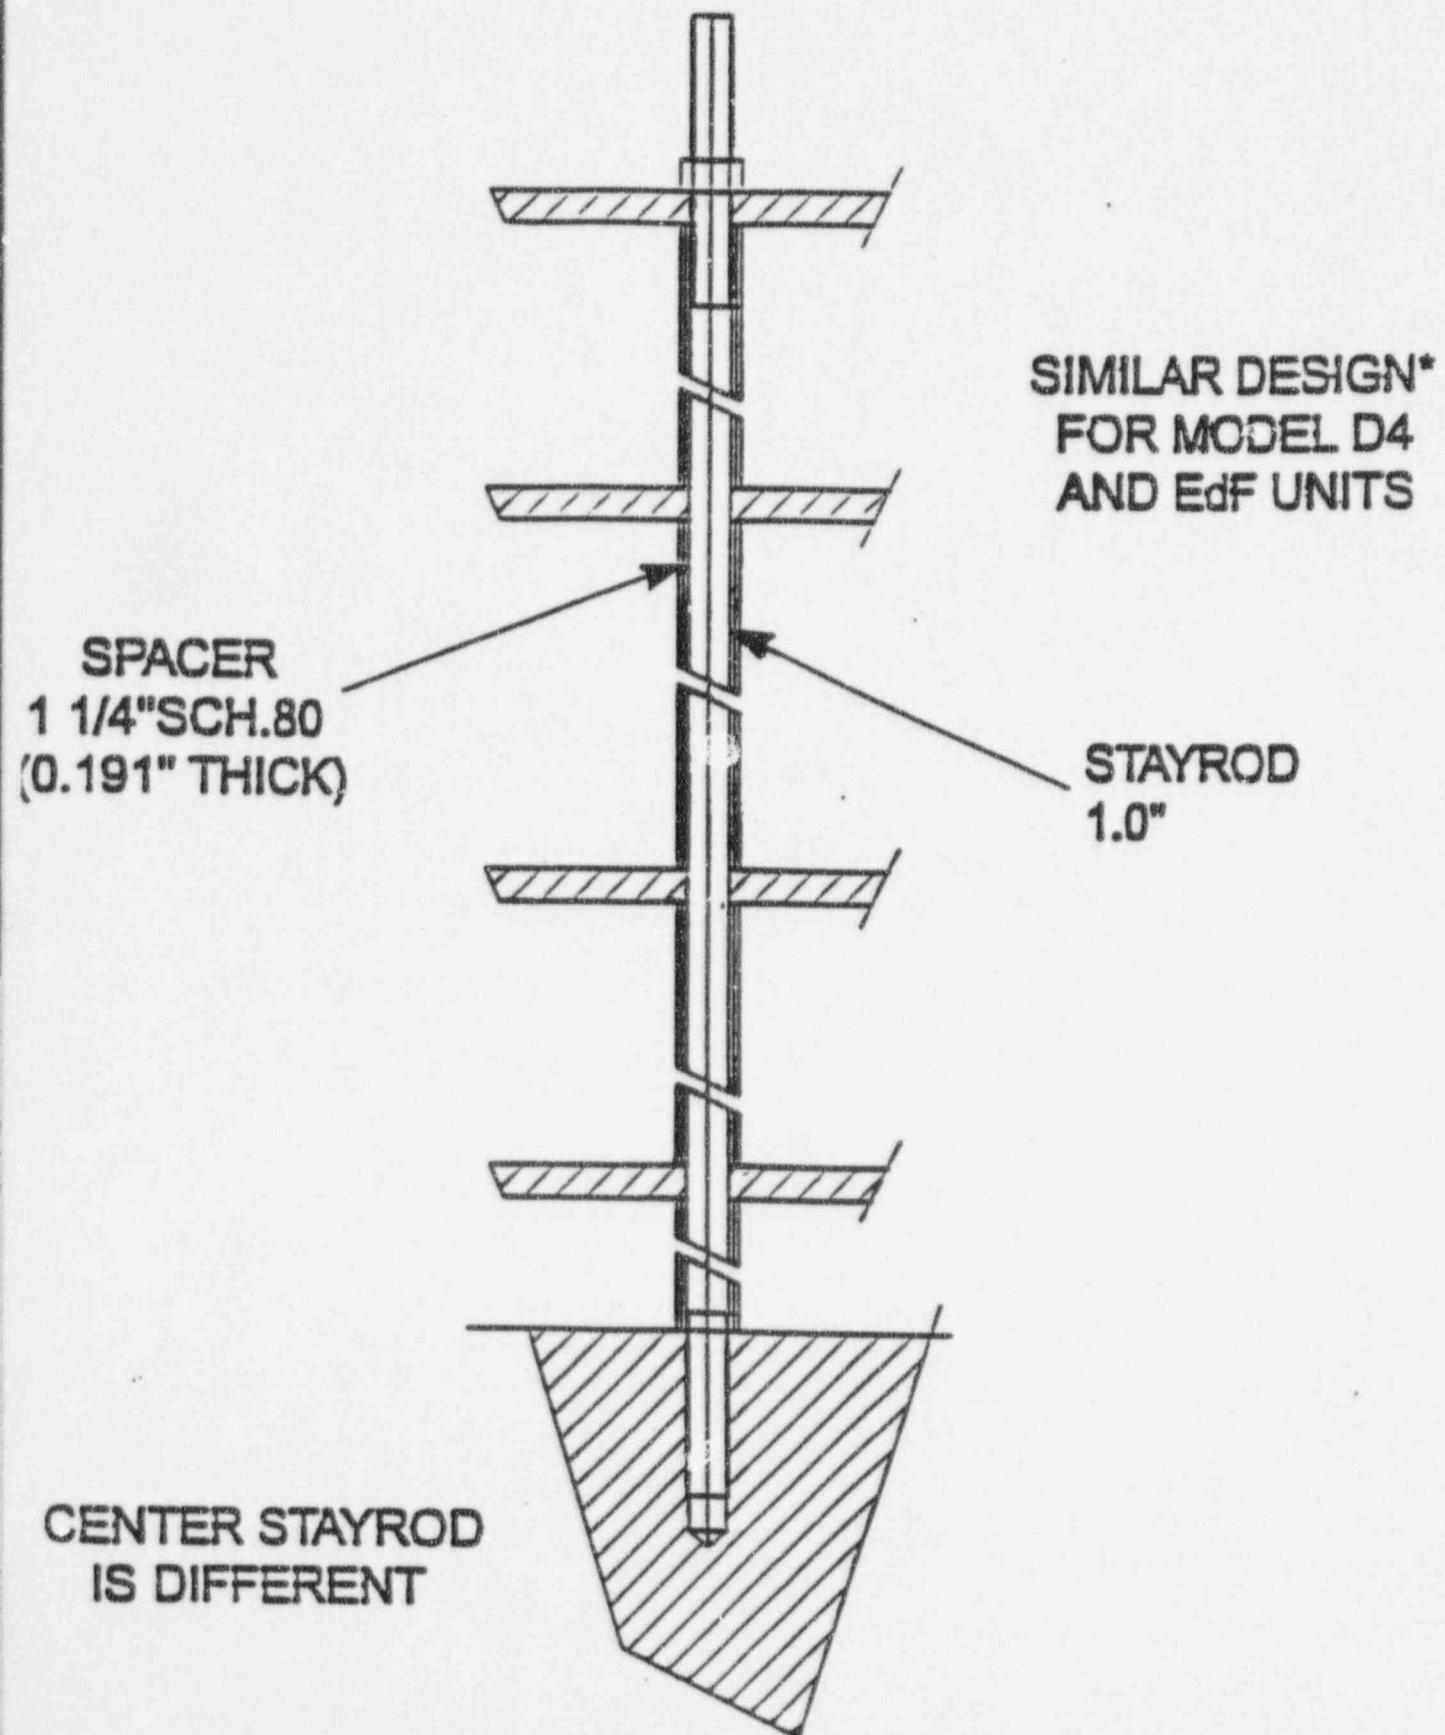
FIGURE 4

There are 5 stayrods on each of the hot and cold legs that extend from the tubesheet to the top TSP. Figure 4 details a typical stayrod configuration. In addition, there is a stayrod at the center of the SG that extends from the top of the preheater divider (plate 8) to the top TSP. For limiting TSP displacements, only the 5 stayrods in the hot leg and the stayrod at the center of the SG are critical to limiting hot leg displacements. The stayrods are 1.0" diameter carbon steel rods. The spacers are 1.25" schedule 80 carbon steel (0.191" thick) and hold separation distance between each TSP.

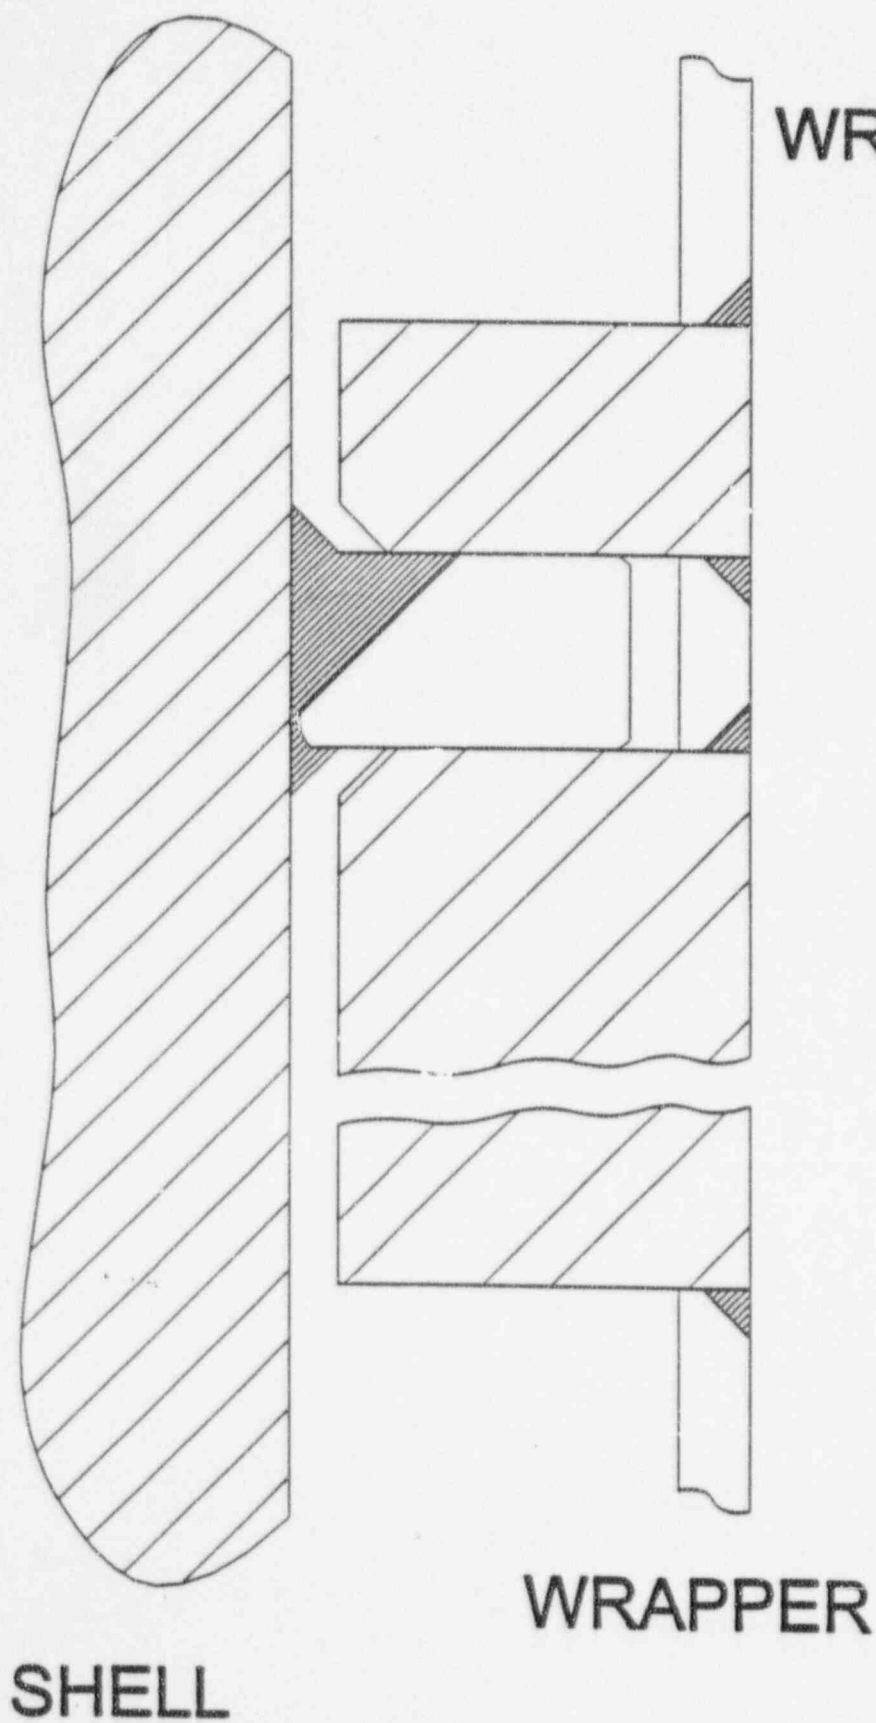
WRAPPER VERTICAL
SUPPORT

The wrapper support blocks transmit loads between the wrapper and the shell. There are seven locations distributed around the wrapper circumference where wrapper support blocks are installed. Figure 6 shows the wrapper block supports. The only known degradation of this structure was seen at a foreign unit with a different internals design. The damage mechanism resulted in the entire wrapper "dropping" within the SG. This was discovered when a secondary inspection port was opened for sludge lancing and the sludge lance equipment could no longer enter the tube bundle due to misalignment.

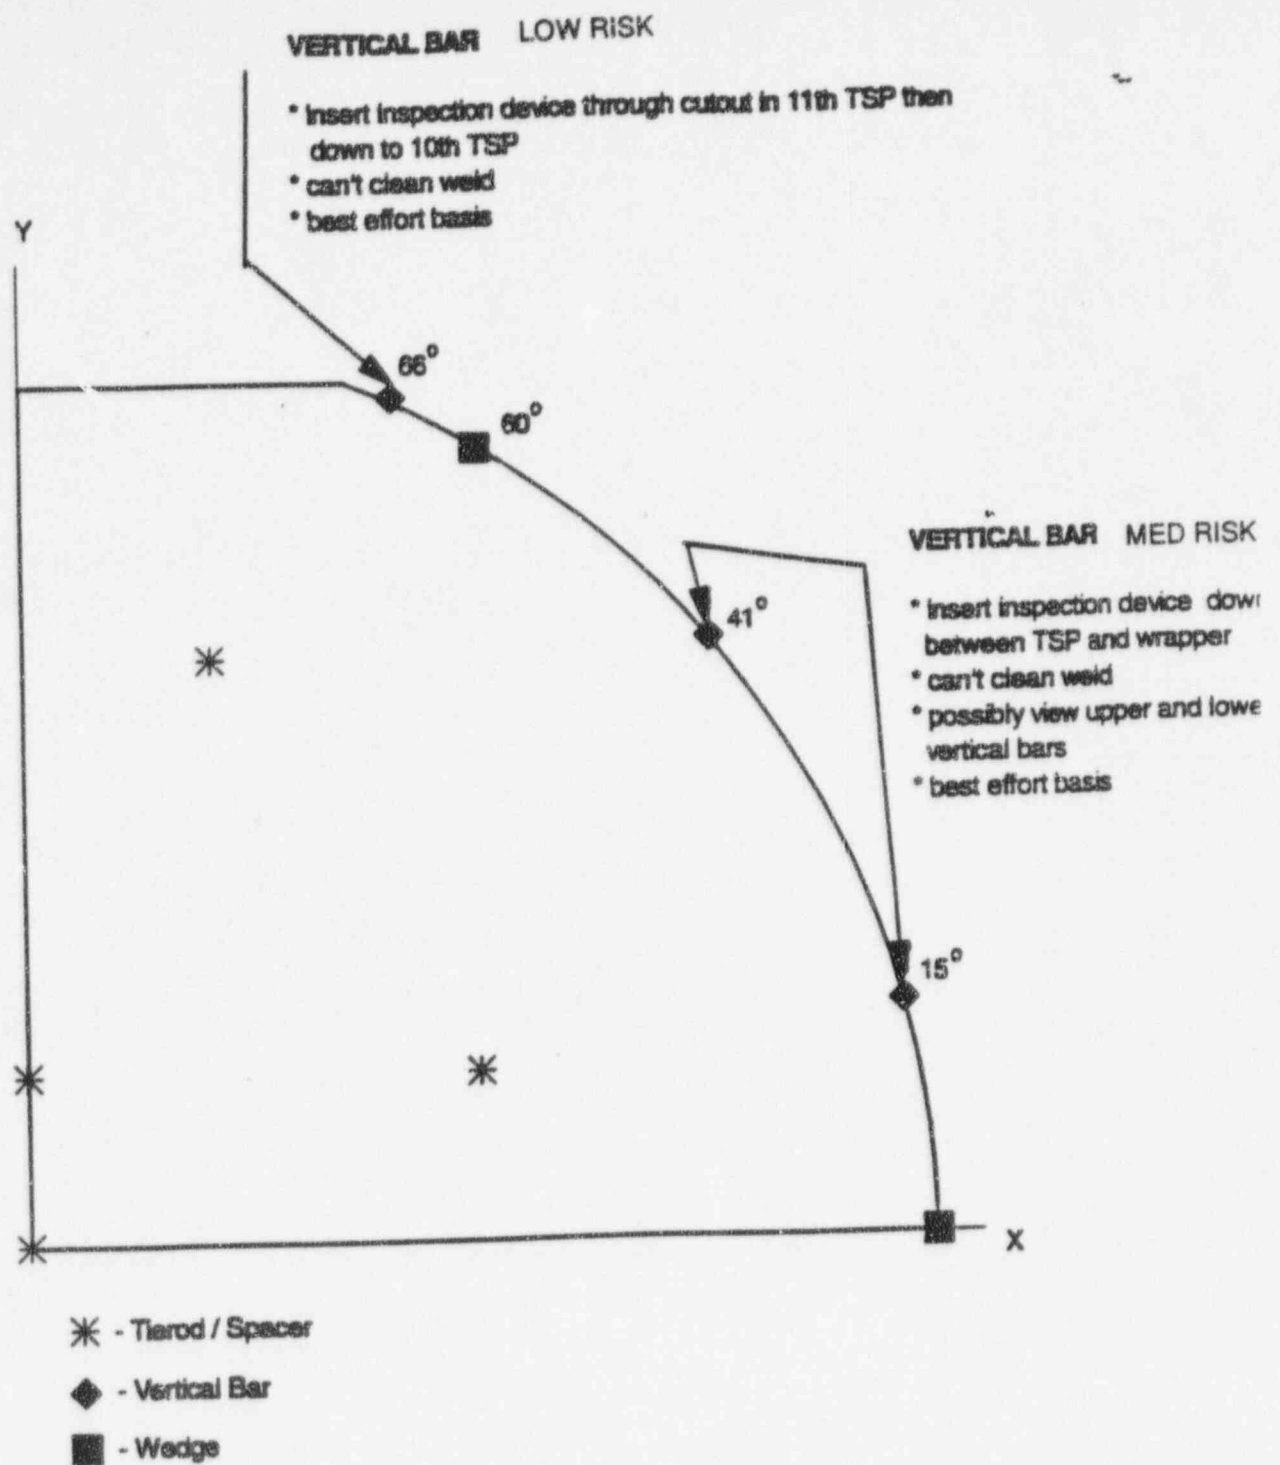
Plate N (10H) Support Locations

- * Insert inspection device through cutout in 11th and 10th TSP then down to 9th TSP
- * can't clean weld
- * can only view one side of bar and weld
- * best effort basis
