ATTACHMENT C  
PHILADELPHIA ELECTRIC COMPANY  
PEACH BOTTOM ATOMIC POWER STATION  
UNIT 3  
DOCKET NO. 50-278

SAFETY EVALUATION FOR THE  
OPERATION OF PEACH BOTTOM  
ATOMIC POWER STATION UNIT 3

SUBJECT: Safety Evaluation for the Operation of  
Peach Bottom Atomic Power Station Unit 3

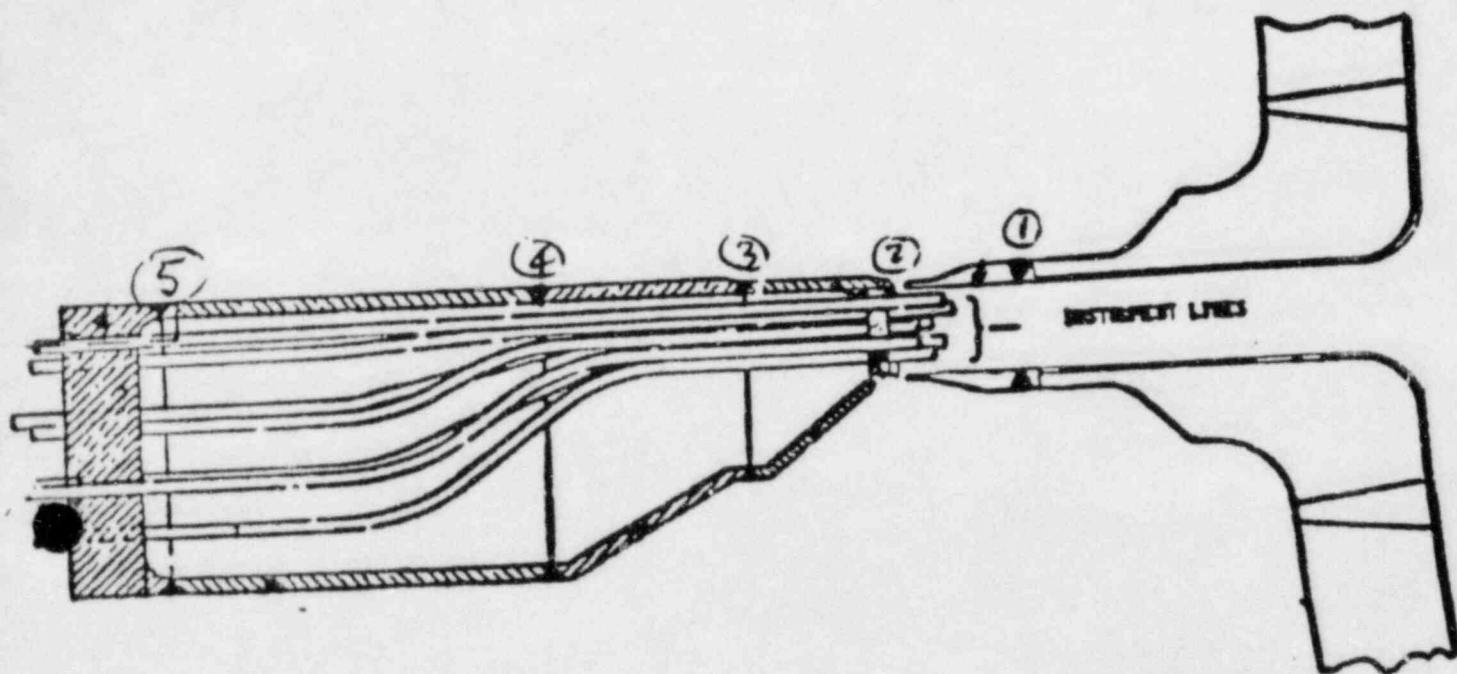
FIGURE 1

Philadelphia Electric Company performed inspections of the Peach Bottom Unit 3 jet pump instrumentation penetrations in response to I.E. Information Notice 84-41 and NRC Generic Letter 84-11. As part of this program, ultrasonic examinations were performed on the five welds associated with each jet pump instrumentation penetration. Circumferential crack-like indications were found on weld No. 2 on each of the two jet pump instrumentation penetrations (see Figure No. 1). In addition to the crack-like indications, the "B" loop No. 2 weld also showed three pin-hole leaks.

The "A" loop circumferential indication was in the 12 o'clock position on the safe-end side of the No. 2 weld. The "B" loop circumferential indication with three pin-hole leaks was in the 12 o'clock position on the reducer side of the No. 2 weld. The pipe material at both of these locations is 4" nominal, Schedule 80 TP-304 Stainless Steel. The minimal wall thickness of these welds is 0.337".

JET PUMP INSTRUMENTATION  
SEAL AND SAFE END

General Electric Company recommended applying a 0.125" thick by 1.5" long overlay on each weld to assure leak-free operation for a minimum of 18 months of full power operation.
