ROBERT E. DENTON
Vice President
Nuclear Energy

September 11, 1995

SUBJECT: Calvert Cliffs Nuclear Power Plant
Unit No. 1; Docket No. 50-317
Supplemental Information; Request for Temporary Relief from ASME Boiler &
Pressure Vessel Code Section XI Requirement IAW-5250

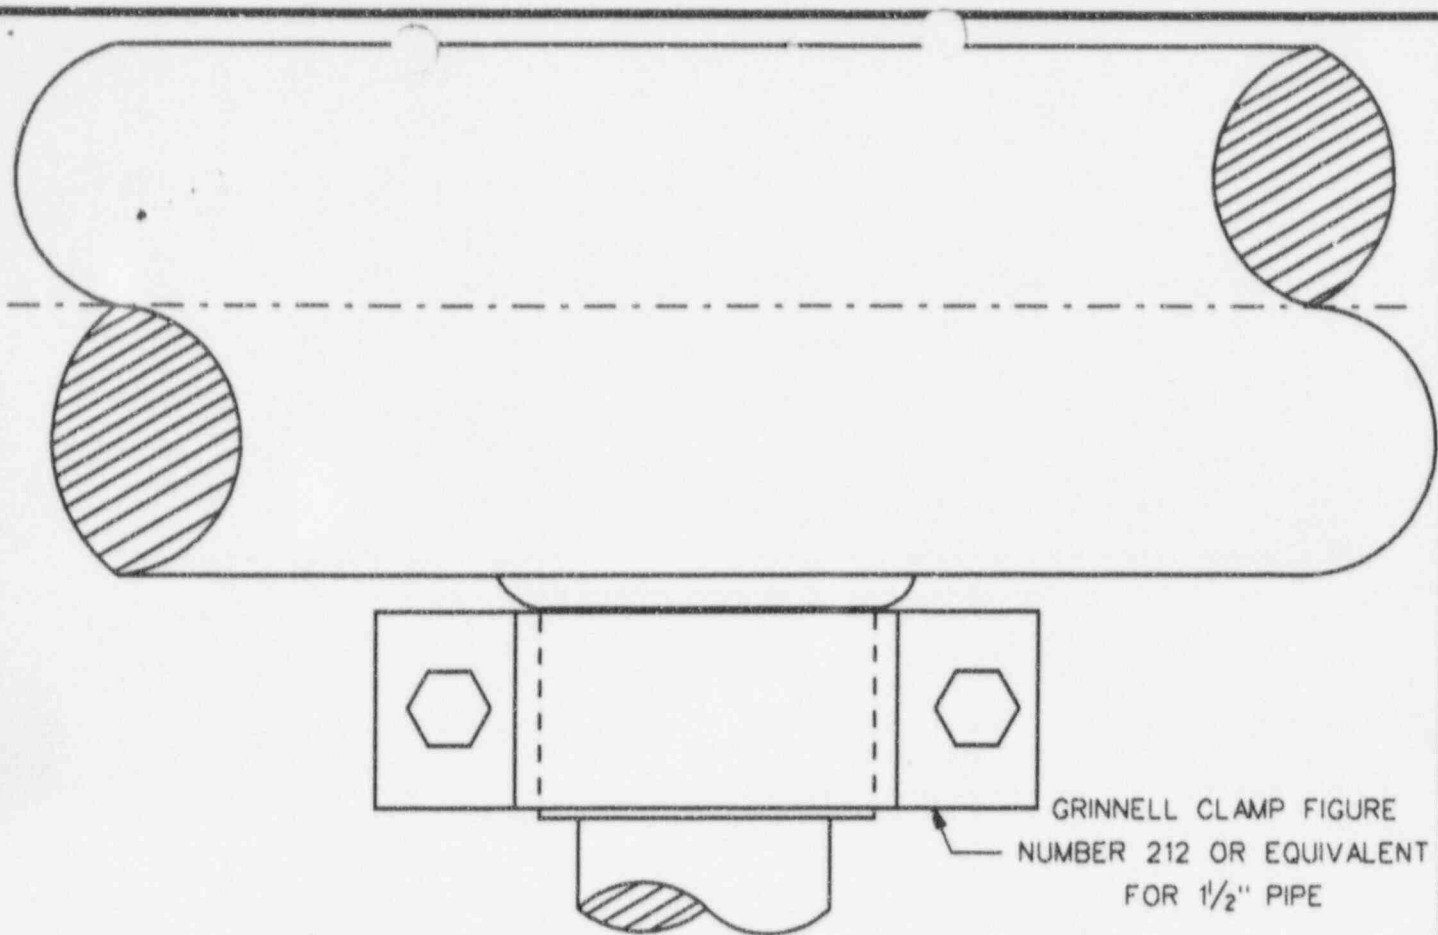
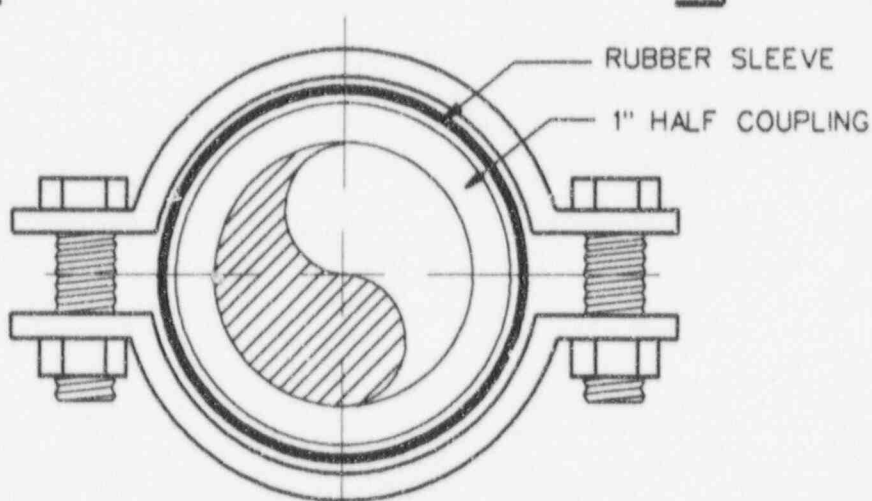
SECTION "A-A"

A description of the leaking half-coupling was provided in Reference (a). The additional degradation was discovered by the team performing the follow-up ultrasonic examination of the saltwater pipe in the area of the half-coupling. The half-coupling now has a visible through-wall hole at the location of the previous flaw. The flow of water from the hole has not changed substantially because as the flaw has continued to degrade, the resultant hole has become clogged with biological growth.

In order to prevent leakage into the service water room from the continued degradation of the half-coupling, we plan to install a rubber-lined pipe clamp around the flawed portion of the half-coupling (see Attachment 1) should the leakage significantly increase. The clamp will have no effect on the structural integrity of the 36" saltwater pipe, and is a reversible leakage limiting device.
