February 11, 1992

SUBJECT: Calvert Cliffs Nuclear Power Plant
Unit No. 2; Docket No. 50-318
Request for Temporary Relief from ASME Boiler & Pressure Vessel Code
Section XI Requirement IWA-5250

ATTACHMENT (1)
UNIT 2
RWT SAFETY INJECTION NOZZLE

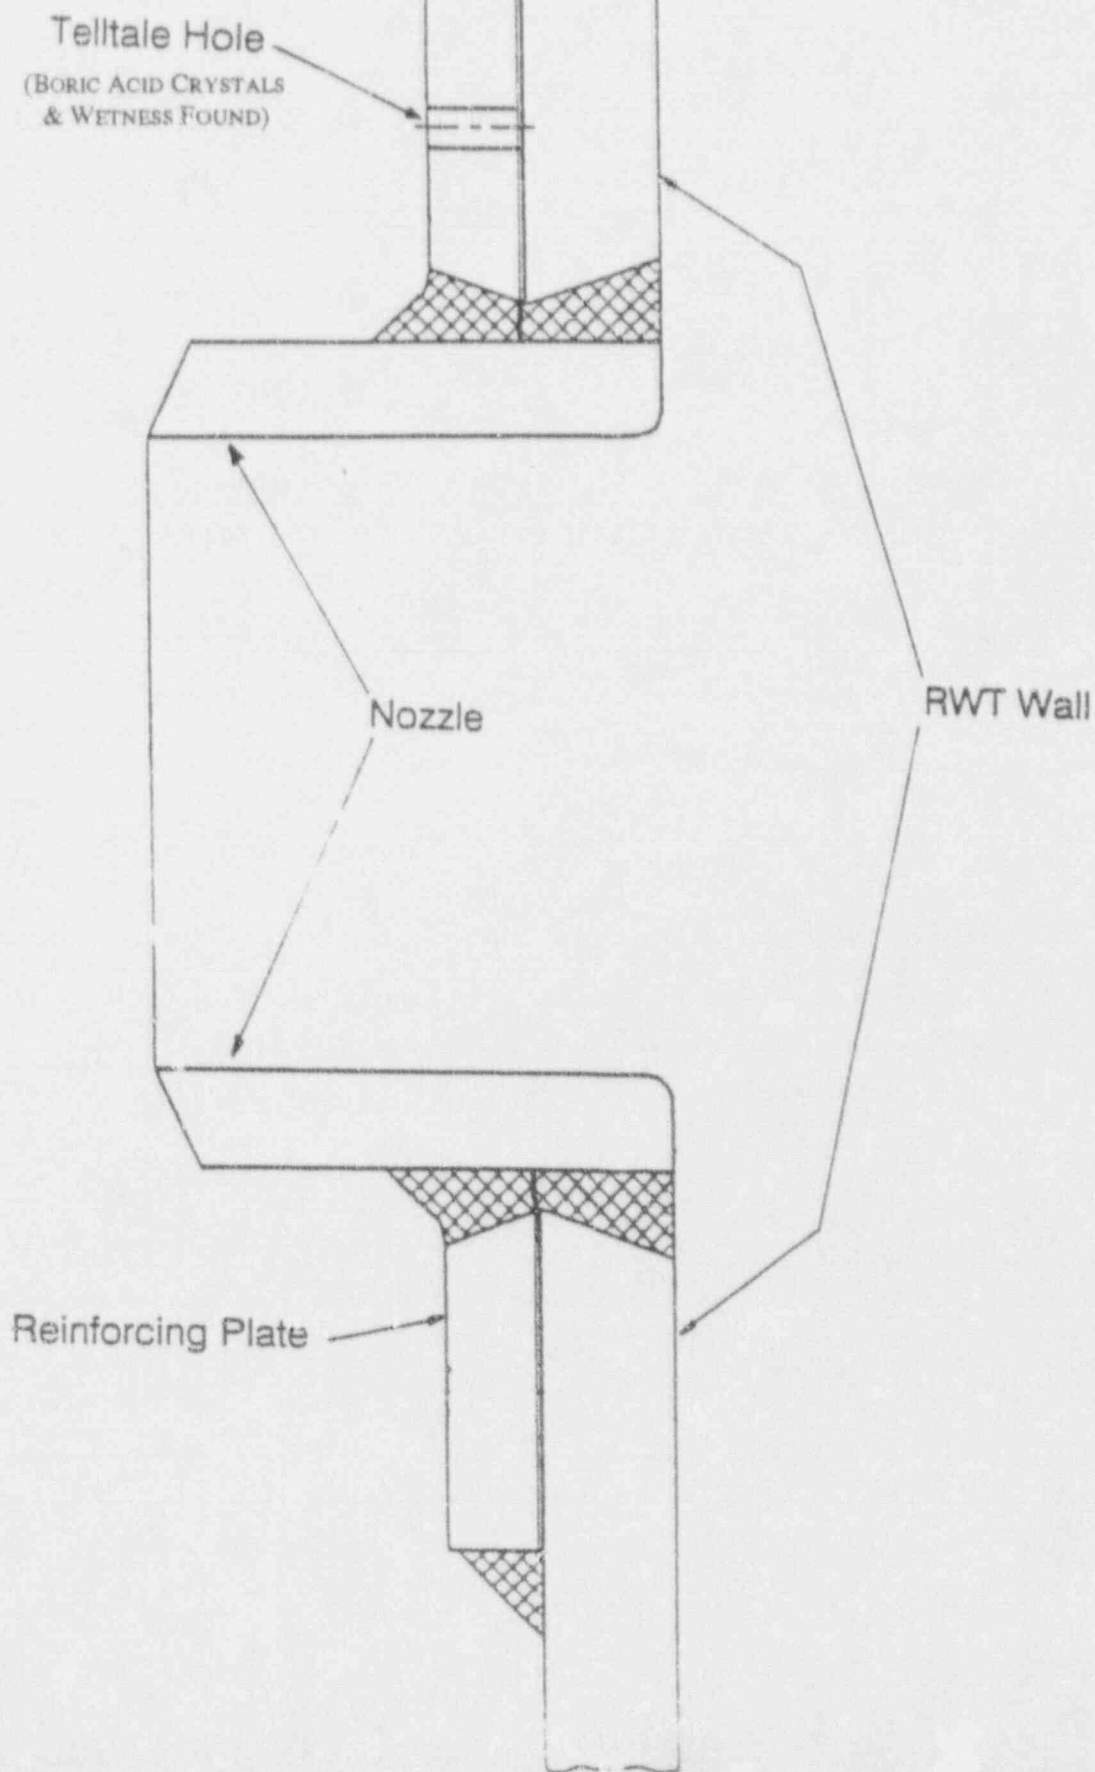
During rounds on February 5, 1992, evidence of a leak from the Unit 2 RWT was found. This evidence consisted of crystalized boric acid and wetness in the telltale hole of the reinforcing plate surrounding the nozzle for the "A" train safety injection suction line (see Attachment 1). No active leakage (drops or stream of water) was found.

Also, in 1989, an internal visual examination of the penetration was performed. No detectable indications were identified. Past problems with similar welds on these tanks have been due to slag inclusions in the weld. The current leakage is probably a direct result of dissolution of entrained slag, which has resulted in a leakage path. It is unlikely that the leakage path size will increase due to the low level of applied alternating stress. The stainless steel tank and weld material is resistant to corrosion or stress corrosion cracking for the ambient temperature and chemistry of the water contained in the RWT. Therefore, because of the low level of applied stress and the resistance to corrosion, the leakage path is not expected to grow larger than the original inclusion.

Instead of conducting a repair at this time, we propose to perform periodic visual examinations to ensure that the leakage from the RWT penetration weld does not significantly increase. This provides appropriate safety assurance until Unit 2's next scheduled refueling outage (spring 1993), at which time a Code repair will be effected.

We will perform daily visual examinations to verify that the leakage from the Unit 2 RWT penetration weld does not increase significantly. Should the leakage from the weld increase to a steady stream, we will reevaluate our analysis.
